Marine Habitat Survey Address | 167 Riverview Road, Avalon Beach Client | Mr Simon Ehrlich Survey Date | 17 May 2021 Report Date | 21 July 2021 Job Number 21-072-02

1. Report Background

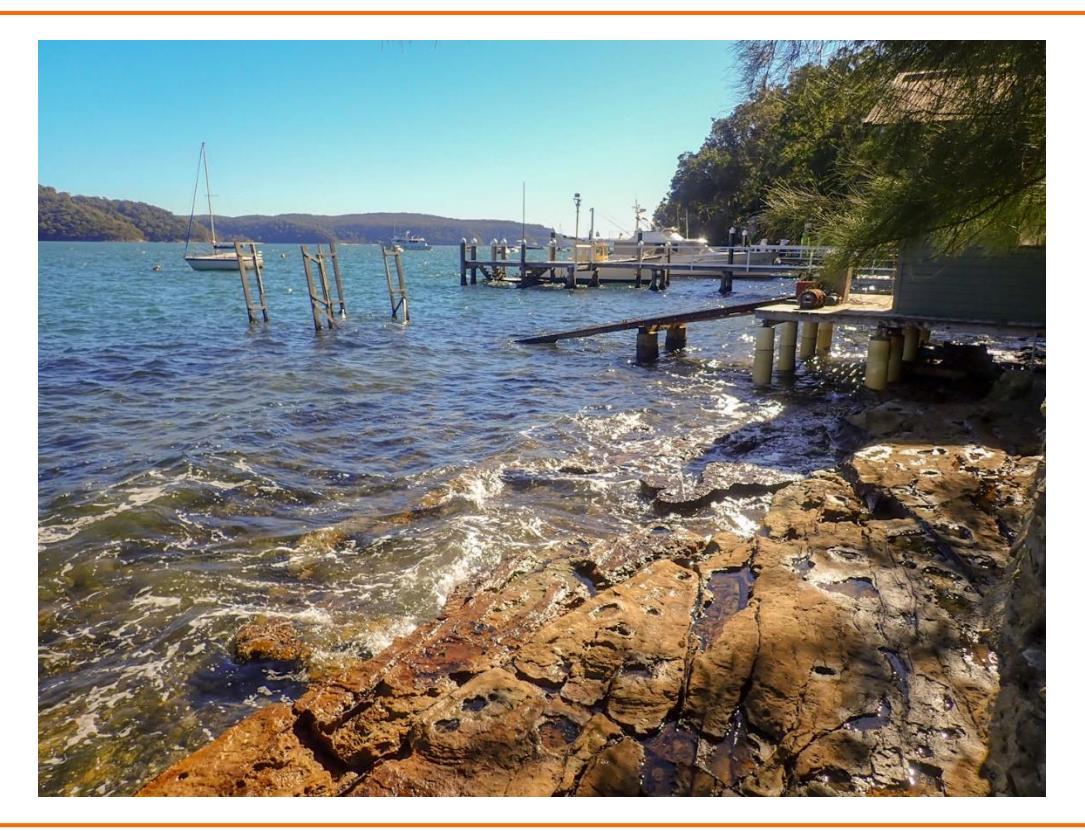
Photo 1. Existing structures (boatshed, deck, slip rails and cradle) at The Property viewed looking north, with extensive intertidal rock platform visible in foreground.

The existing structures (Photos 1 - 3) present at The Property at the time of the on-site survey included:

- a timber boatshed and deck (extending 4 7 m beyond the MHWM), supported on 12 sleeved concrete piers, on the northern edge of The Property; and
- a set of metal slip rails (23 m in length), supported on concrete piers, extending out from the centre of the boatshed deck.

The intertidal zone at The Property consisted of artificial and natural habitats. A sandstone block seawall stretched across the width of The Property (Photos 2 and 4) and was fronted by an extensive intertidal rock platform (Photos 1 and 4). The rock platform extended 14.5 m out from the seawall (to the end of the proposed jetty). The sleeved shed and deck piers, and the metal slip rails provided additional artificial intertidal habitats (Photos 1 and 3).

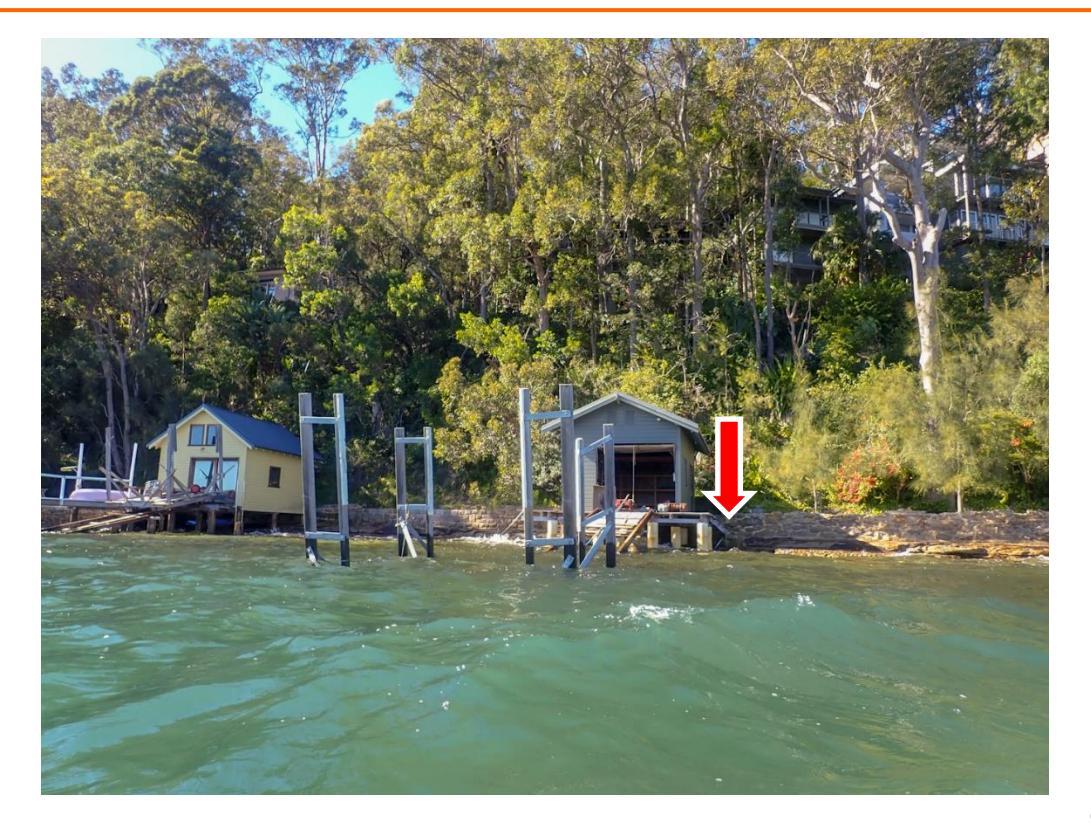
Photo 2. Existing structures viewed from the water – the red arrow indicates the location of the proposed jetty.

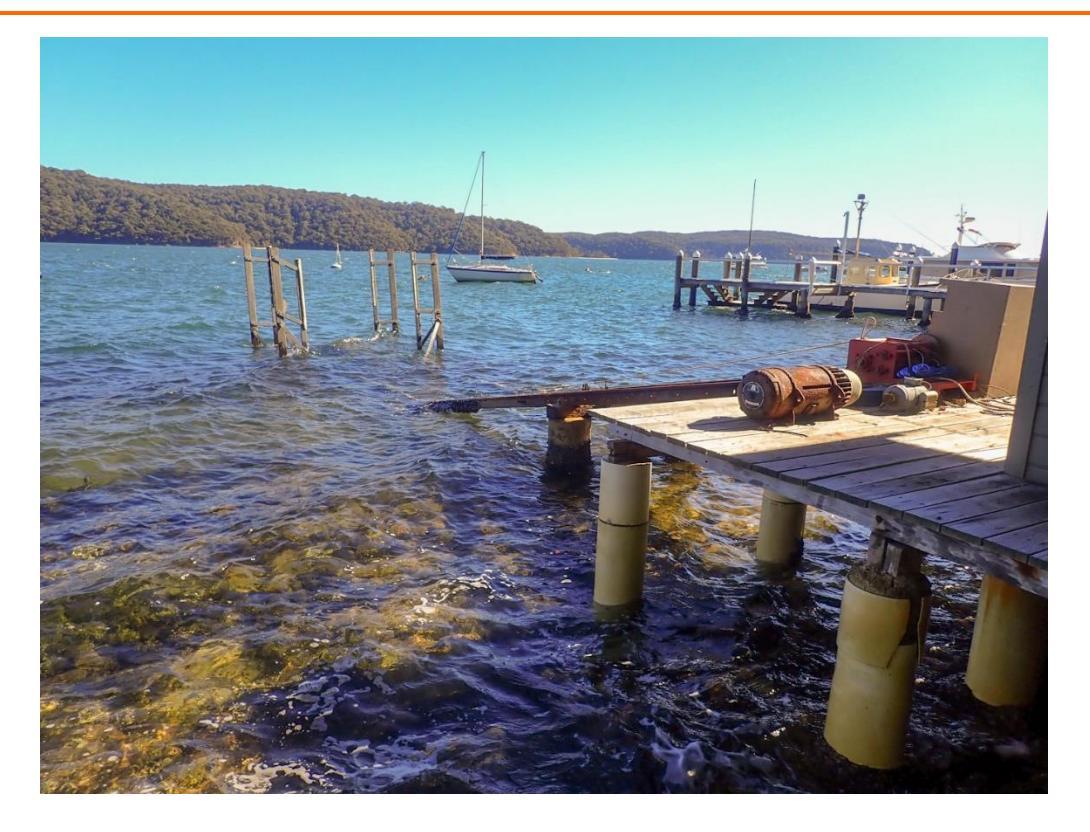
Photo 3. The location of the proposed jetty, adjacent to the southern side of the timber deck.

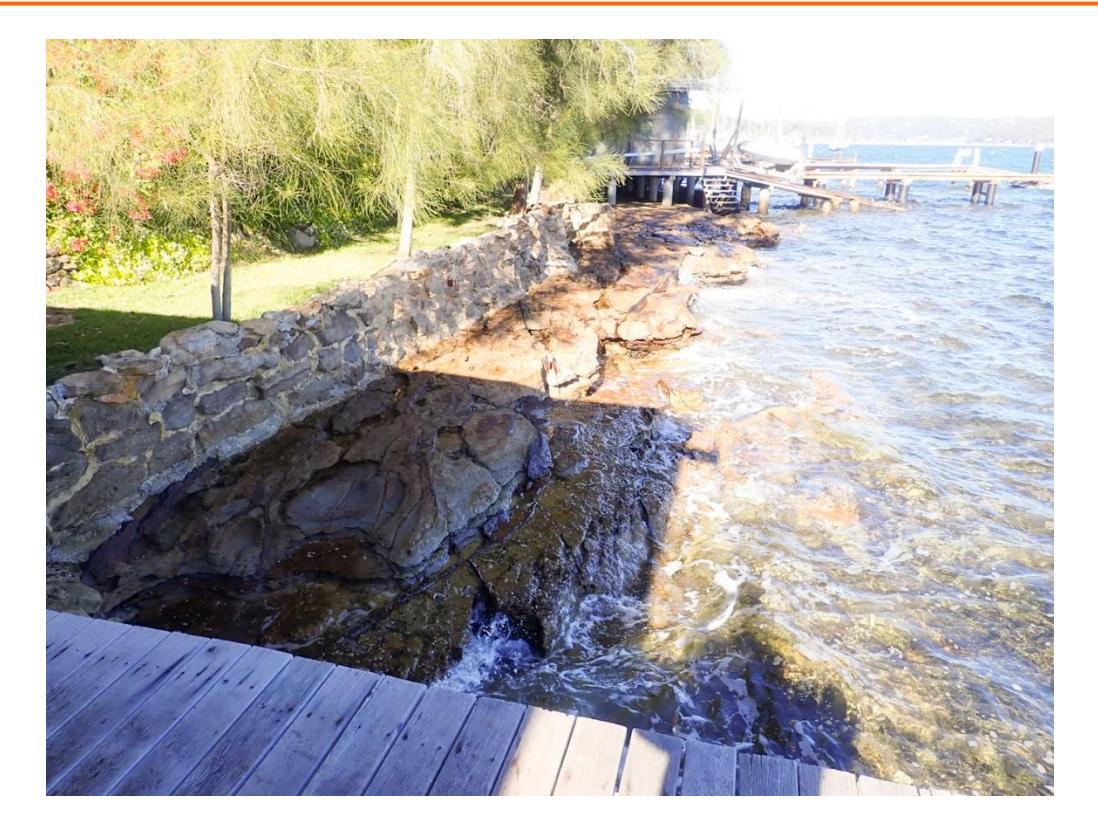
Photo 4. The seawall and upper zone of the intertidal rock platform at the location of the proposed jetty.

The base of the seawall was colonised by low numbers of small periwinkles (*Nodilittorina unifasciata*). The rock platform had two intertidal zones of biota. The upper zone (extending the upper 5 m out from the seawall), was colonised by low numbers of periwinkles (*Austrocochlea porcata, Bembicium nanum* and *Nodilittorina unifasciata*) and mulberry whelks (*Morula marginalba*). The lower zone (that extended the outer 10 m) was colonised by brown algae (Neptune's necklace *Hormosira banksii*, encrusting *Ralfsia verrucosa* and unidentified filamentous; Photo 5) and a low density cover of Sydney rock oysters (*Saccostrea glomerata*). The sleeved shed and deck piers were colonised by barnacles (*Tesseropora rosea*) on their inshore sides. The metal slip rails and concrete piers were colonised by oysters and green filamentous alga.

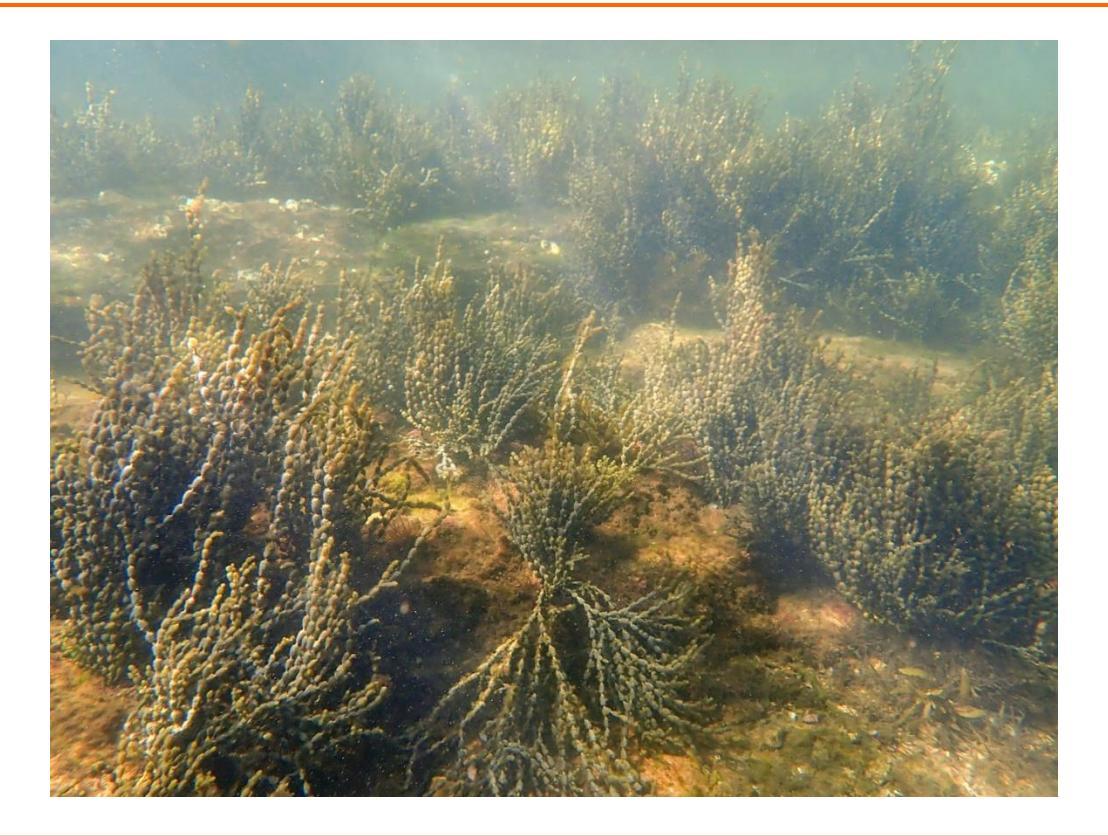
Photo 5. Brown algae (Neptune's necklace and turfing filamentous) colonising the submerged, lower zone of the intertidal rock platform in the footprint of the proposed jetty.

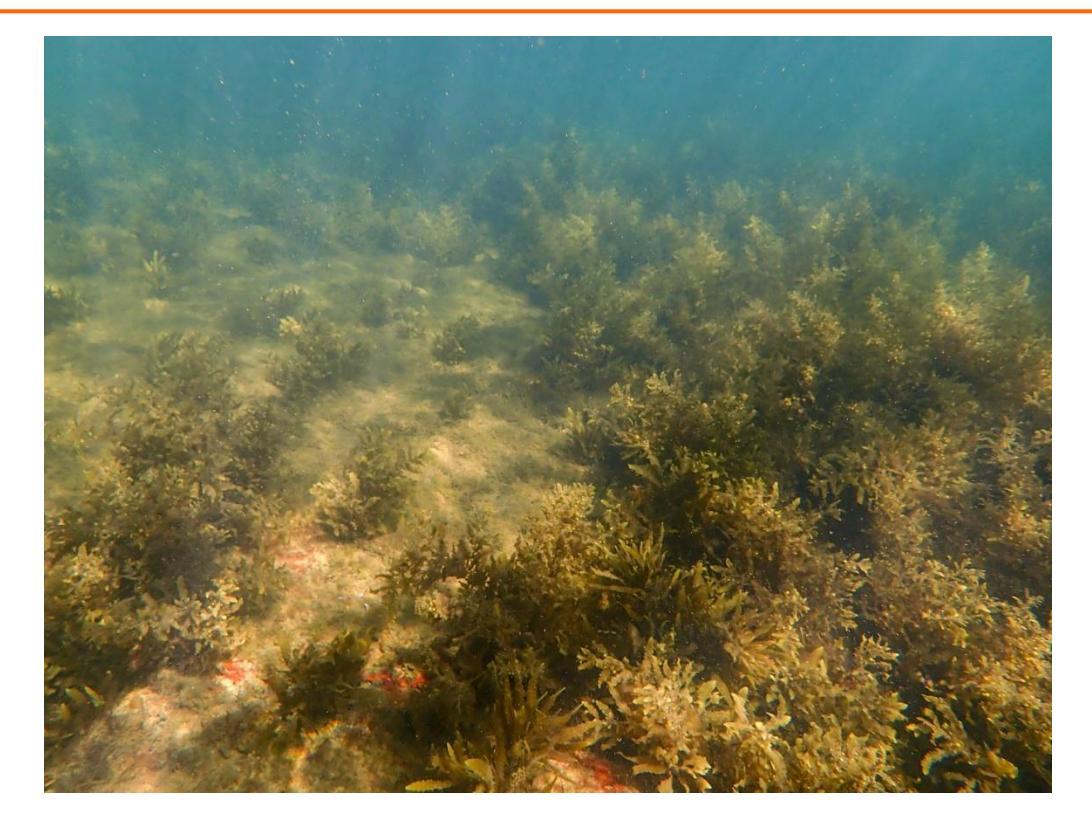
Photo 6. The subtidal rocky reef in the footprint of the proposed jetty end, ramp, pontoon and pontoon stabilising piles, colonised by brown macroalgae and turfing red coralline algae

The subtidal zone within the on-site survey area of The Property consisted of a gradually sloping rocky reef with several patches of sand, that extended offshore from 14.5 - 24.5 m off the seawall (Photo 6). The proposed outermost jetty piers, ramp, pontoon and pontoon stabilising piles would be located in/over this rocky substratum. Beyond 24.5 m off the seawall, the seabed consisted of gradually sloping sandy silt (Photos 7 - 8) that was bioturbated from the burrowing activities of benthic fauna and continued offshore beyond the onsite survey area.

The rocky reef from 14.5 - 19 m was colonised by a high density cover turfing brown filamentous alga along with sparse short clumps of brown bubbleweed (*Sargassum* sp.). The outer section of rocky reef from 19 - 24.5 m (Photo 6) was colonised by a high density cover of brown macroalgae (bubbleweed, kelp *Ecklonia radiata*, forkweed *Dictyota dichotoma* and scrollweed *Padina* sp.) and red coralline alga (*Corallina officinalis*). The sandy silt seabed beyond 24.5 m off the seawall (and 2 m seaward if the end of the proposed pontoon) was colonised by *Zostera* and then *Posidonia* seagrass (Photos 7 – 8; see section c. below for more distribution details).

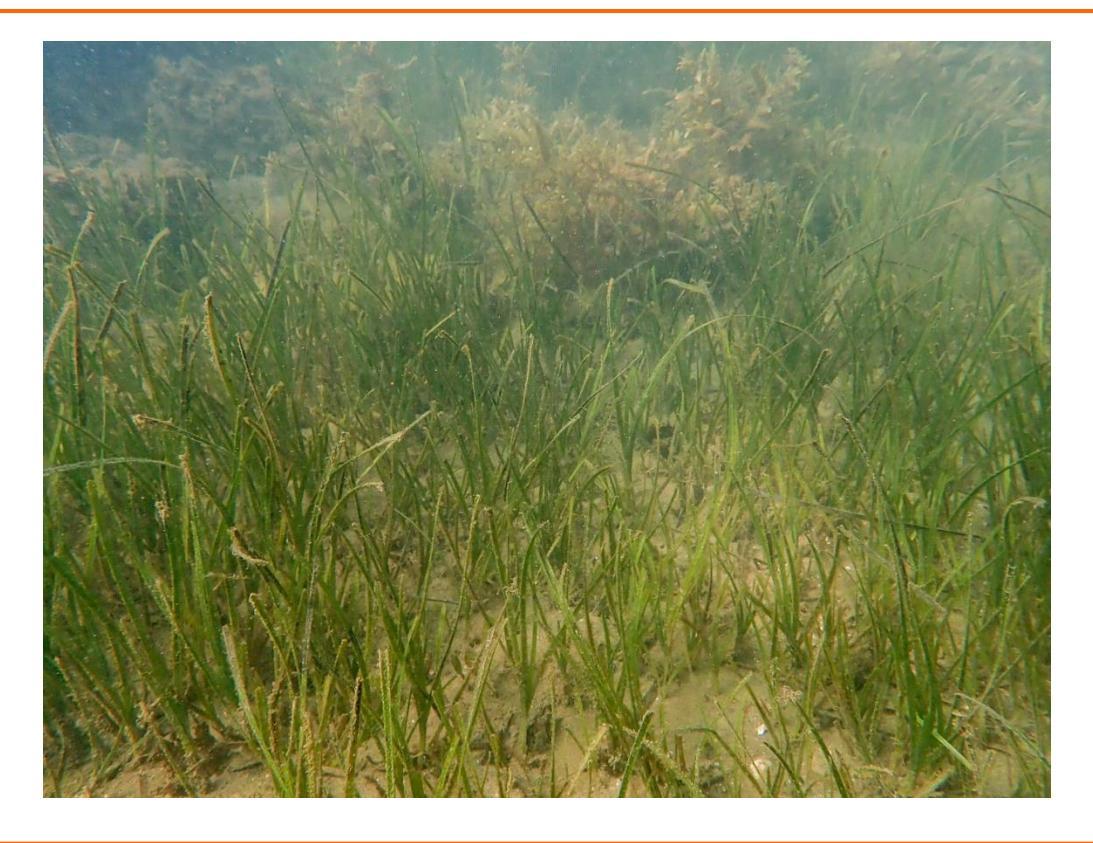
Photo 7. Inner edge of the medium density *Zostera* bed (ZosC2M) located off the end of the subtidal rocky reef (visible in the background) and 2 m offshore of the proposed pontoon.

There was a bed of medium density, medium leaf length *Zostera* (ZosC2M; Photo 7) located 24.5 m off the seawall, in the sandy silt off the end of the subtidal rock reef. This *Zostera* bed ran parallel to the shoreline and was 7 m in width (see seagrass map in Appendix B). The *Zostera* bed transitioned to a low density, medium leaf length bed of *Posidonia* (PosC1M; Photo 8) 31.5 m off the seawall, and continued a further 9 m offshore. At 40.5 m the soft seabed was unvegetated.

There was no seagrass present within the footprint of the proposed structures (see Appendix B). The outer edge of the proposed pontoon would be located 2 m inshore of the *Zostera* bed and the proposed pontoon stabilising piles located 3.5 m inshore of the *Zostera* bed. The inner margin of the *Posidonia* bed would be located 9.5 m offshore of the proposed pontoon.

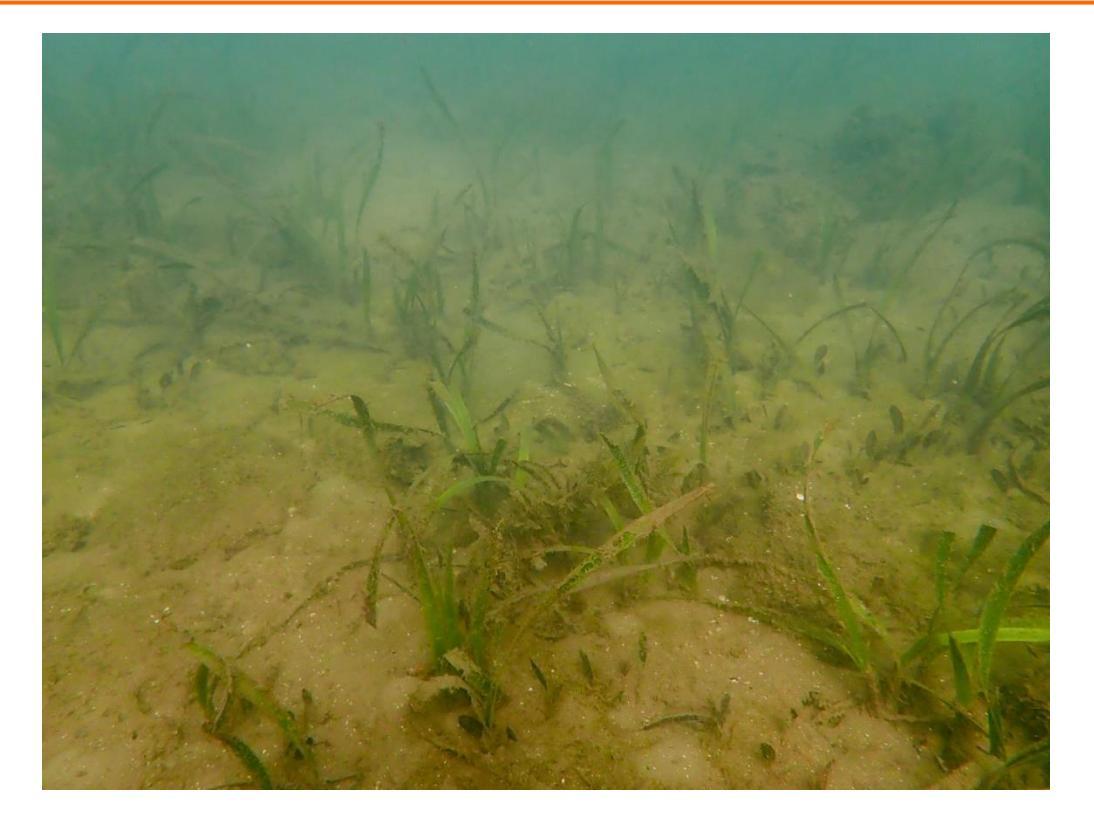
Photo 8. Low density bed of *Posidonia* (PosC1M) on the sandy silt, located 9.5 m offshore of the end of the proposed pontoon.

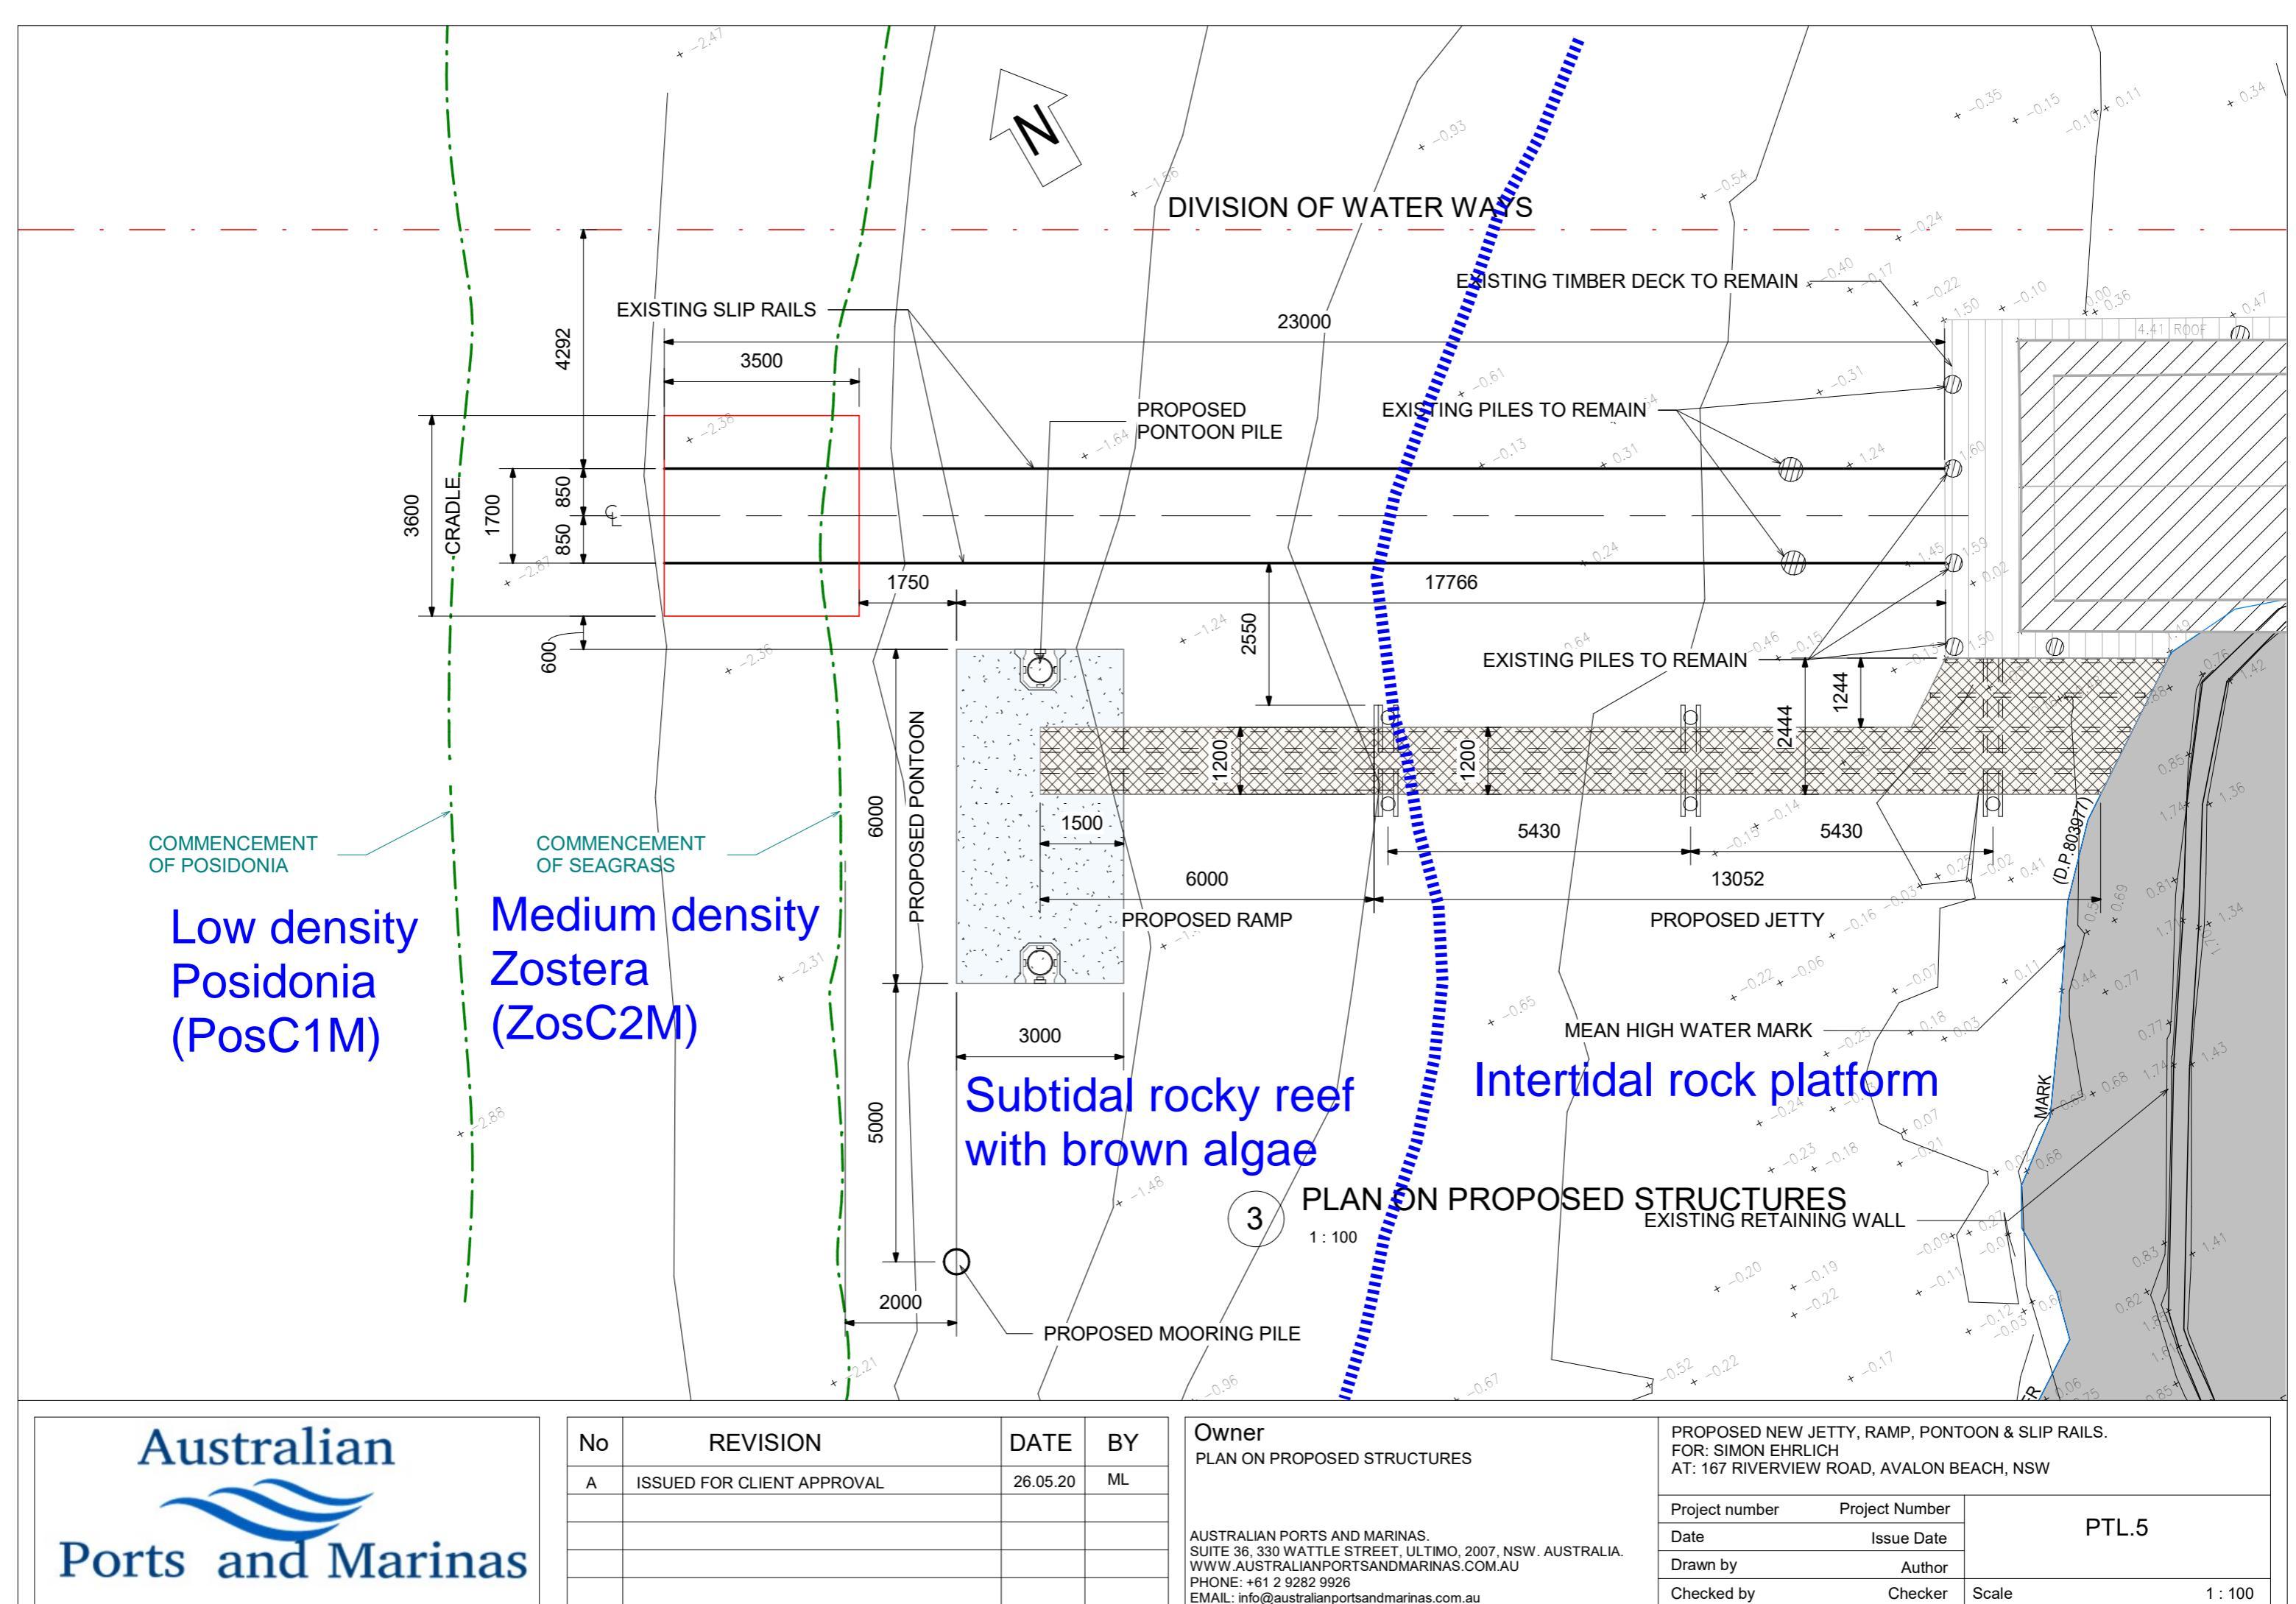
Appendix B - Existing Structures and Seagrass Map

The waterfront development design layout plan for 167 Riverview Road, Avalon Beach provided by Australian Ports and Marinas and mapped seagrass habitats is provided overleaf.

All the proposed structures (jetty, jetty piers, ramp, pontoon and pontoon stabilising piles) would be located in/over the intertidal rock platform and subtidal rocky reef. There was no seagrass present within the footprint of the proposed structures (see seagrass map in Appendix B). The outer edge of the proposed pontoon would be located 2 m inshore of the *Zostera* bed and the proposed pontoon stabilising piles located 3.5 m inshore of the *Zostera* bed. The inner margin of the *Posidonia* bed would be located 9.5 m offshore of the proposed pontoon.
