Preliminary Geotechnical Assessment.

Project: Proposed alterations and additions 179 Alfred Street, Narraweena Narraweena NSW 2099

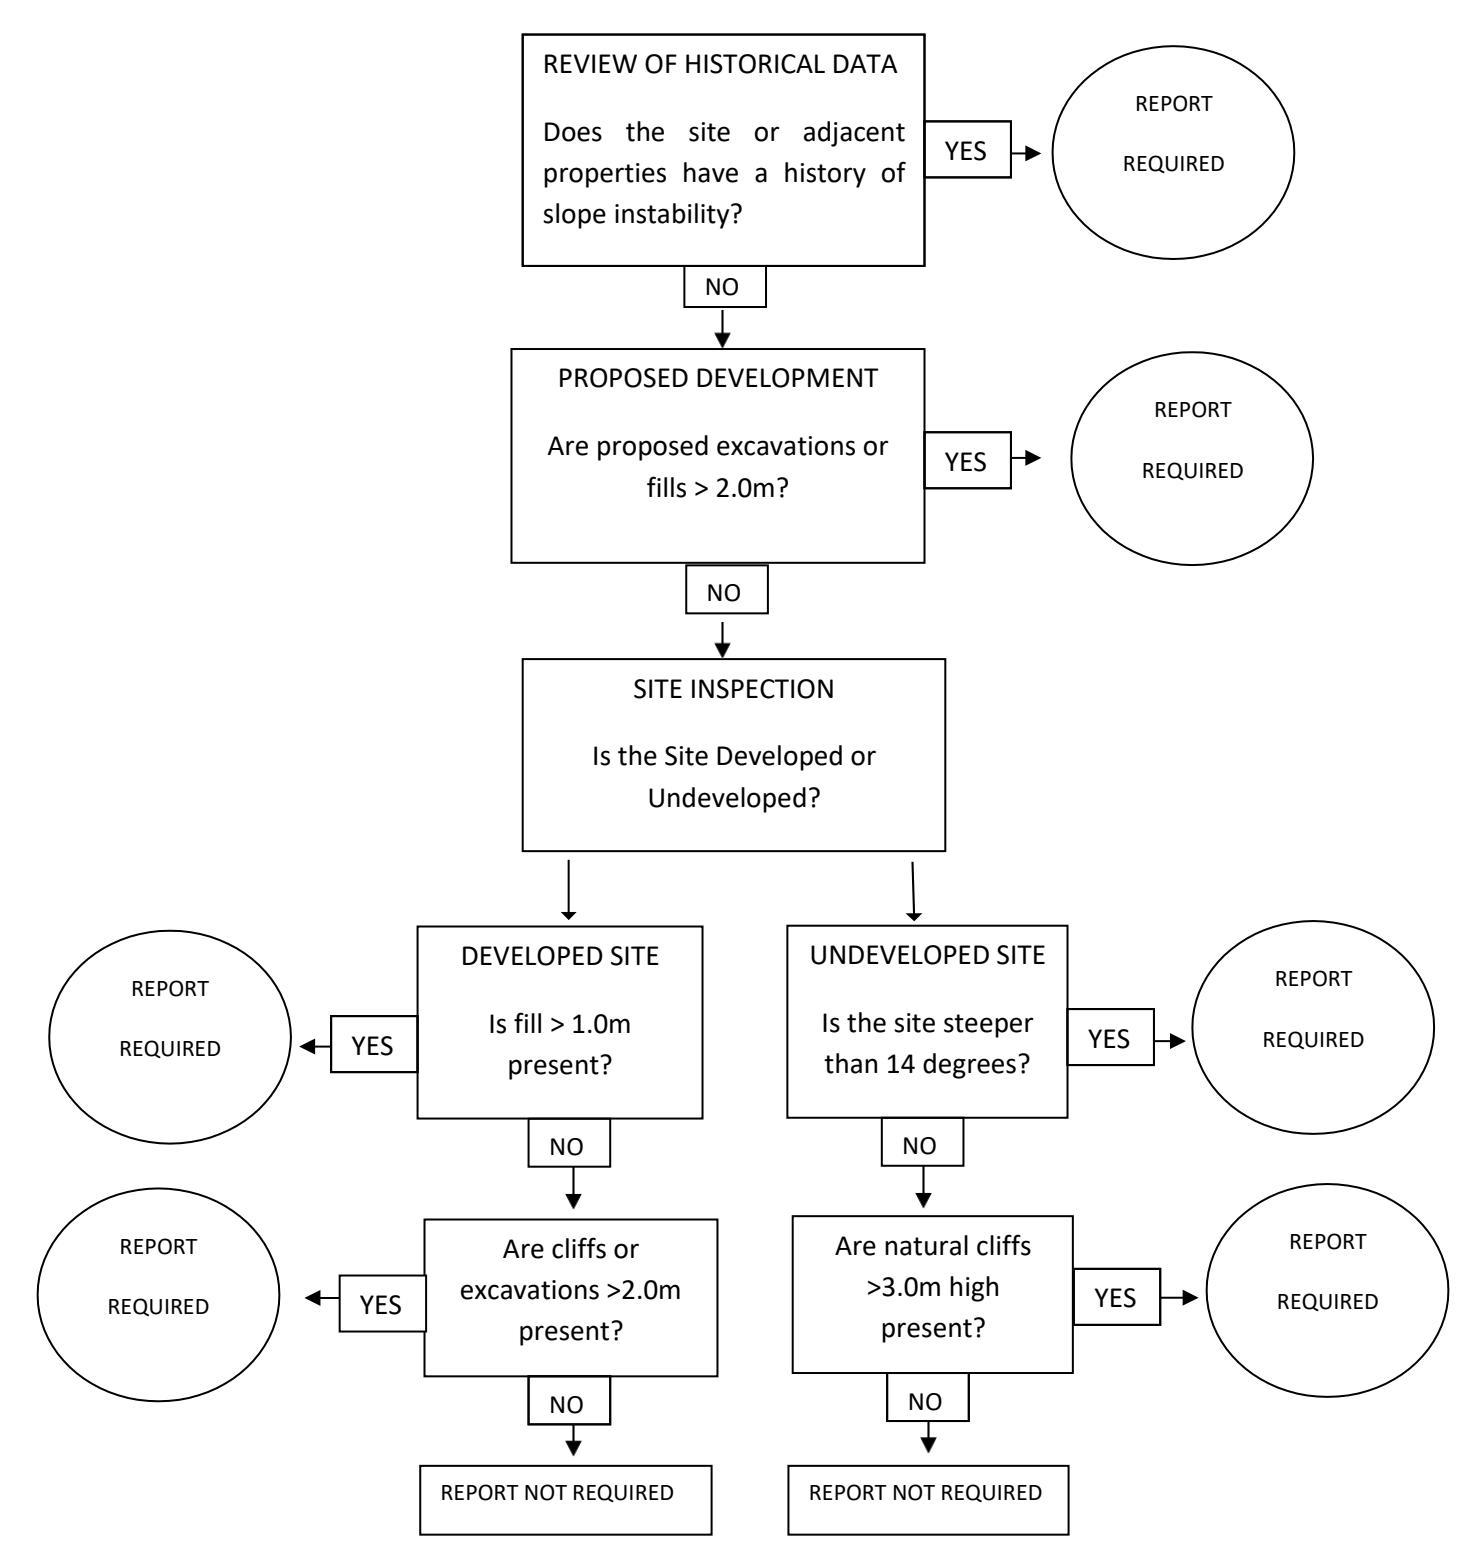
Preliminary Assessment Flow Chart – Northern Beaches Council (Warringah)

The proposed development and site conditions were considered and applied to the Council Flow Chart.

Provided good engineering and building practice are followed, no further Geotechnical assessment is recommended for the proposed development.
