SITE ADDRESS: 18 & 20 The Serpentine, Bilgola Beach.

PROJECT- Addendum to Arboricultural Impact Assessment (AIA) in relation to Development Application No. DA2023/0374 - Construction of a studio and car parking structure.

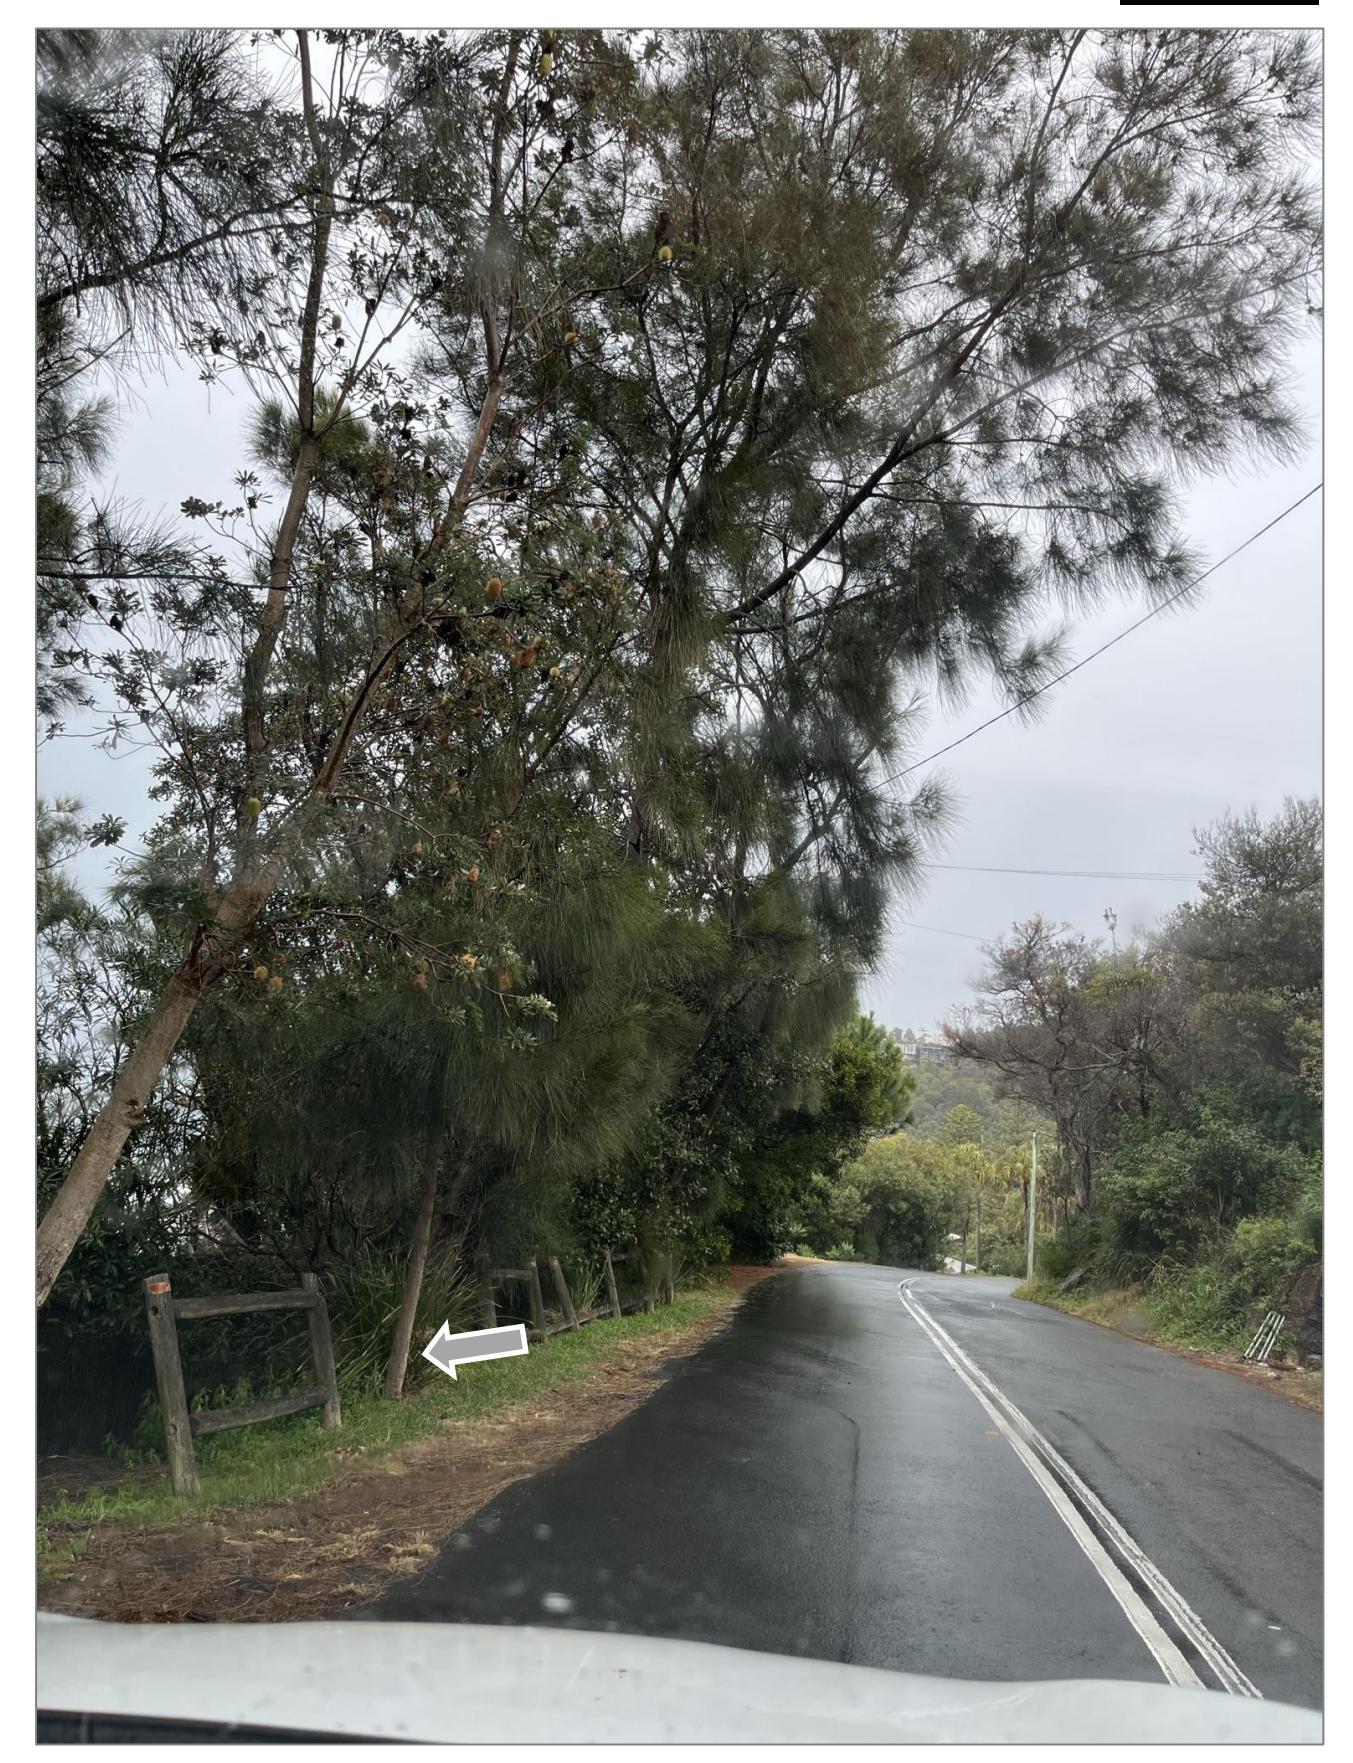
Plate 1 – Arrow notes Tree 15. Crown raise pruning will facilitate sight lines.

Minor crown-raise pruning of Tree 12, 15, 17 and 18 is recommended to allow clear vision. A maximum branch diameter of 30mm at the branch junction and 10% of total live canopy is all that is required to facilitate clear vision.

Pruning of Tree 12, Tree 15, Tree 17 and Tree 18 is to be in accordance with AS4373-2007 Pruning of amenity trees, a maximum 10% of total live and canopy and branch diametre of 30mm is to be removed.

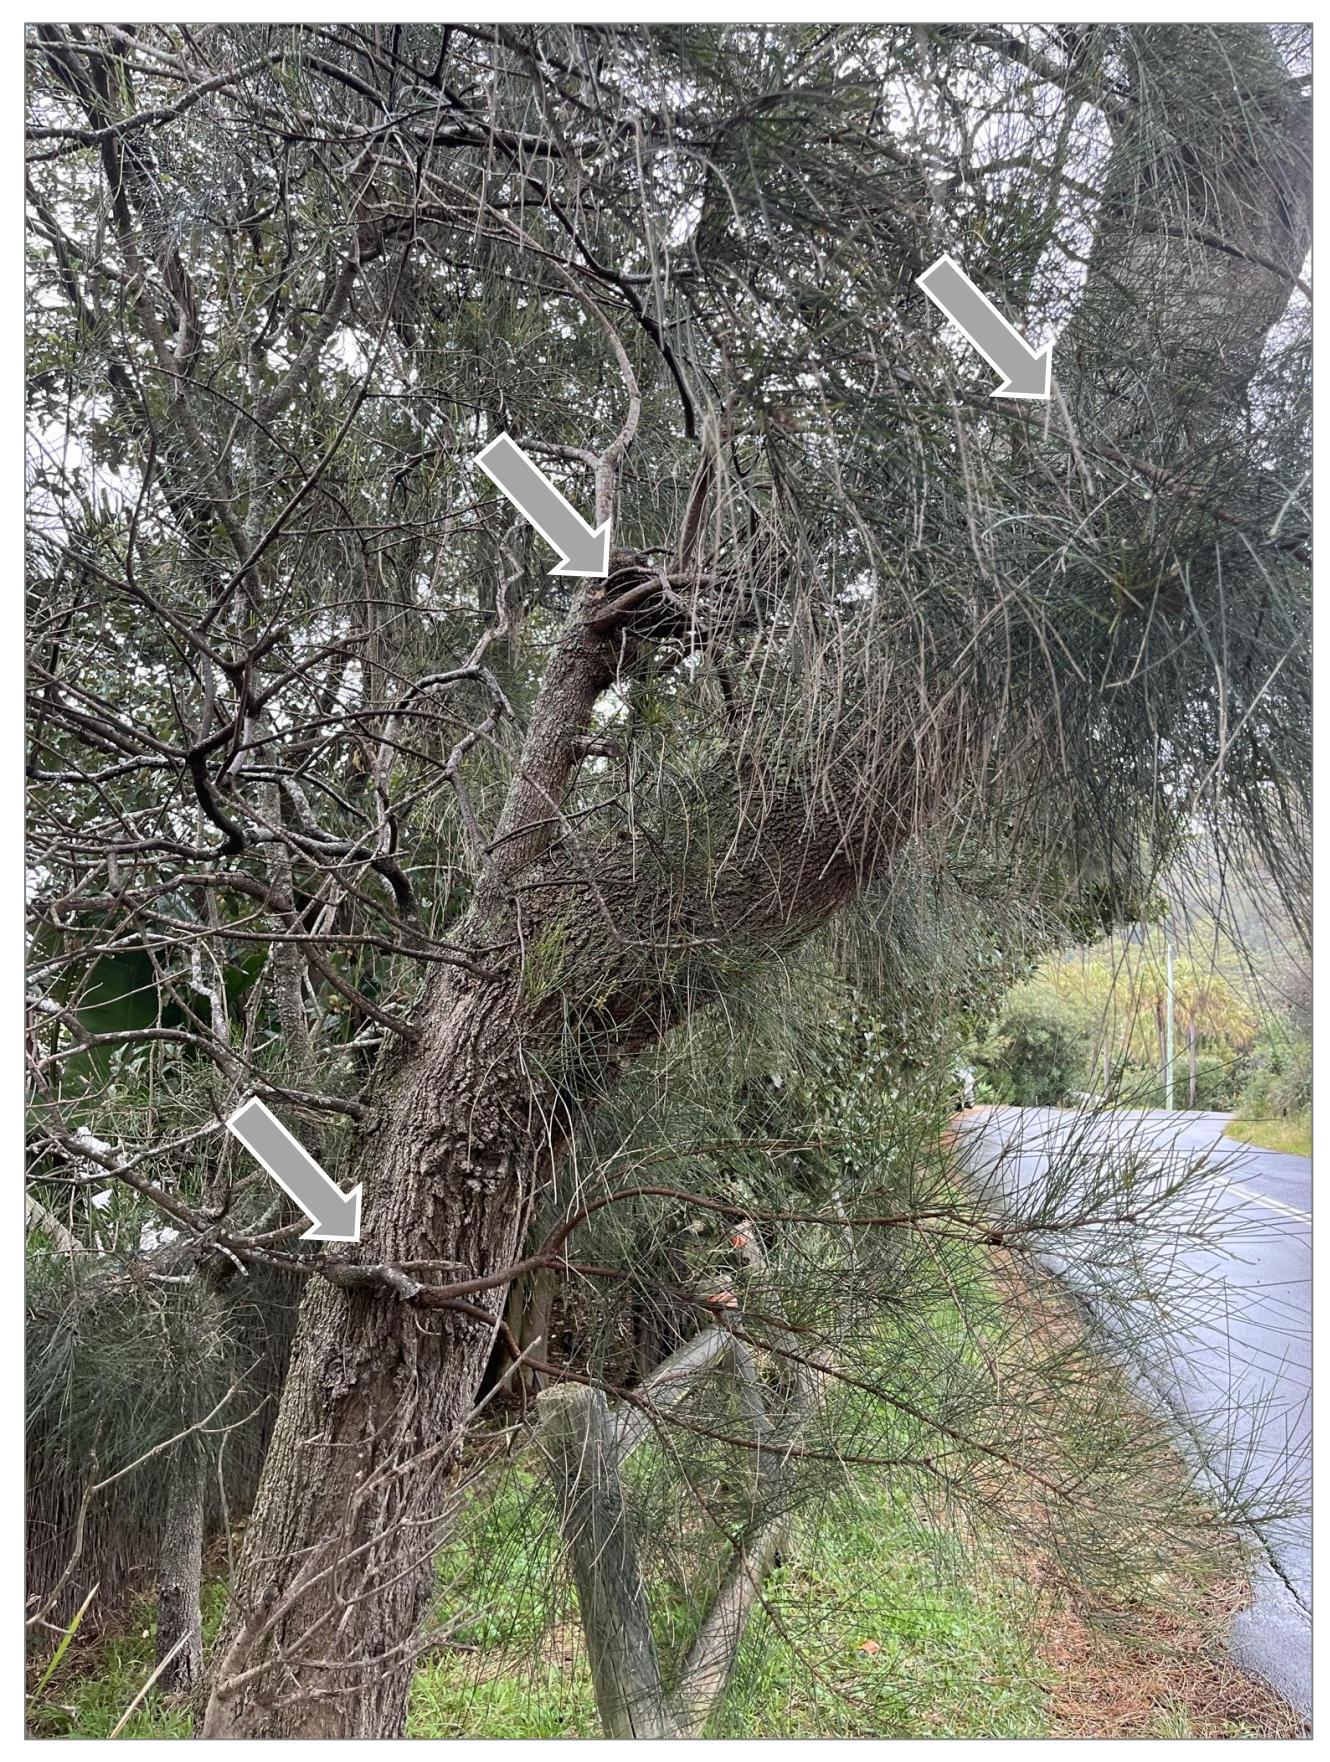
Plate 2- Tree 12 - Arrows note small diametre branches that once pruned will facilitate clear sight lines.

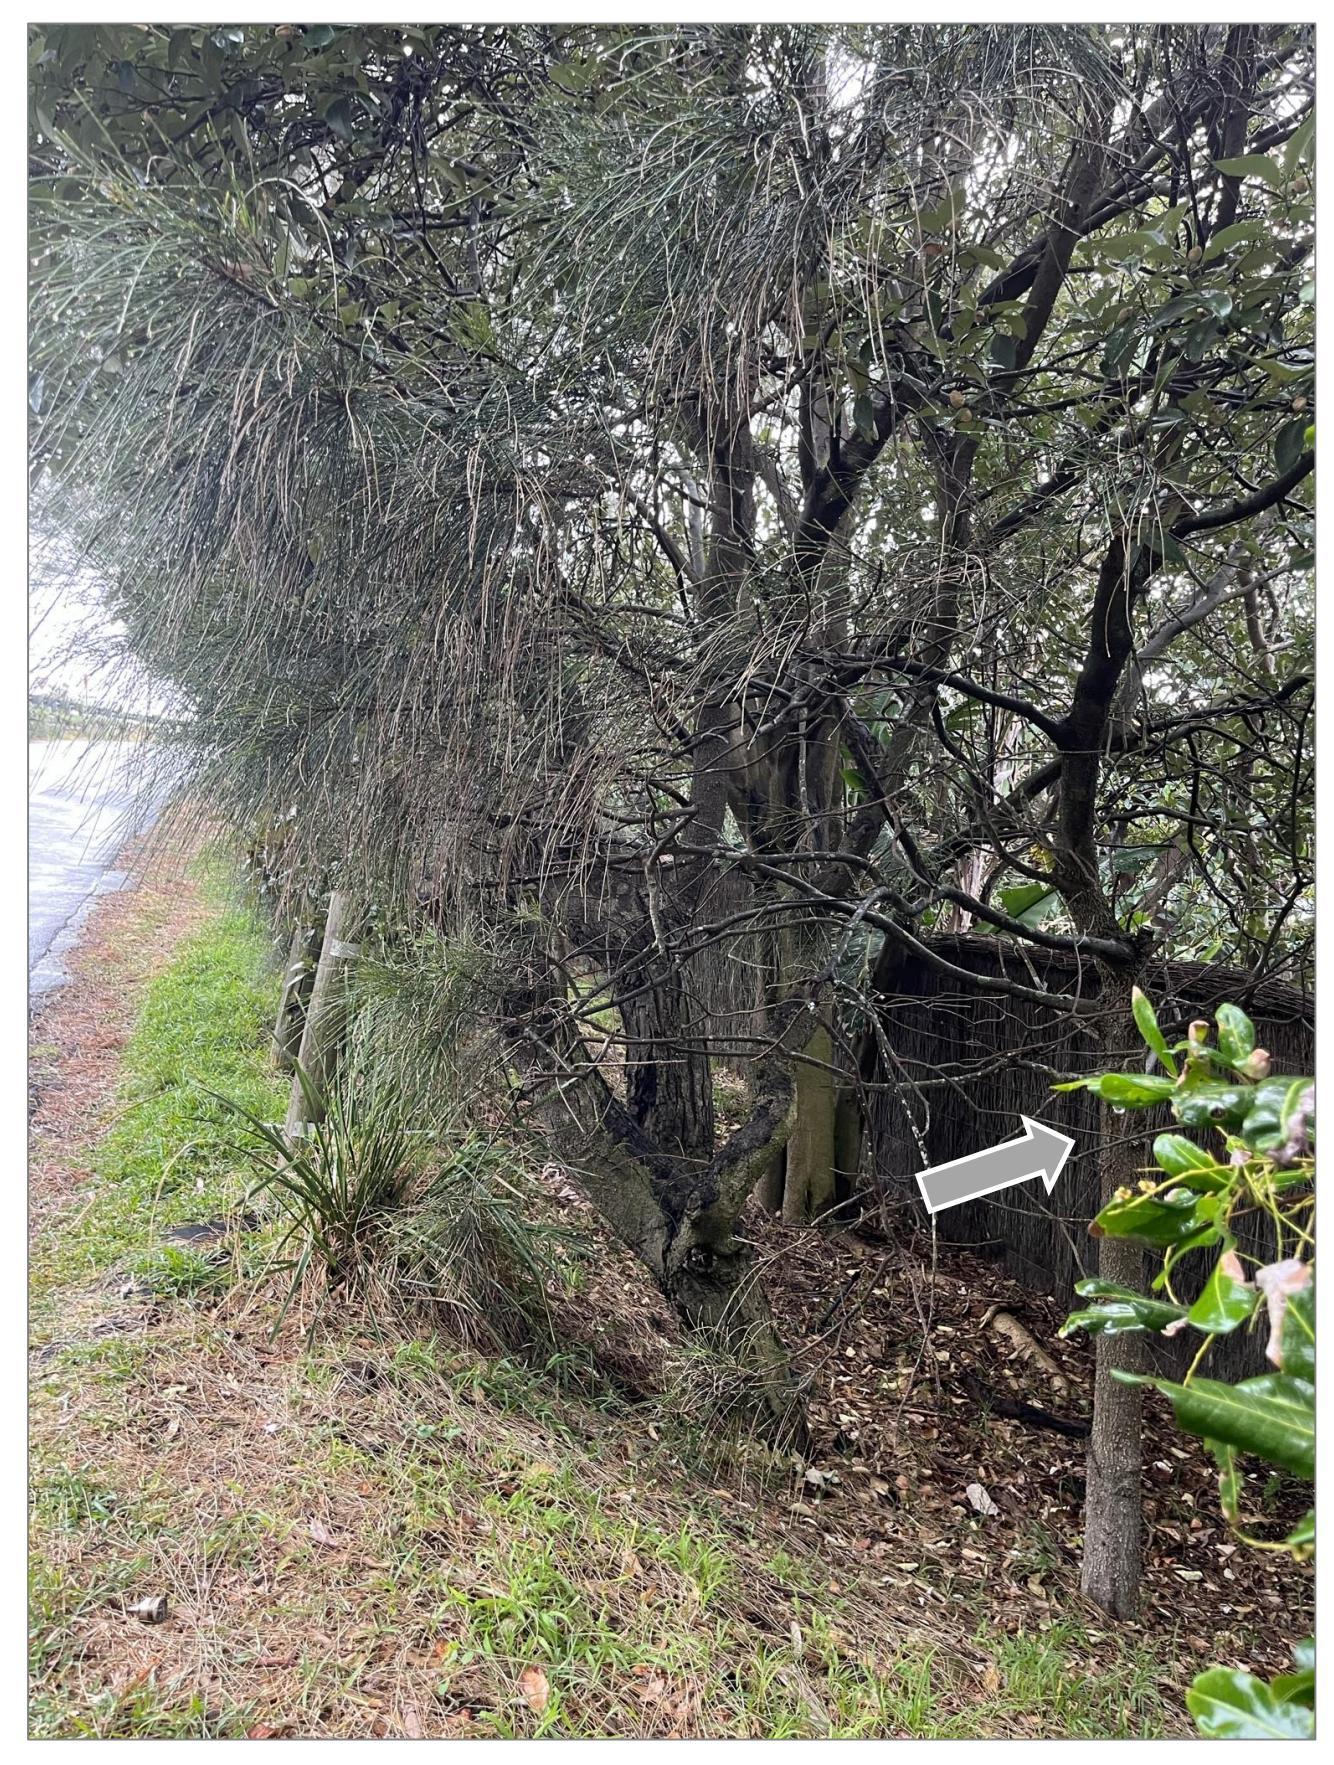
Tree 8 has the bulk of its canopy within the viewline, the pruning could not be carried out in compliance with AS4373, the required pruning would render the tree not viable for retention. Removal of Tree 8 is now recommended.

Plate 3– Tree 8 – Arrow notes Tree 8, requires removal for sight lines.

Cut to ground level Tree 8 and Tree 16. Given the suckering nature of the discussed trees DO NOT poison the stumps (as this can affect the parent trees).

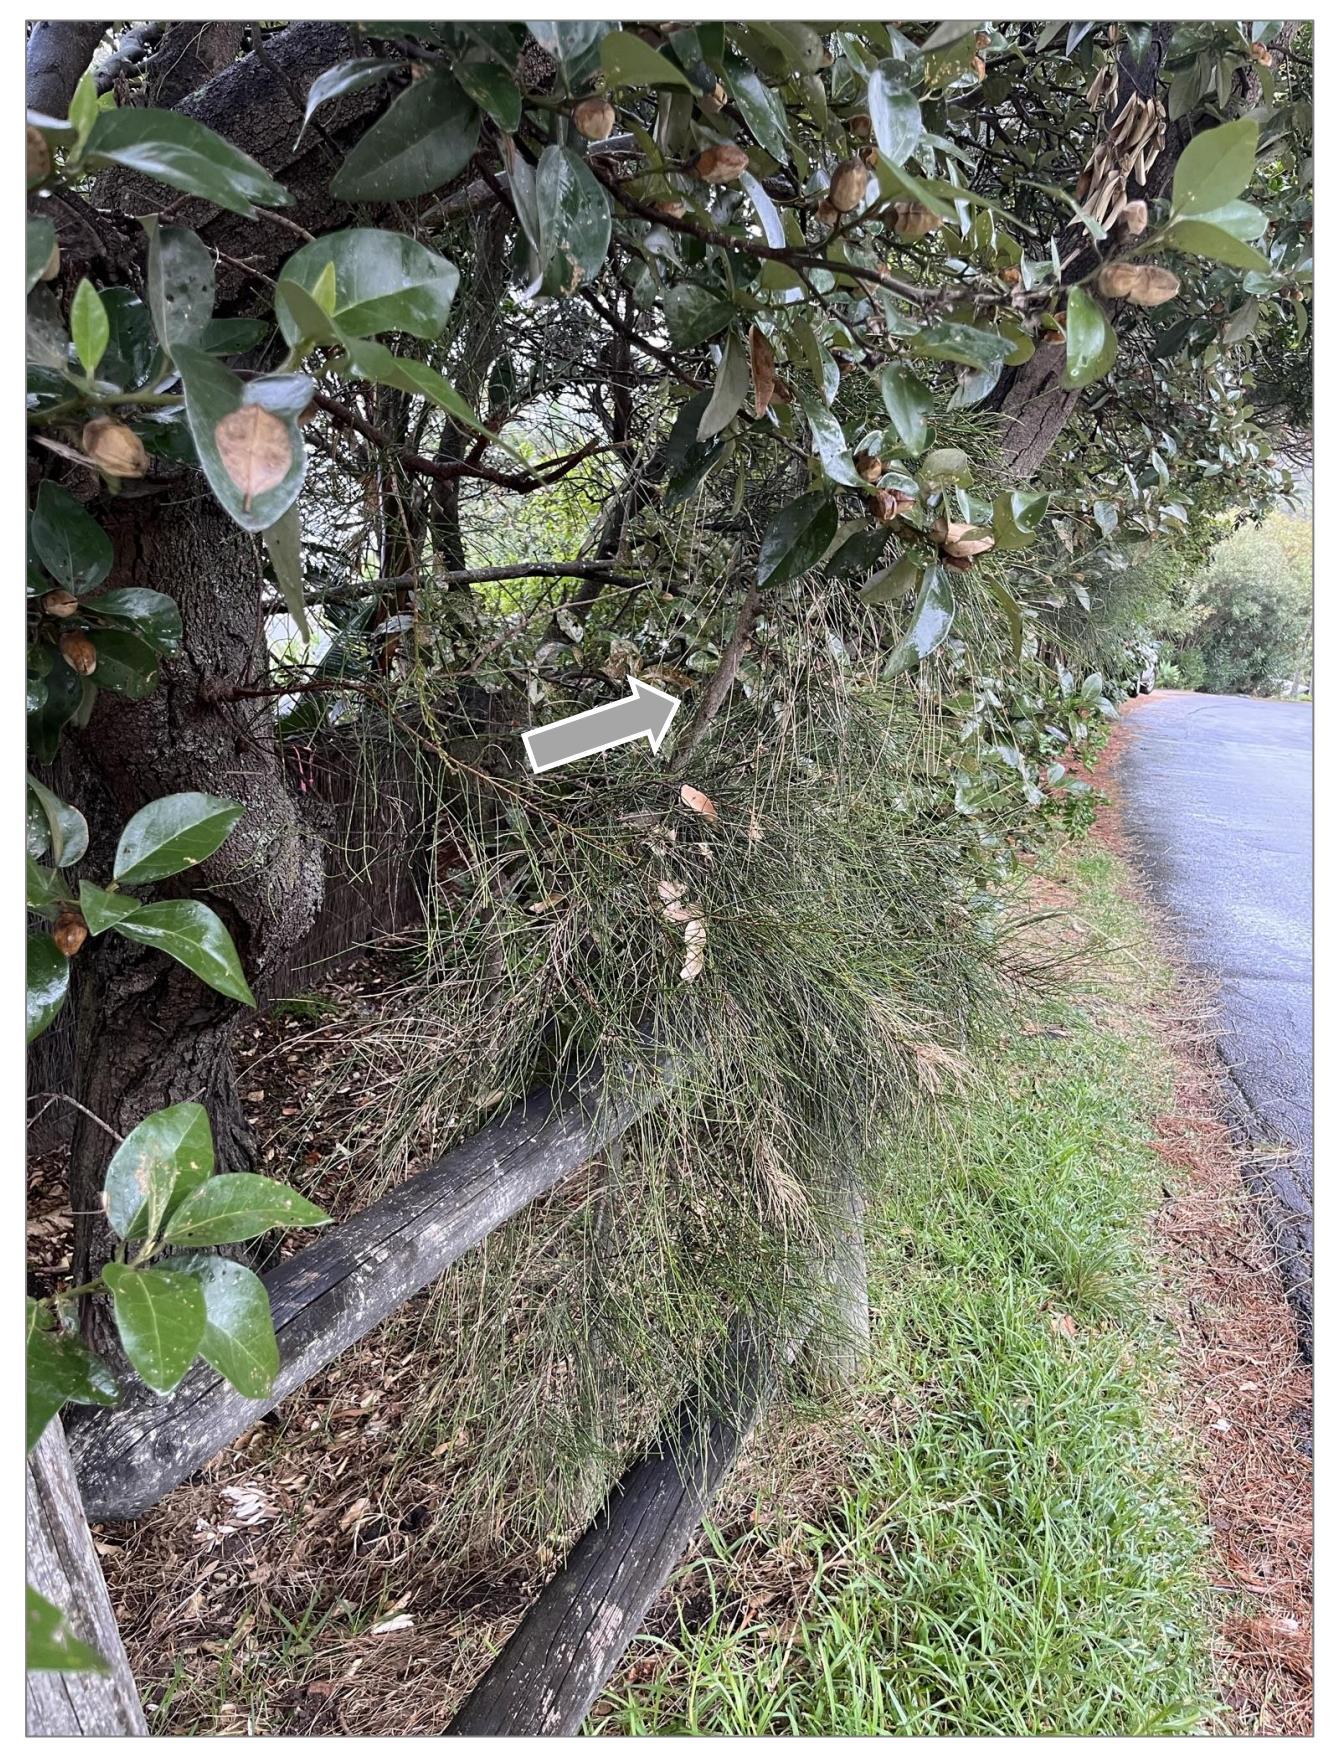
Tree 16 is located very close to the roadway edge and has a at base diametre of approximately 60mm, the canopy obscures vision and as such removal is recommended.

Plate 4– Tree 16 – Arrow notes Tree 16, requires removal for sight lines.

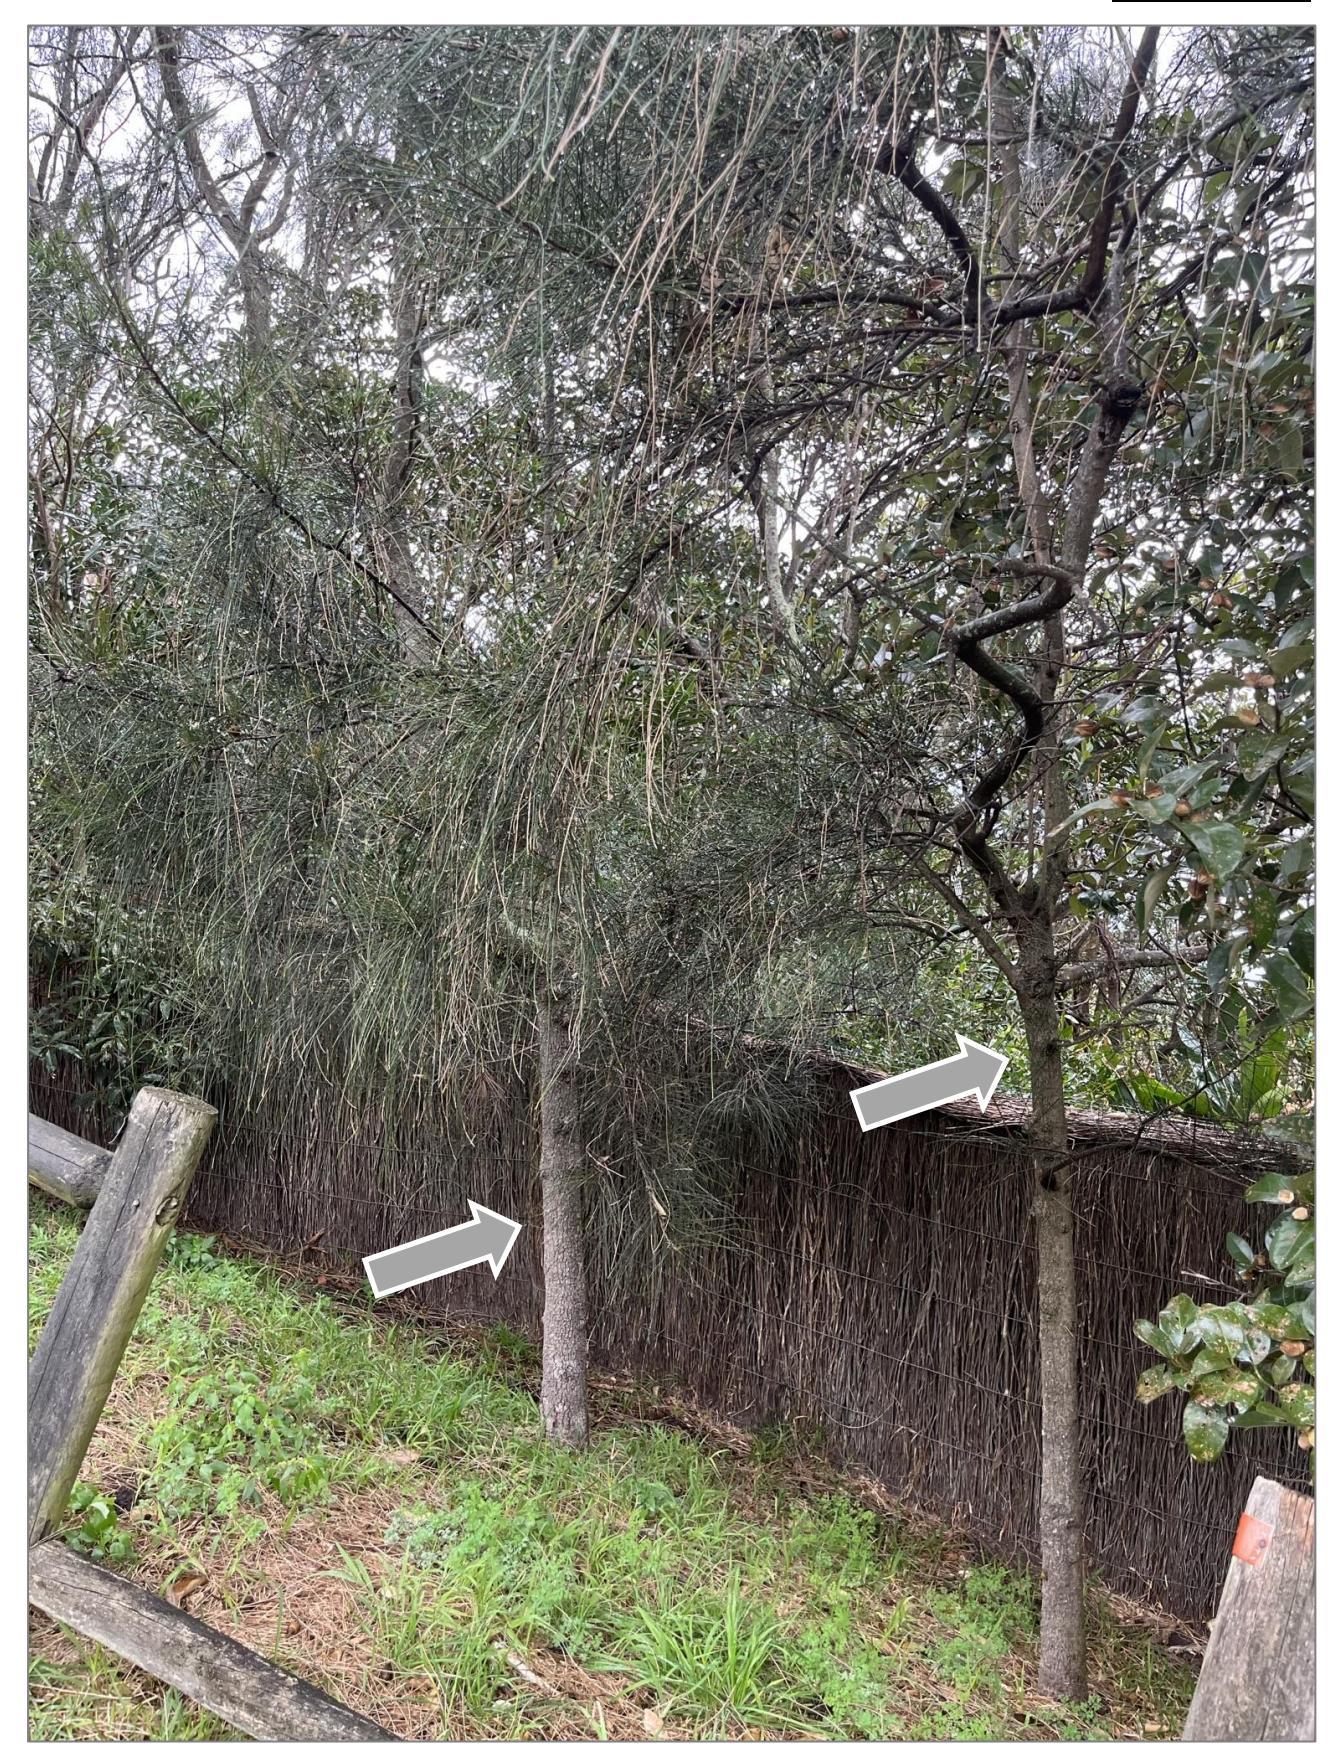
Plate 5– Tree 17 and 18 – Arrow notes Tree 17 and 18, require minor pruning for sight lines.

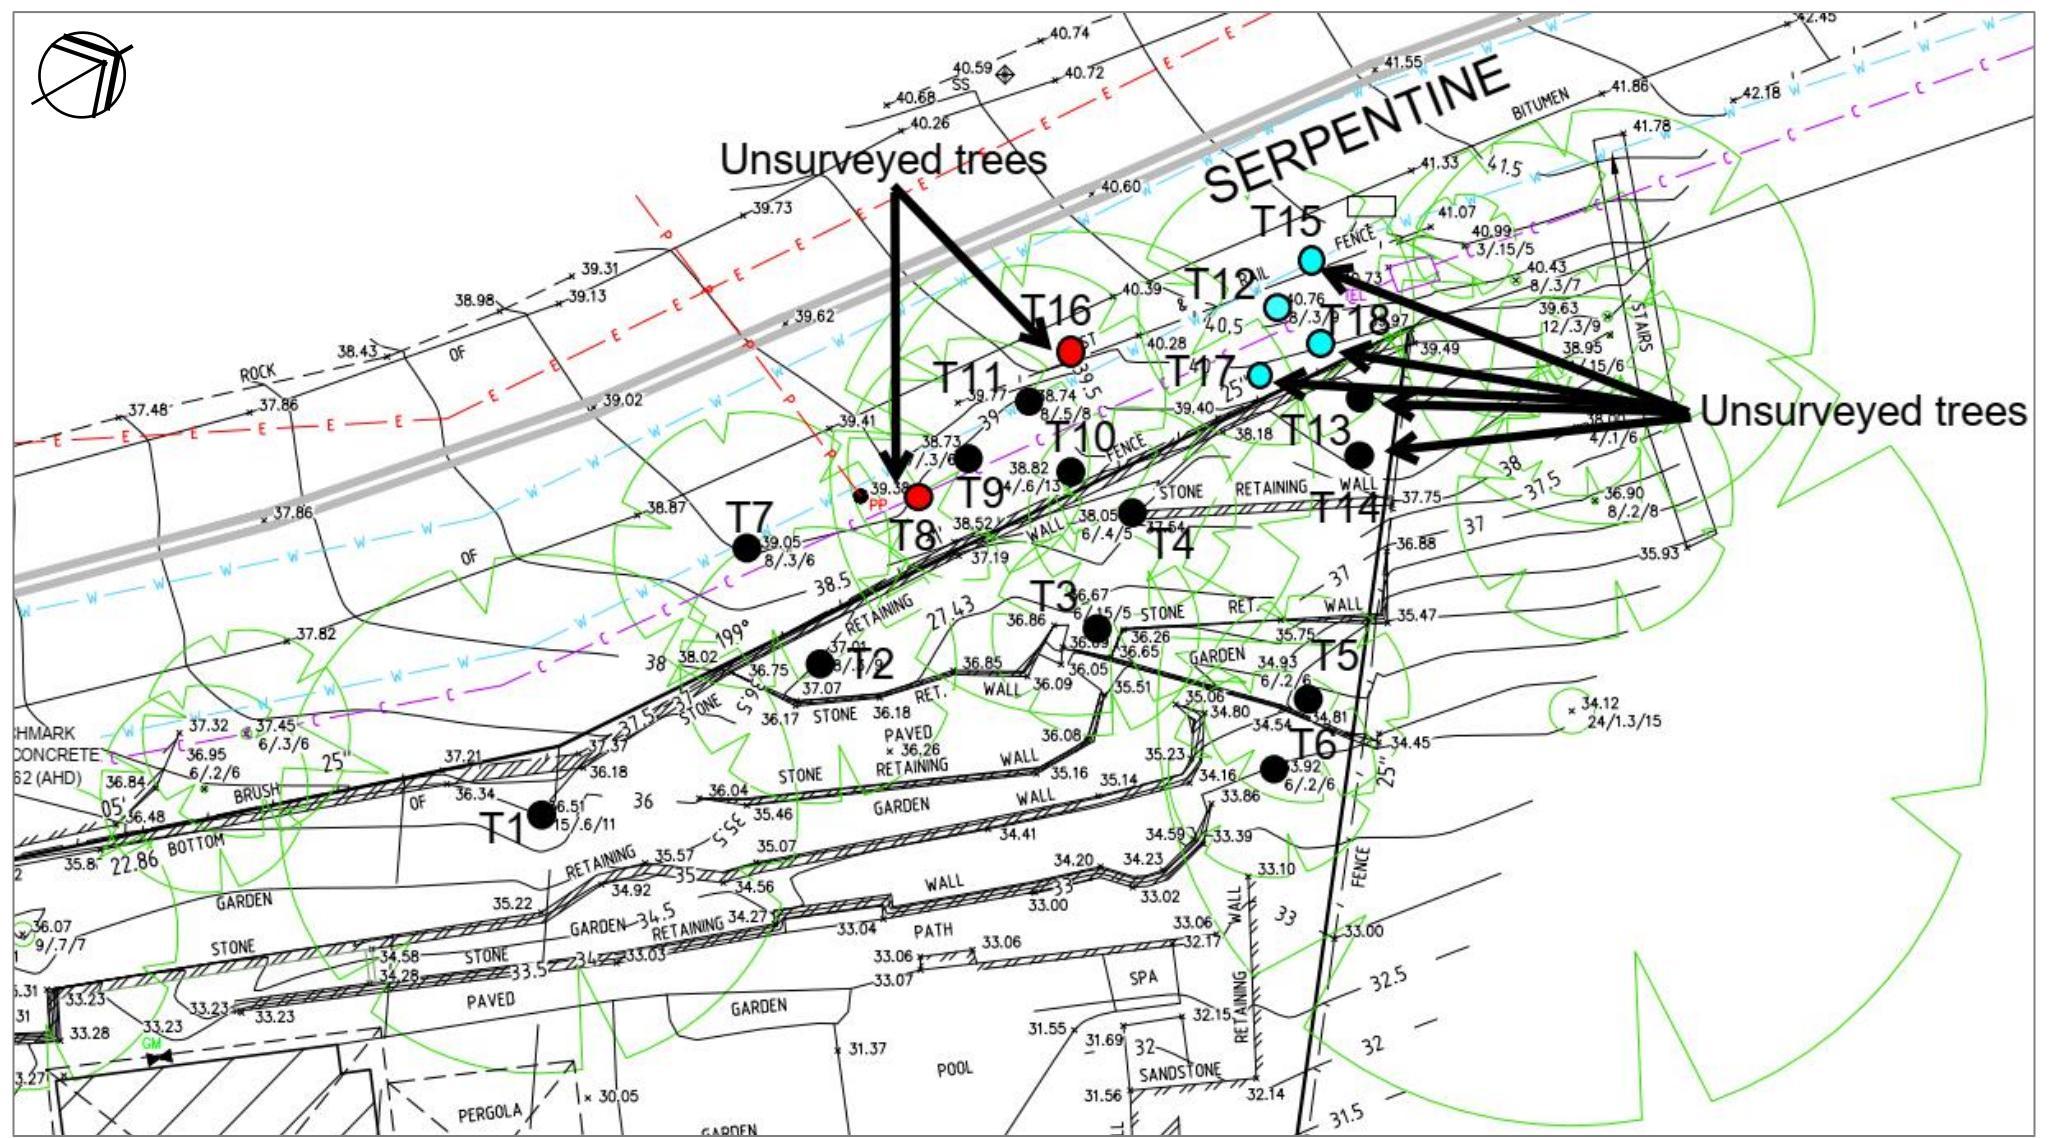
Several suckering¹ *Casuarina glauca* (Swamp she-oak) are located within the road reserve. Not all these suckers were discussed within the original AIA as they were outside the zone of impact for the proposal, and they had not been plotted within the Survey Plan. Tree 8 was marked up manually within the Survey Plan by Treeism for the original AIA. An additional four (4) suckers impacting the view line have been identified in the recent inspection (Tree 15, 16, 17 and 18, see Appendix B).

Figure 1 – Excerpt of Survey Plan, Reference no. 22044 005DT, dated 3 November 2020, authored by LTS Surveying. Red dotted trees additional removals required for sight lines, blue dots additional pruning required for sight lines. Rest of removals/pruning discussed within Treeism AIA dated January 2023. Marked up by C Hughes (NOT TO SCALE).
