Arboricultural Impact Assessment

Proposed Alterations & Additions at

41 Pacific Parade, Manly

Client: Castlepeake Architecture Date: February 2021 Author: Alexis Anderson Qualifications: -Diploma Horticulture (Arboriculture) –AQF Level 5. -Bachelor of Applied Science (CM) Membership: -Arboriculture Australia-Member No.2268 -International Society of Arboriculture –Professional Member A.B.N: 989 613 015 96 Contact: 0431 286 080 info@bluegumarborist.com.au

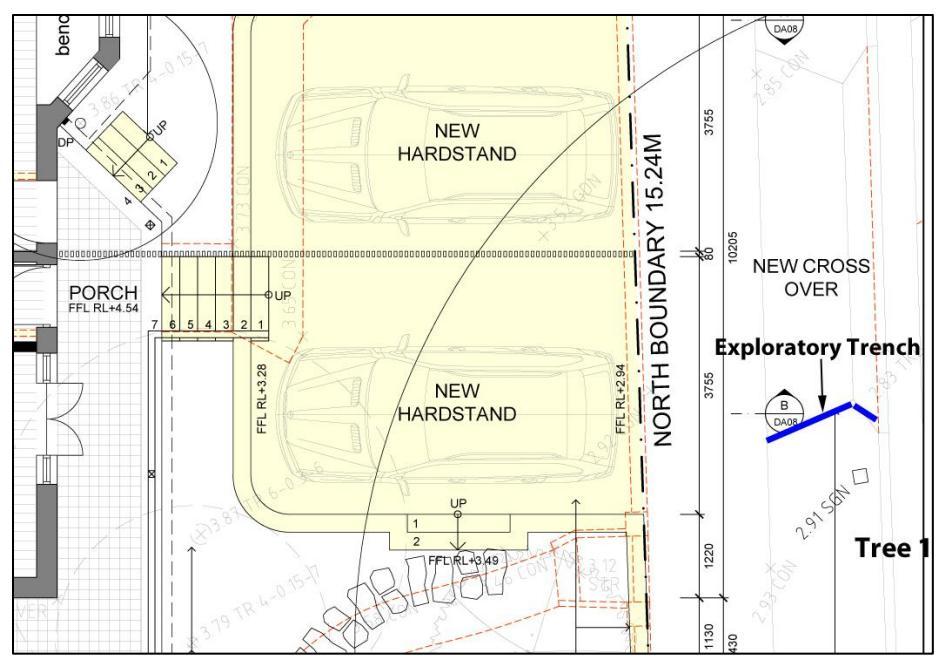
Figure A: Excerpt from the Proposed Ground Floor Plan (Part 1) showing the location of exploratory trenching.

Exploratory excavation was undertaken in the area where the proposed driveway cross-over overlaps the Tree Protection Zone of Tree 1. The purpose of this was to determine the number and size and depth of any roots that were growing into the area of proposed excavation. Exploratory excavation was undertaken with care by Alexis Anderson using hand tools to a depth of 200mm. This depth was sufficient to clear the likely depth of a driveway slab. Refer to Figure B below for the trench location.

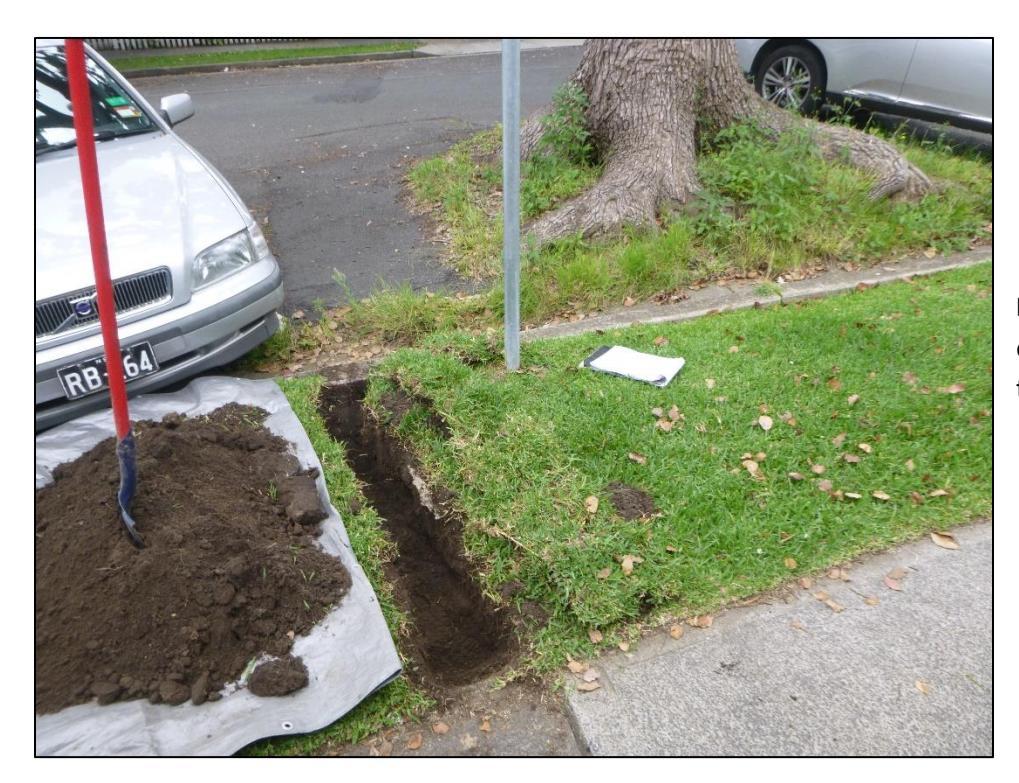
Exploratory excavation was undertaken along the eastern edge of the proposed driveway cross-over. This was undertaken to a depth of 200mm. No tree roots were encountered within the driveway cross-over alignment.

Photo A: Area of exploratory excavation taken facing north.

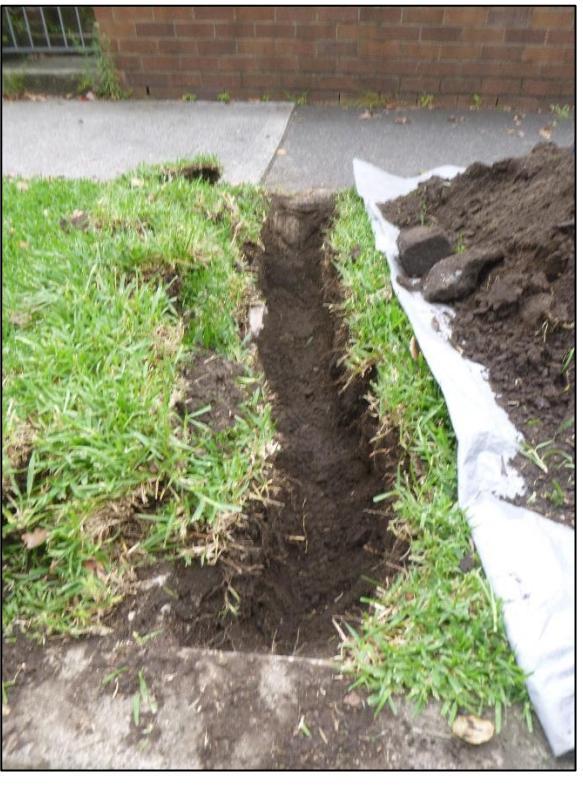
Photo B: Area of exploratory excavation taken facing south.

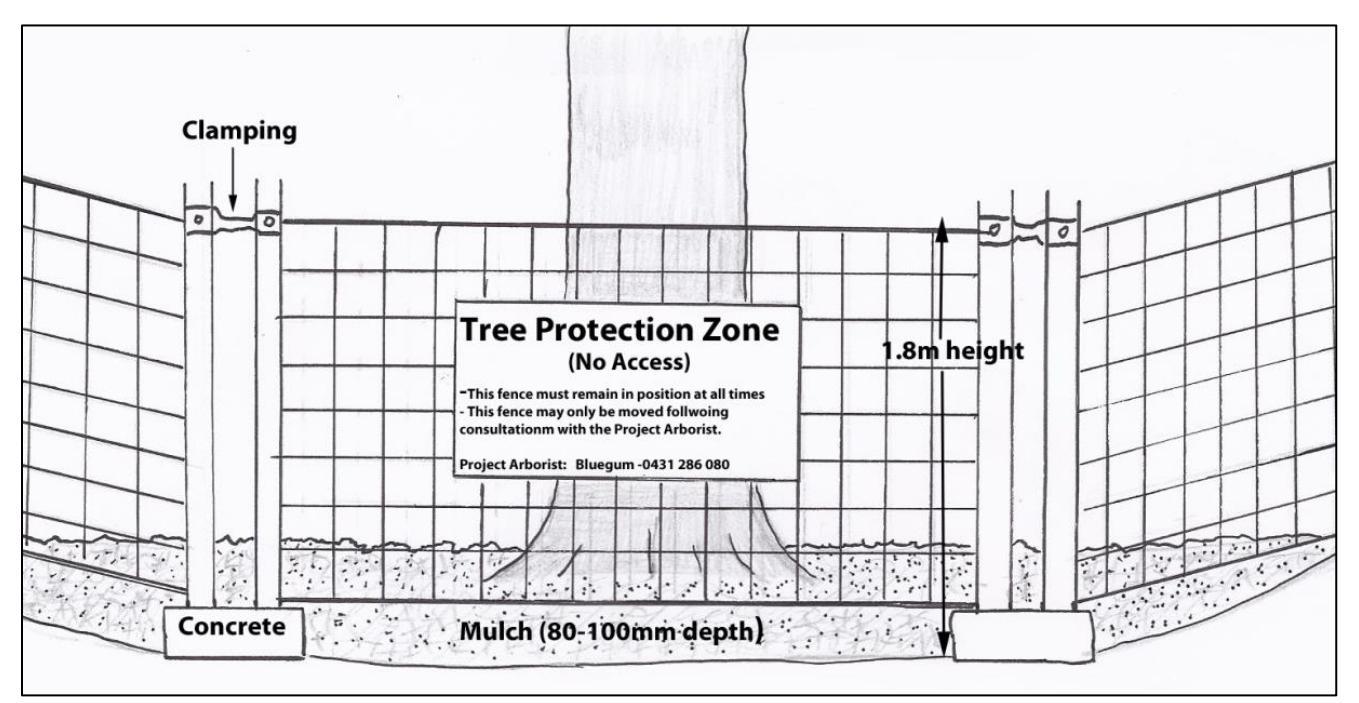
Figure B: Example of adequate tree protection fencing

Tree Protection Fencing (Trees 5, 16, 17, 18, 19): Tree Protection Fencing should be installed prior to any machinery or materials being bought on site and remain in position throughout the entire project. Tree Protection Fencing should be erected in the areas defined in the Tree Protection Plan (Attachment C). Tree Protection Fencing should consist of 1.8 metre high chainlink panels on moveable concrete pads. Tree Protection Fencing should be clamped at each panel junction.

Tree Protection Fencing should not be moved at any time without consultation with the Project Arborist. An example of adequate tree protection fencing is detailed below.

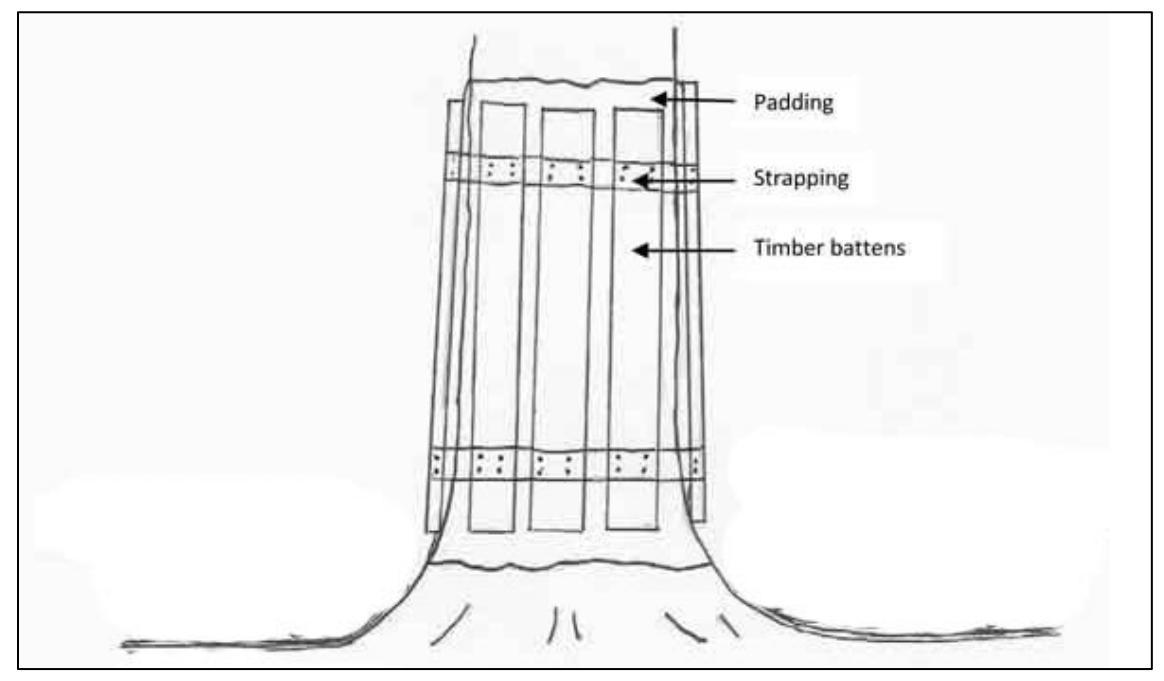
Figure C: Example of adequate trunk protection.

<u>Trunk Protection</u> (Trees 1, 4 and 6): Trunk protection is recommended for Trees 1, 4 and 6 as an alternative to fencing due to the limited available space. Detail of adequate trunk protection is detailed below.
