Re: Review of APZ at 13 Bungendore Street Ingleside NSW

Advanced Bushfire Performance Solutions Pty Ltd (ABPS) has been engaged to review the asset protection zone (APZ) associated with the Bush Fire Safety Authority granted to a Farm Stay development at the above site.

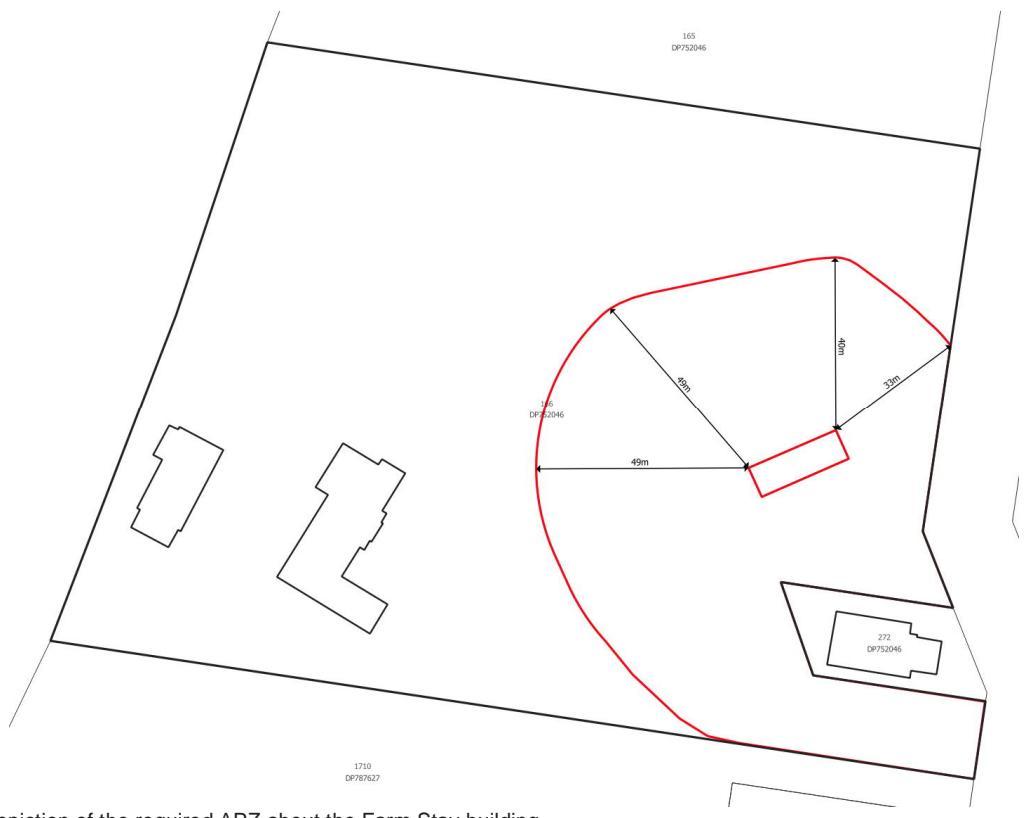
- North for a distance of 40 metres;
- North east for a distance of 33 metres;
- East to the property boundary;
- South to the property boundary;
- West for a distance of 49 metres; and,
- North west for a distance of 49 metres.

Spatial depiction of the required APZ about the Farm Stay building.

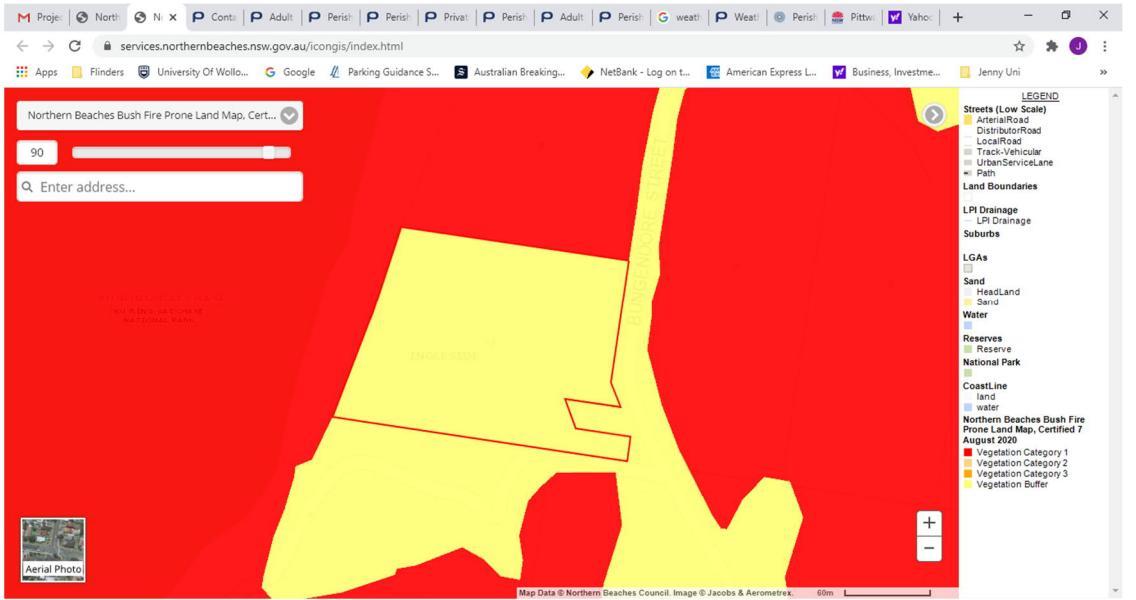
The Northern Beaches Council with NSW Rural Fire Service approval, revised the Bush Fire Prone Land Map on 7th August 2020. This revision recognised the absence of Bushfire Hazard Vegetation within the lot. The Lot is within the 100m Vegetation Buffer and as such any development will still be subject to compliance with bushfire requirements.

Extract of BFPL Map from Northern Beached interactive mapping website

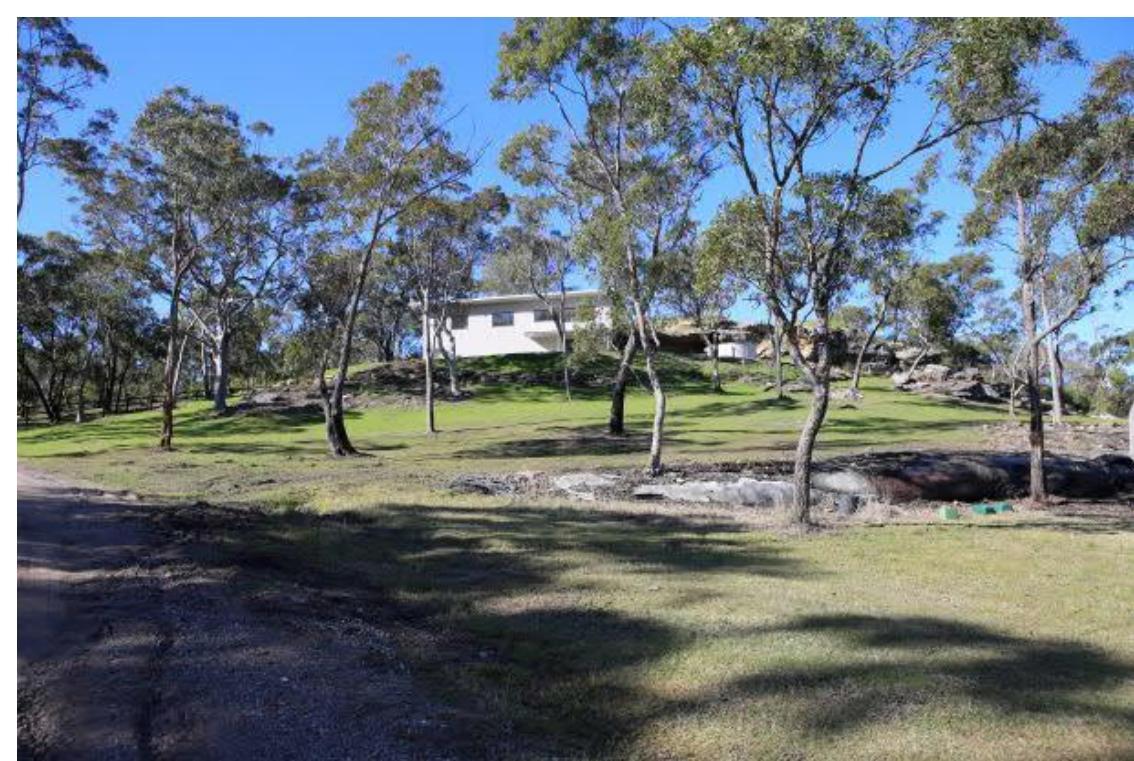
Image of the existing APZ viewed from the north west as at 27 July 2020. Farm Stay building is in the background. The APZ begins beyond the rocks in the centre of the image.

Surface coverage is predominantly managed lawn (<100mm) with small portions of bare earth and rock. It was noted that the grasses were quite lush at the time of the inspection.

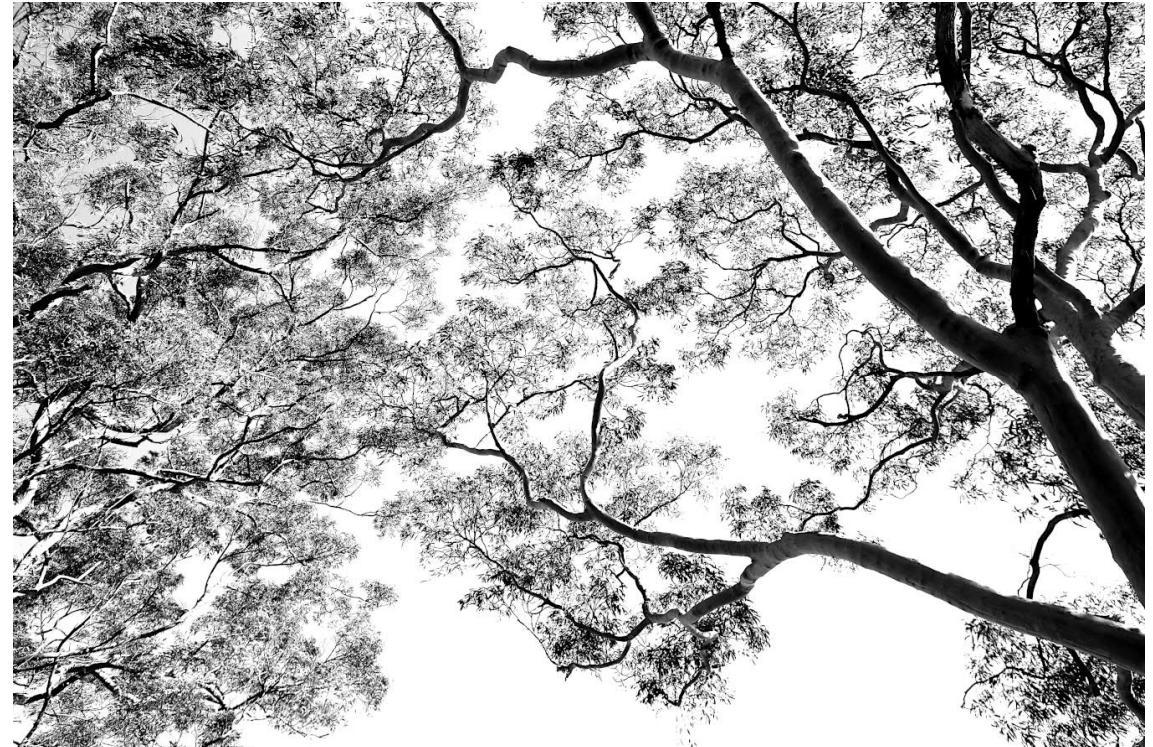
Photos of each tree canopy were taken from directly below the centre of the canopy to capture a balanced canopy spread. Photos were then digitally modified to increase contrast and convert to grey scale enhancing the difference between leaves and the sky above. Each photo was then compared with the Projected Foliage Cover (PFC) Matrix in Appendix A (Source NPWS) to determine a PFC factor to apply to the solid canopy. This process was repeated to confirm the original estimate as a means of further minimizing the subjectivity and improving the consistency.

Example of a digitally modified photo for use in a comparative assessment (Tree 24 & 25).
