### Re: Limited Condition Report – Structural to 92 Narrabeen Park Parade Job N° 2307015

We refer to the architectural plans prepared by ID Studios, which detail the proposed works at 92 Narrabeen Park Parade in Warriewood.

We have been commissioned by the owners to comment on the structural adequacy of the existing dwelling post demolition works and site investigations.

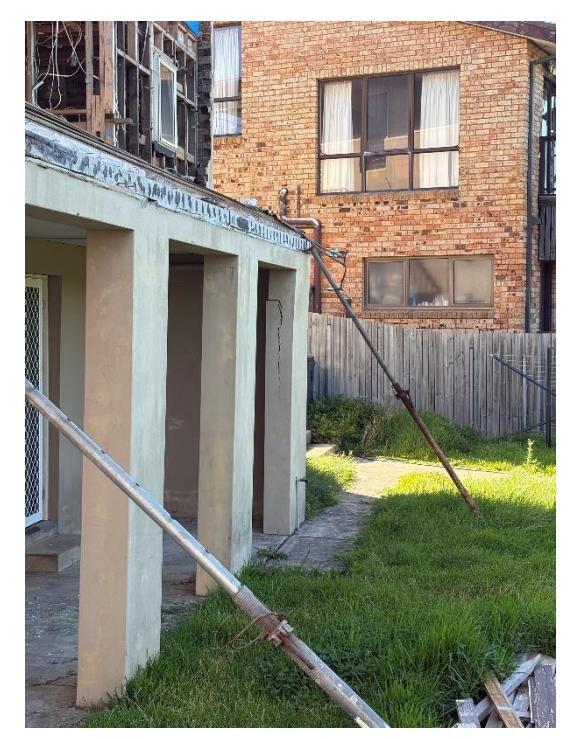
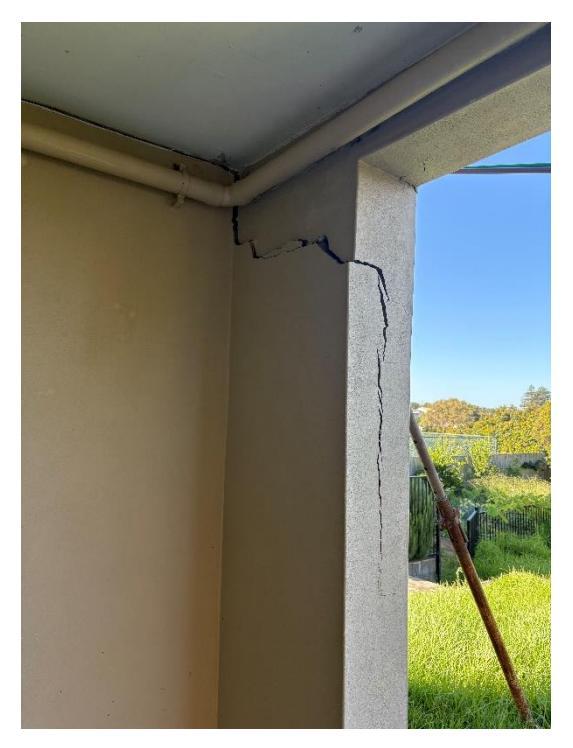
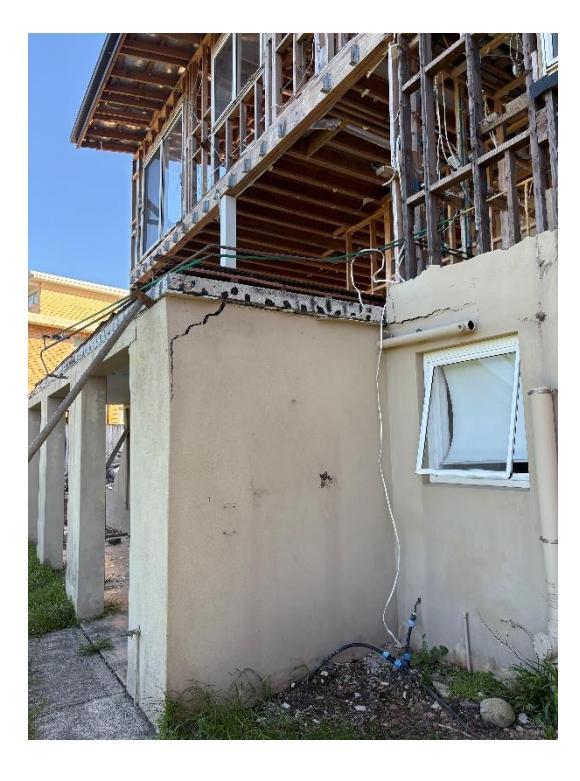
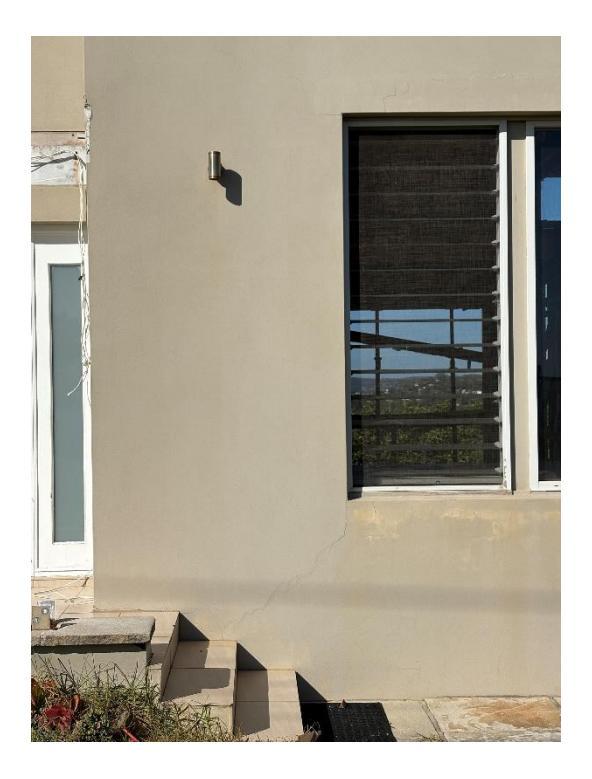
From test pits dug on site, it has been found that the existing footings are 300mm deep and not in accordance with the current Australian Standards. It is believed that the footings were built to the requirements of ordinance 70, a standard that was superseded in 1989. The house exhibits many cracks in the façade. Whilst hairline, these cracks indicate foundation movement (refer Photo 1-4).

Due to the foundation moment, structural damage and inadequate existing structural frame, we recommend that the existing building is demolished.

Further, the geotechnical report prepared by JK Geotechnics notes the site to be in a potential landslide area. Their recommendation is for all new footings to be taken down to the underlaying sandstone. For good building practices we recommend that the existing walls be reconstructed in the same location, but with compliant footings, piered to rock.

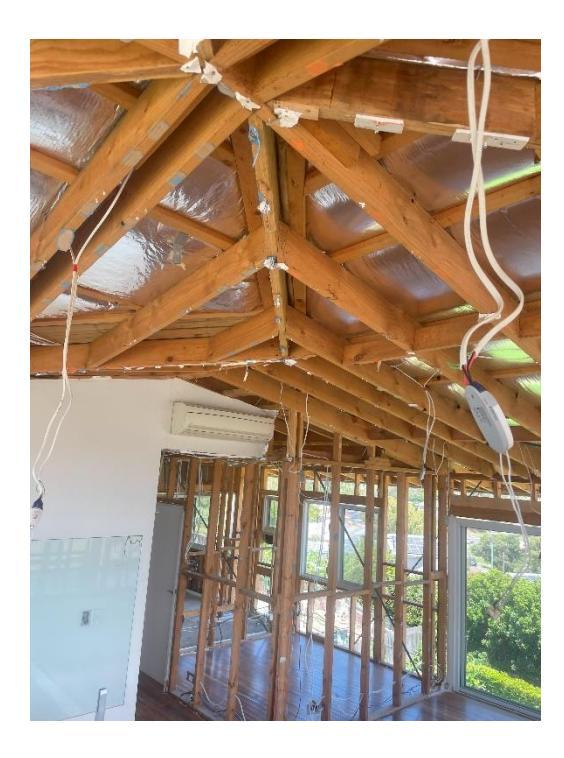
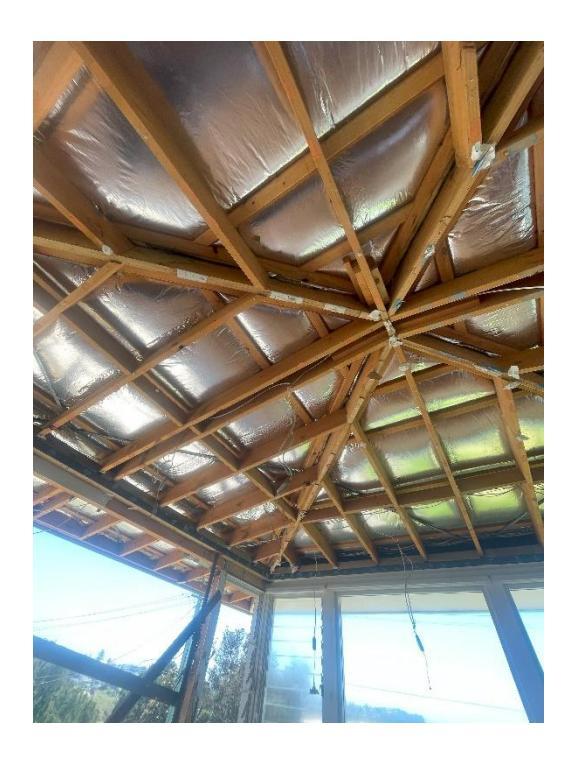
Further, soft demolition revealed areas of structural mechanisms in the roof structure that cannot be repaired without reconstruction (refer Photo 5 & 6).

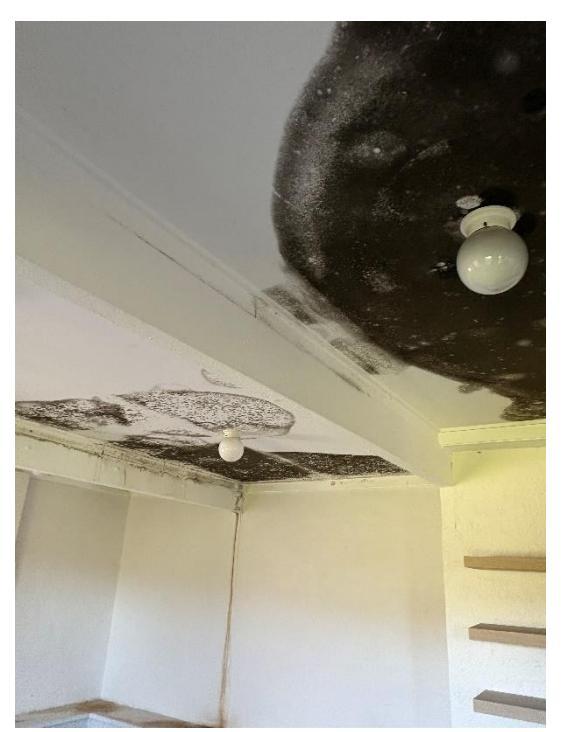
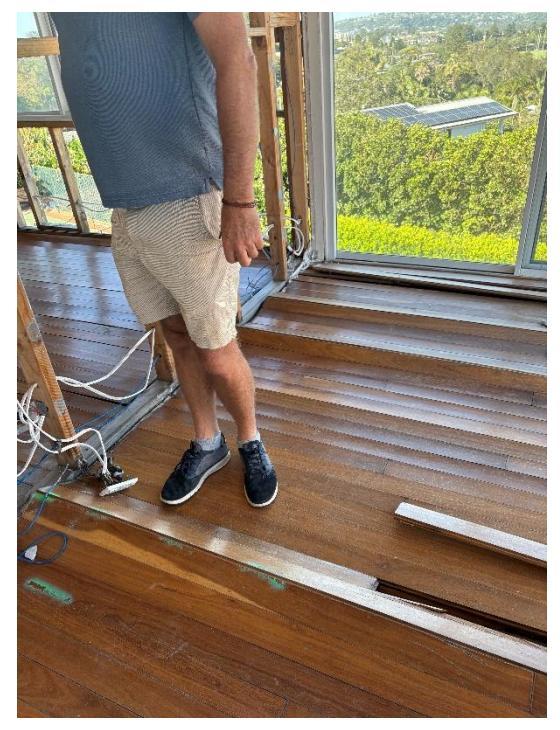
After the soft demolition and removal of external cladding, the structure has been left exposed to weather and internal floor coverings have been destroyed and cannot be salvaged. In addition, water has entered the internal areas of the building that were intended to be retained which are now damaged beyond repair (refer Photo 7&8).
