Tree Removal and Tree Pruning Application

ARBORICULTURAL REPORT

1031 Barrenjoey Road, Palm Beach Version 1

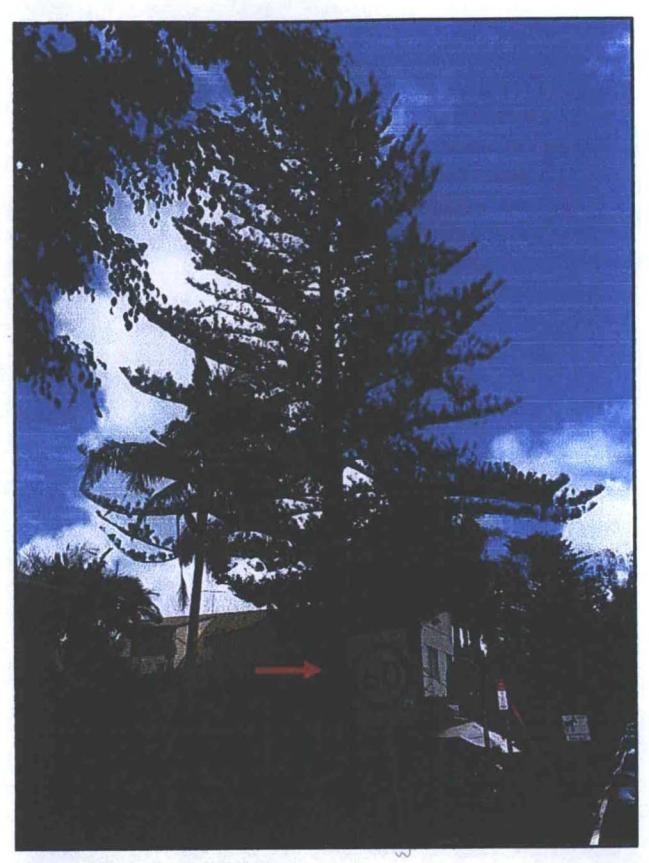
Figure 1: The subject tree.

The subject tree (*Araucaria heterophylla*) is approximately 32m in height, with a canopy spread of 16m and a trunk DBH of 1200mm. The tree is growing in a raised garden bed adjacent to a small outdoor café/patio area. The following observations were made during the site inspection:

This tree is growing in an unsuitable location which cannot accommodate long term future growth without further conflict between tree roots and the surrounding built structures. To avoid conflict between roots and adjacent structures as the tree continues to grow, removal and replacement is recommended.

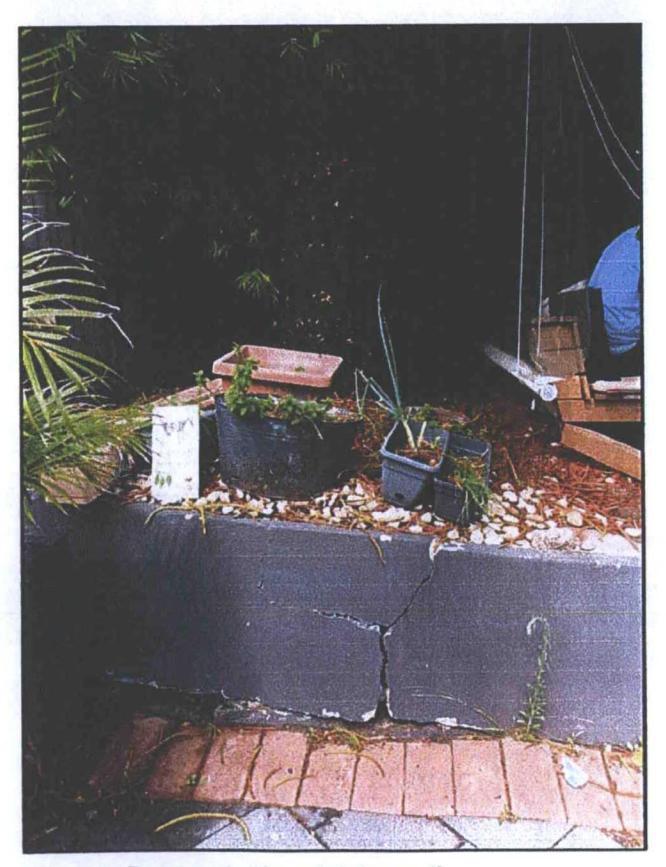
Figure 3: Damage to the retaining wall.

- The overall health and condition of the tree is good.
- There is evidence of damage to the retaining wall and deck of the outdoor patio area immediately
 adjacent to the base of the tree.
- The trunk of the tree is rubbing against the roof of the café.

The subject tree is growing in a restricted location. As the subject tree continues to grow in its current location, further conflict between tree roots and surrounding built structures is likely. This tree is not a suitable species for long term retention in its current location.
