Arboricultural Impact Assessment

16 Cabarita Road Avalon 2017 NSW

Prepared 13 April 2020 Revised 7 July 2020 Our Ref: 2006

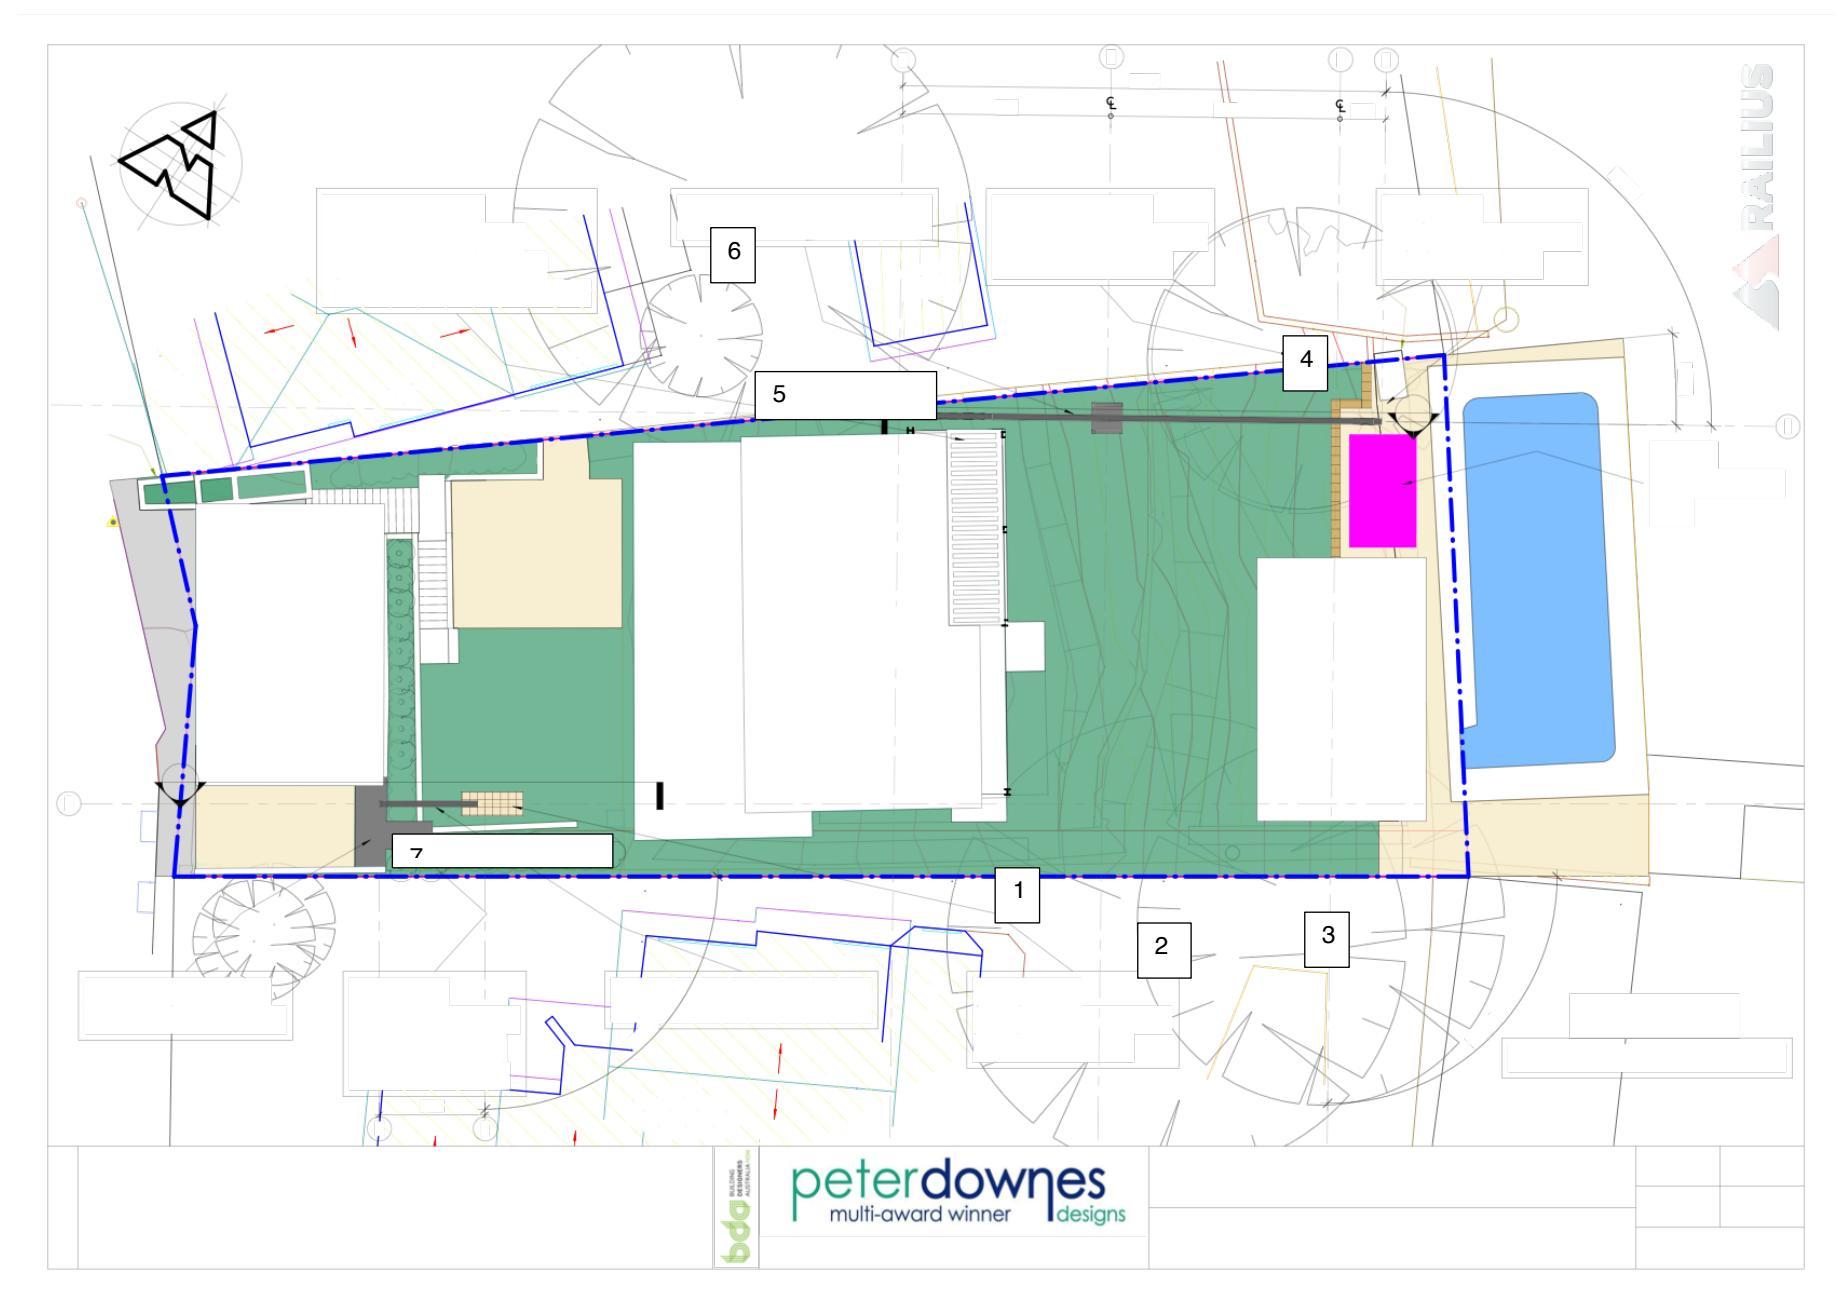
Appendix A – Tree Location Plan

- 1.2 Craig Martin carried out a survey of the site's trees on the 3rd April 2020.
- 1.3 The results of this assessment using VTA methodology after (Mattheck & Breloer, 1994) are tabulated below with the trees (1 6 inclusive) location shown on site plan by peter downes designs, Ref 200301, dated 19 March 2020.

- 1. Trees 1, 2, 3, 4, 5, 6 and 7 to be retained TPZ fencing and mulch to be installed prior to commencement of any building works as close to calculated TPZ as practicable on site as determined by project arborist.
- Excavation of proposed pier adjacent tree 5 to be supervised by project arborist. Where
 roots > 25mm in diameter are encountered, footing design to bridge roots so that they are
 not severed.
- 3. If pruning for clearance from approved works is required for tree 5 it is to be carried out under supervision of project arborist. Contractor to be insured and AQF Level 3 Arborist and works to be carried out according to AS4373 Pruning amenity trees.

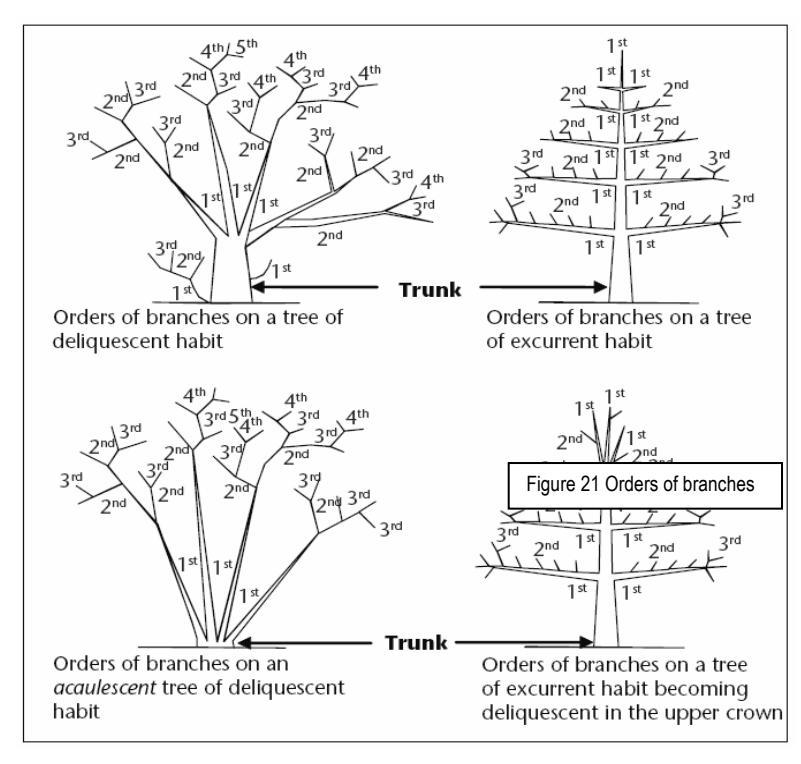
Branch An elongated woody structure arising the development of other branches. A branch successive orders of branches with the length the crown. These may develop initially as a division as in a young tree or a tree of terminates at or some distance from the root the foliage crown. In an acaulescent tree, may arise from a sprout mass from damaged

Orders of branches The marked divisions 168) commencing at the initial division where branches on an *excurrent* tree. Successive in branch diameters at each division, and numerically, e.g. first order, second order,

initially from the trunk to support leaves, flowers, fruit and may itself fork and continue to divide many times as and taper decreasing incrementally to the *outer extremity* of gradually tapering continuation of the *trunk* with minimal *excurrent habit*, or in a *sapling*, or may arise where the trunk *crown*, dividing into *first order branches* to form and support branches arise at or near the *root crown*. Similarly, branches *roots, branches* or *trunk*.

between successively smaller branches (James 2003, p. the trunk terminates on a *deliquescent* tree or from *lateral* branching is generally characterised by a gradual reduction each gradation from the trunk can be categorised third order etc. (See Figure 21.)

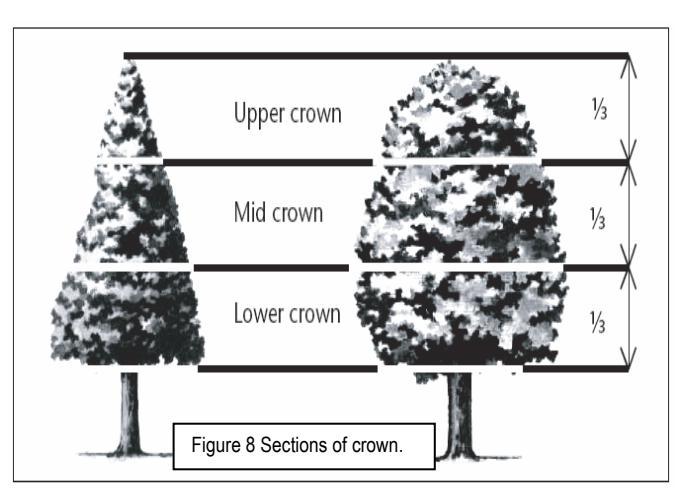
Crown Of an individual tree all the parts arising above branches, e.g. the branches, leaves, flowers and fruit; or crown of any tree can be divided vertically into three and *upper crown* (Figure 8). For a *leaning* tree these can *base* to *apex*. The volume of a crown can be categorised *crown*.

Crown Projection (CP) Area within the *dripline* or beneath the and *Dripline*.

the trunk where it terminates by its division forming the total amount of foliage supported by the branches. The sections and can be categorised as *lower crown*, *mid crown* be divided evenly into crown sections of one-third from the as the *inner crown*, *outer crown* and *outer extremity of*

when divided vertically into one-third (1/3) increments. See

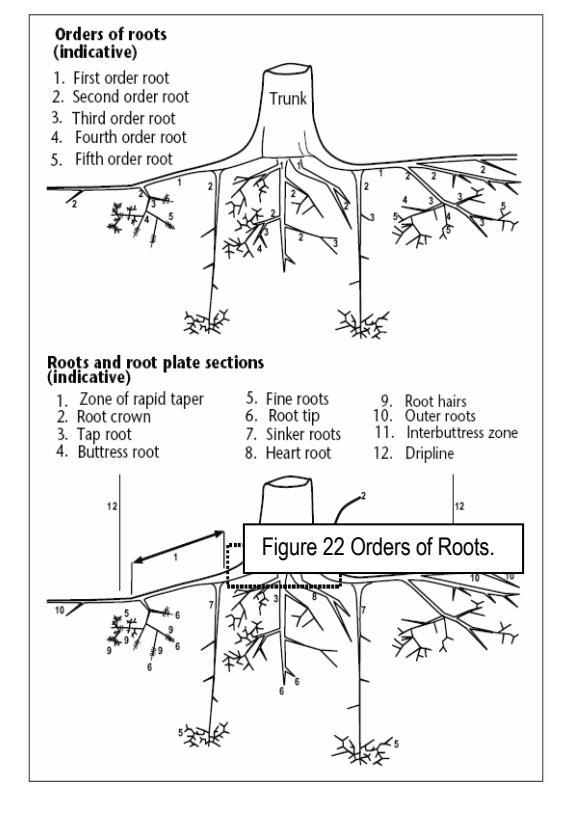
Zone of Rapid Taper The area in the *root plate* where the diameter of from the *trunk*. Considered to be the minimum radial distance to provide *Structural Root Zone (SRZ)*.

Structural Roots Roots supporting the infrastructure of the *root plate* may taper rapidly at short distances from the *root crown* or become dicotyledonous angiosperms and are usually 1st and 2nd order roots; or angiosperms (palms). Such roots may be crossed and grafted and are extend just beyond the *dripline*.

at the base of the *trunk*, or as an *adventitious root mass* for divided as a marked gradation, gradually tapering and Depending on soil type these roots may descend initially soil levels. Trees may develop 4-11 (Perry 1982, pp. 197relatively even distribution, or be prominent on a particular *asymmetrical* crown; and constraints within the growing exposure to predominant wind, soil moisture, depth of

commencing at the initial division from the base of the characterised by a gradual reduction in root diameters and *first order roots*, second order roots, third order roots etc. dependent on species, age class and the growing

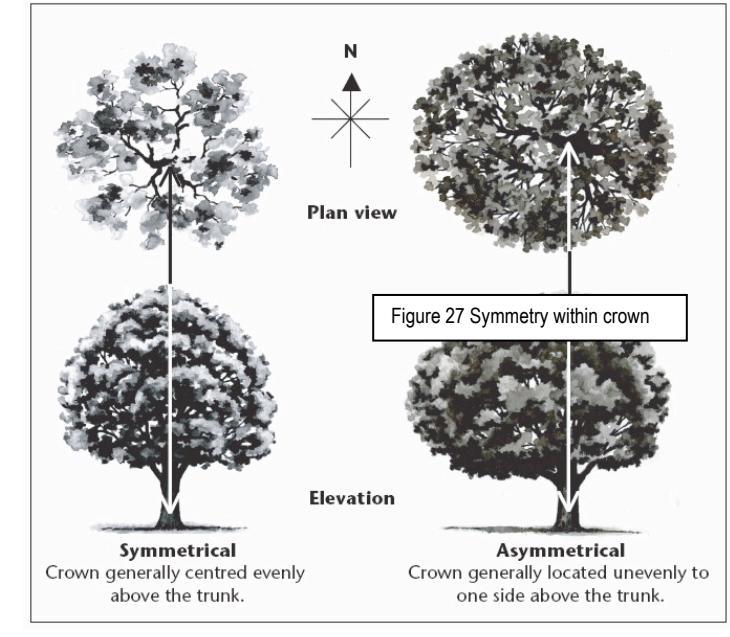
Crown Form Codominant or *Crown Form Suppressed* from competition for space and light with other trees, for clearance of roads, buildings or power lines. An asymmetrical, bias to west.

Symmetrical Balance within a crown, where there is around the vertical *axis* of the trunk. This usually *Forest*. An example of an expression of this may be

as a result of natural restrictions e.g. from buildings, or or from exposure to wind, or artificially caused by pruning example of an expression of this may be, crown

an even distribution of branches and the *foliage crown* applies to trees of *Crown Form Dominant* or *Crown Form* crown symmetrical.

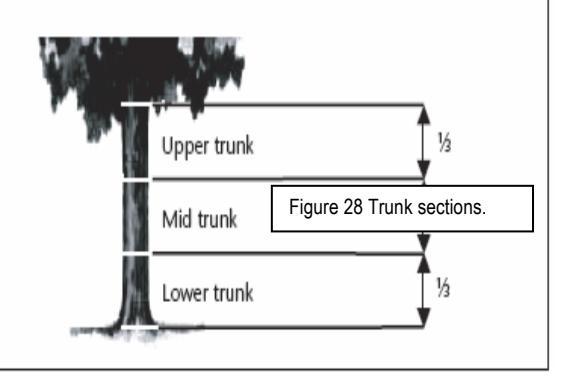
Mid trunk A middle section of a trunk when divided into onetrunk and Upper trunk.

Upper trunk Highest, or *distal* section of a trunk when divided *Lower trunk* and *Mid trunk*.

Mid Trunk and Upper Trunk. For a leaning tree these may

short trunk. See also Caulescent. (See Fig. 21)
