Arboriculture Impact Assessment Report 121 Pacific Rd Palm Beach

Site Assessment conducted by Aaron Erbacher and report prepared by: Geoffrey Ashton Arboriculture AQF Level 5 November 2021

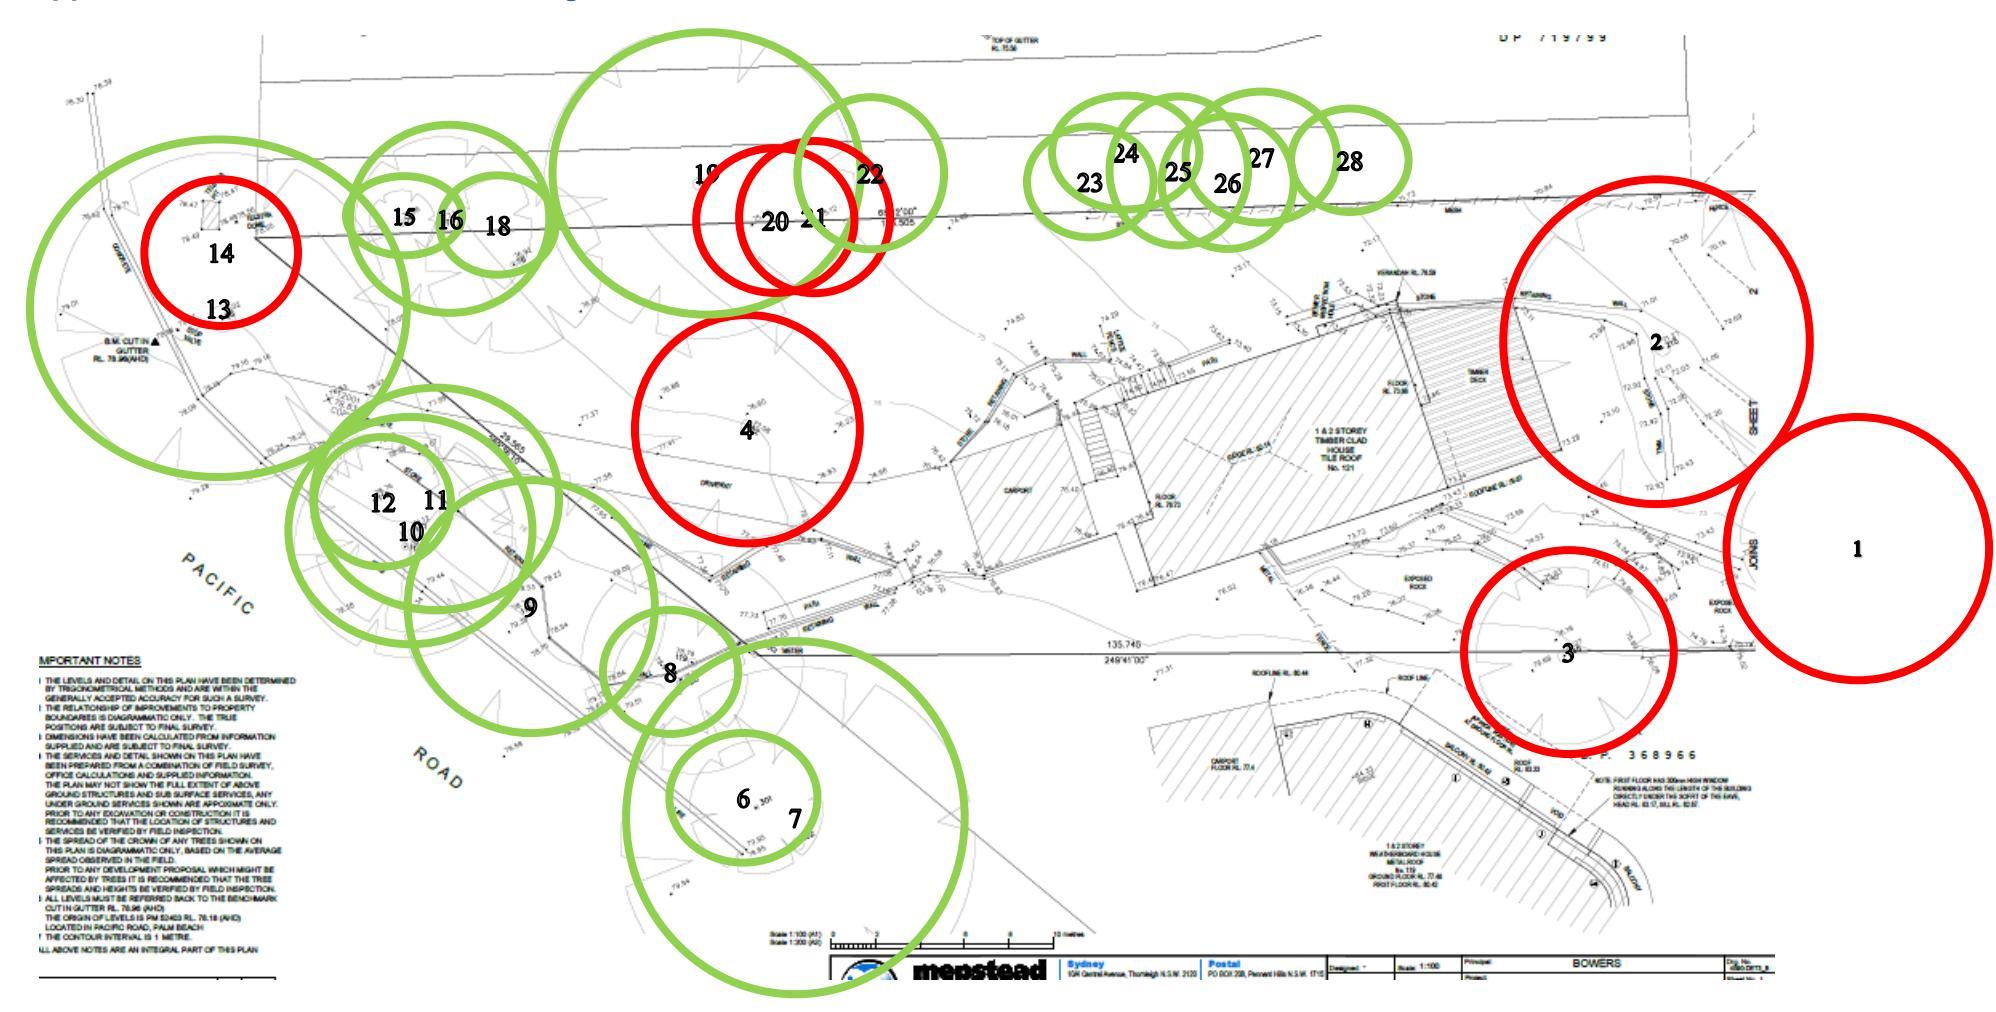
9 Appendix A Tree Protection Plan Diagram

An overlay of the trees and their numbers onto the existing plan building footprint is provided within the Tree Protection Plan Site Diagram. This plan in conjunction with the measurements supplied within the Tree Profile Table will allow for a measured analysis of the trees canopy and rootsystems as well as the associated impacts. Where plans are not measured, or access is not achieved an estimated distance is utilised. Measurements of neighbouring trees were estimated and a thorough VTA was not conducted as access to the property was not obtained.

As per Tree Protection Plan and Tree Protection Plan Site Diagram an AQF 5 level arborist (Site Arborist) is to establish and oversee all works in the Modified Tree Protection Zones as well as assess tree health and record compliance/non-compliance at each stage of development as per Australian Standard Protection of trees on development sites AS 4970 2009. The elevation of the driveway above grade and the encroachment from the proposed structure within Tree Protection Zones will require restrictive measures throughout the development process.

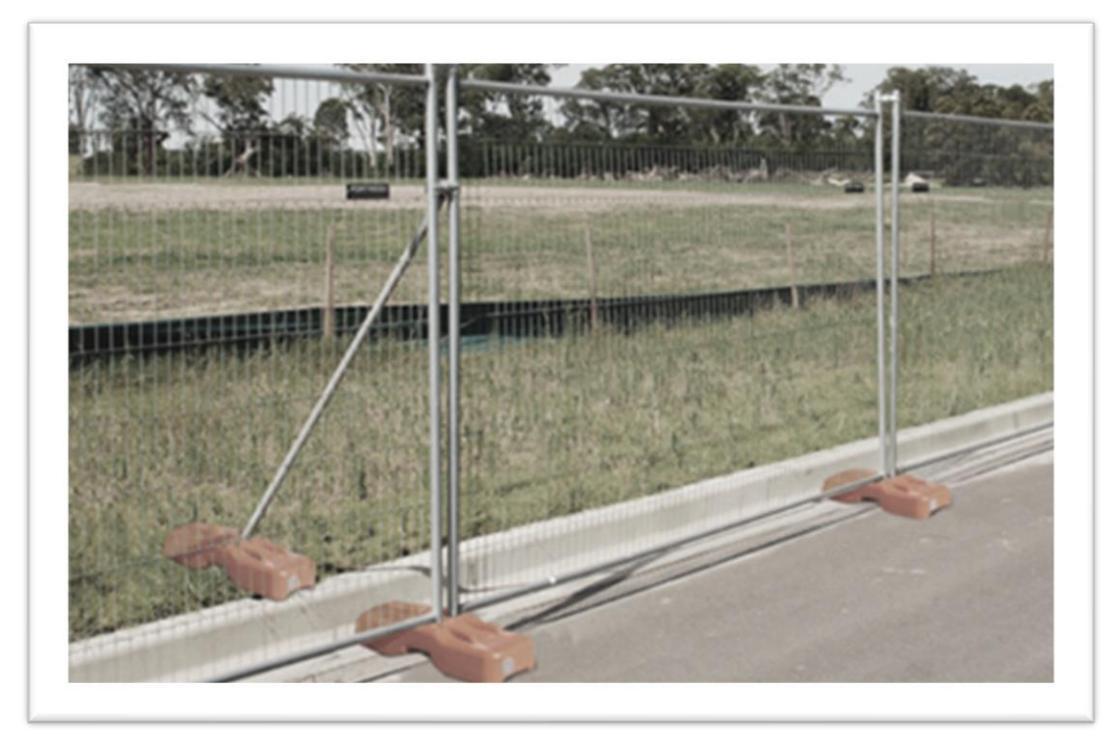
An example of fencing that is to be included as per Tree Protection Plan
