Arboricultural Impact Assessment

SITE ADDRESS 1 WHALE BEACH ROAD AVALON BEACH NSW 2107

Prepared by Chantalle Brackenridge Hughes Consulting Arboriculturist & Horticulturist Diploma of Arboriculture AQF Level 5

DECEMBER 2020

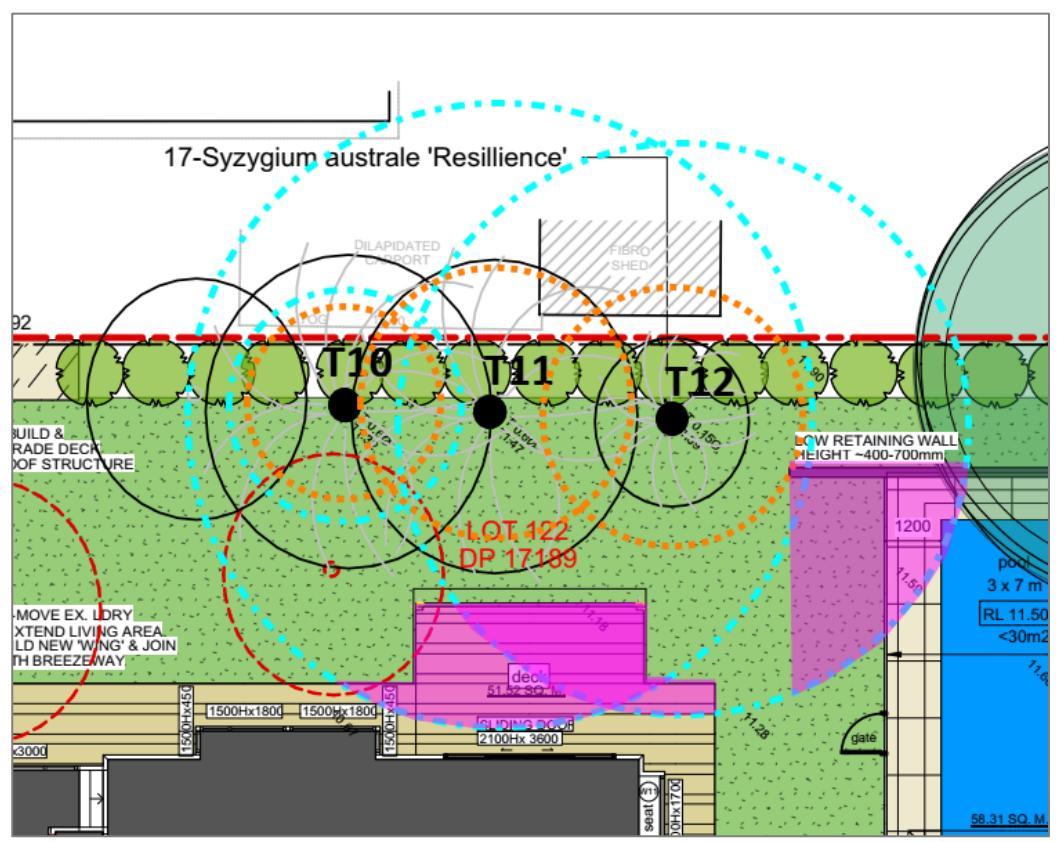
Figure 1 – Tree 10-12 – Proposed encroachment, orange dotted circle SRZ, blue dashed TPZ. Pink shading represents encroachment. (excerpt of Preliminary Landscape Plan by Discount Landscape Plans). Not to scale. Marked up by C. Hughes.

- A total encroachment of 12.4m² or 9.1% (see Figure 1 below) has been calculated within the TPZ placing it in the *minor* category under AS4970. The encroachment is solely from the proposed decking for the rear extension.
- This lightweight deck structure is unlikely to affect the long term survival of this specimen.

• The proposed retaining wall surrounding the sits just outside the SRZ of this specimen (see Figure 1 below).

- A total encroachment of 19.5m² or 17.3% has been calculated within the TPZ for the proposed pool and decking for the rear extension. This is considered a *major* encroachment under AS4970, however, is not a true indication of encroachment for this tree.
- The decking will be a lightweight structure and unlikely to require solid strip footings to accommodate it.
- The retaining wall and pool encroachment has been estimated as 12.5m² or 9.1%, the encroachment solely from the pool and wall is considered in the *minor* category of encroachment under AS4970.

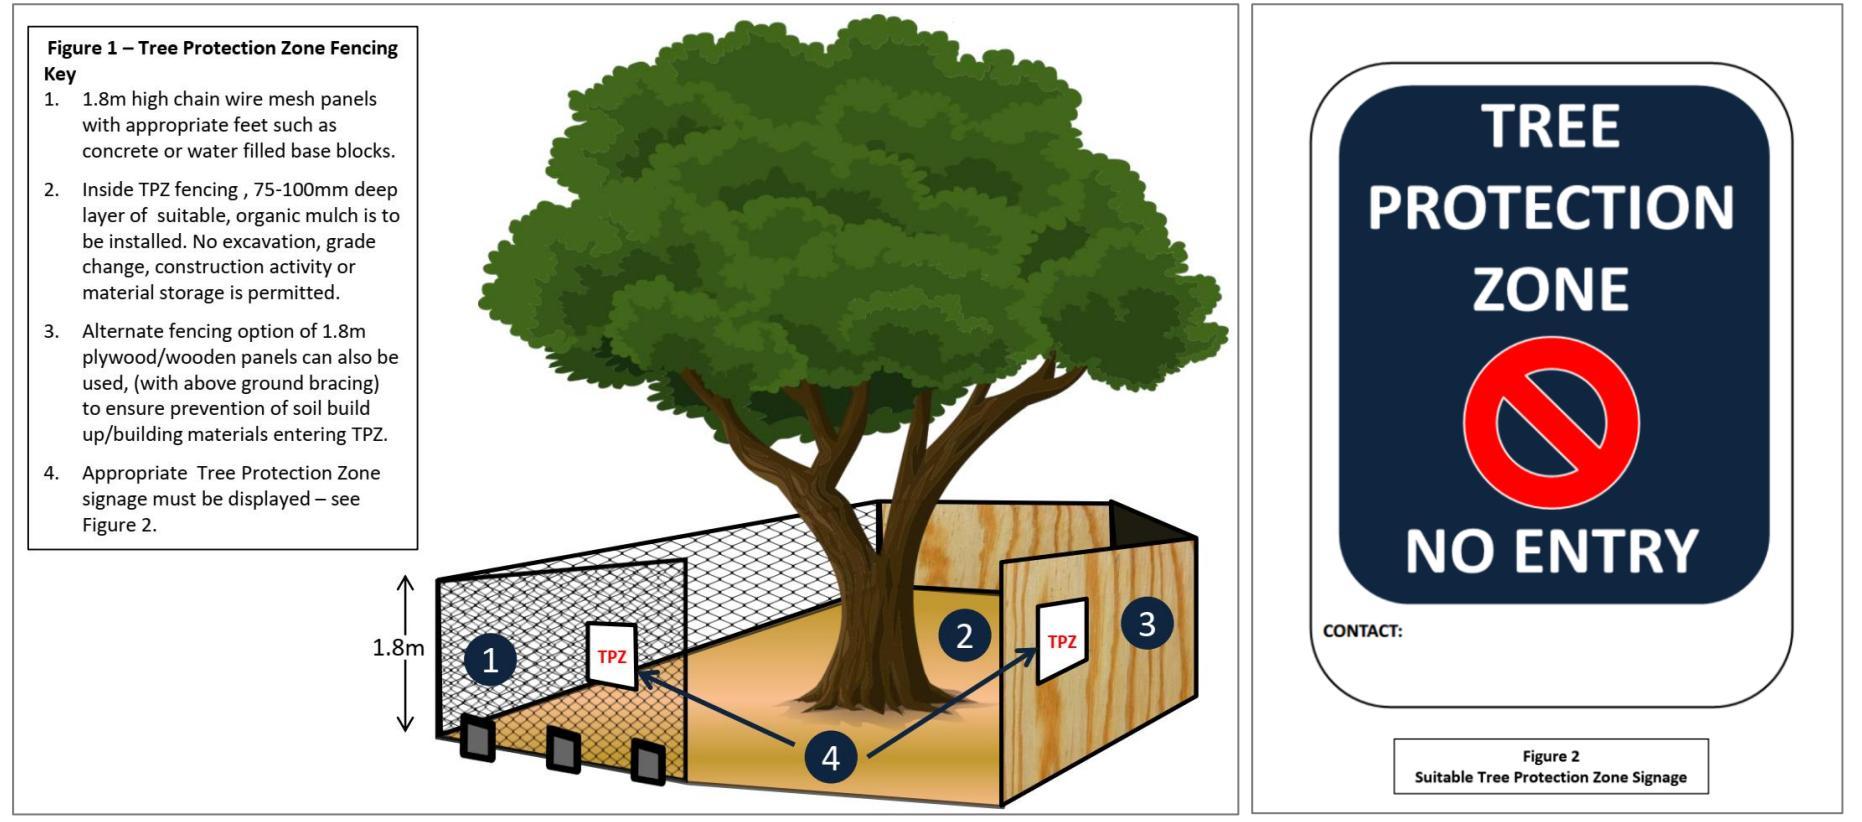
Figures 1 & 2 – Tree Protection Fencing and appropriate signage.

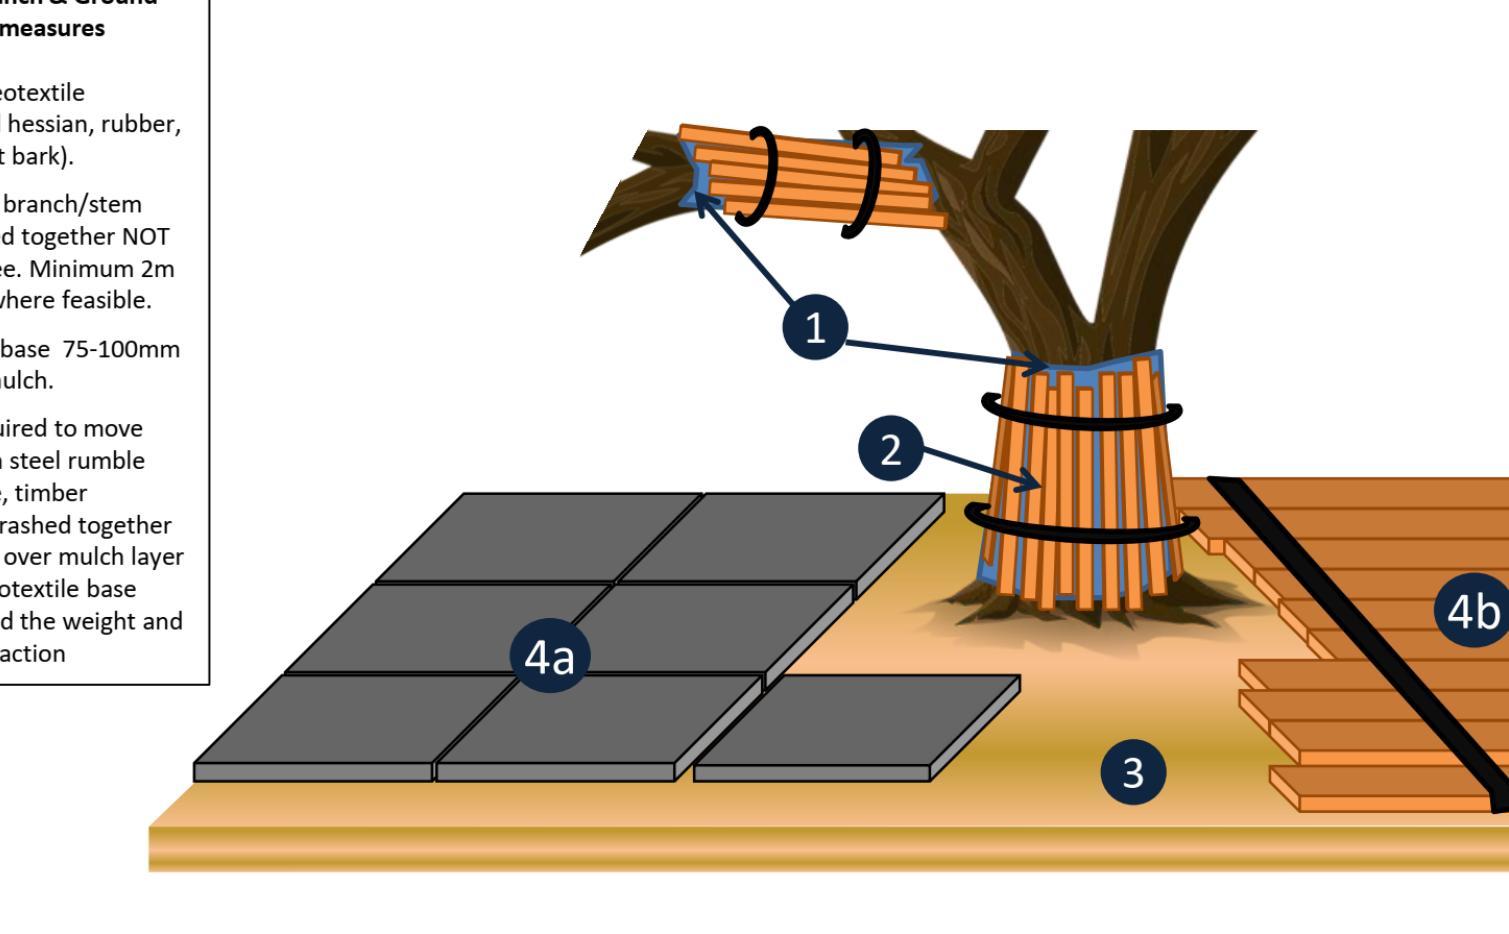
- Padding (such as geotextile membrane, natural hessian, rubber, or carpet to protect bark).
- 2. Battens/boards for branch/stem protection, strapped together NOT nailed into bark/tree. Minimum 2m in height on stem where feasible.
- 3. Ground protection base 75-100mm of fit for purpose mulch.
- If machinery is required to move within the TPZ then steel rumble boards (4a) or wide, timber sheeting/boards thrashed together (4b) is to be placed over mulch layer (preferably with geotextile base layer), this to spread the weight and minimise soil compaction

Figure 3 – Stem and ground protection measures.

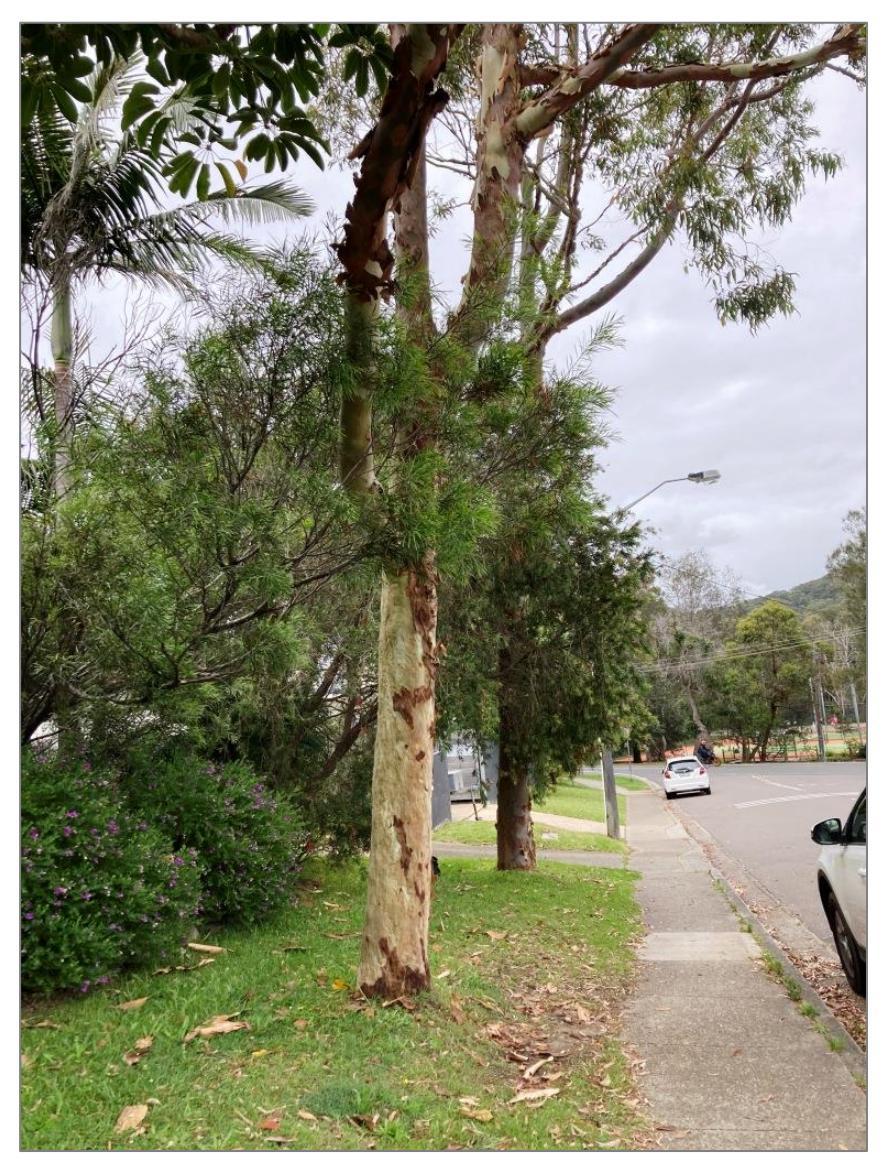
<u>Plate 1</u> – Tree 1 & 2 – Street trees will remain unaffected from the proposed works.

• The existing driveway is remaining unchanged, no impacts to the SRZ are foreseen.

• The existing driveway is remaining unchanged, no impacts within the TPZ have been calculated.

- No pruning is required for these two street trees.
- 3.2.4 <u>Tree 3</u> Weeping Bottlebrush located on subject site.

- 5.3.1 <u>Tree 1 & 2</u> Sydney Red Gum located adjacent to subject site.
 - Protect Tree 1 & 2 by placing temporary fencing and signage a minimum 4.5m from the tree stems ensuring pathway, driveway and road access.

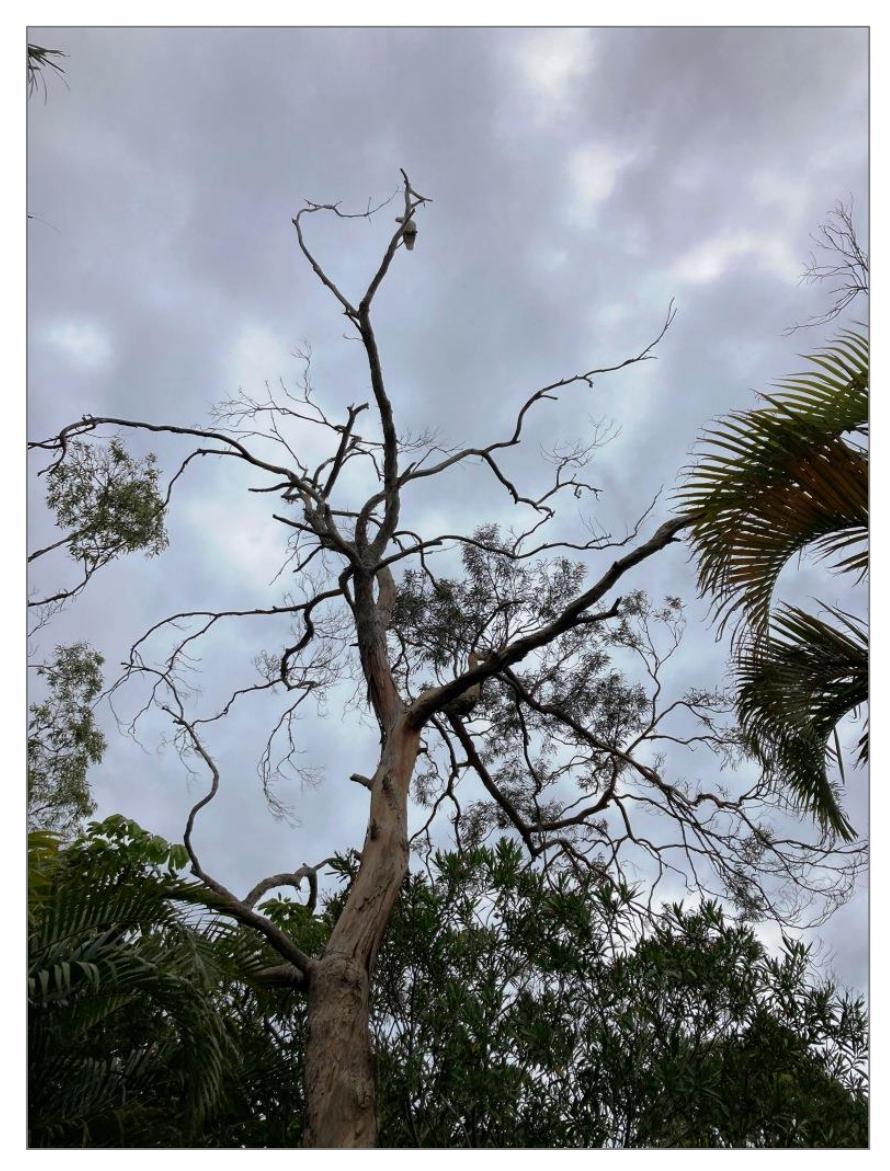
<u>Plate 2</u> – Tree 5 – Upper canopy of tree has significant die-back.

- An estimated encroachment of 4.3m² or 4.6% has been calculated in relation to the proposed detention tank, front porch, and side access paving. This is considered *minor* encroachment under AS4970.
- It is unlikely the proposed works would further impact the already poor health of this specimen.

- 5.3.3 <u>Tree 5</u> Gum– located on subject site.
 - Protect Tree 5 by placing temporary fencing and signage a minimum 5m from the tree stem outside active work zones.

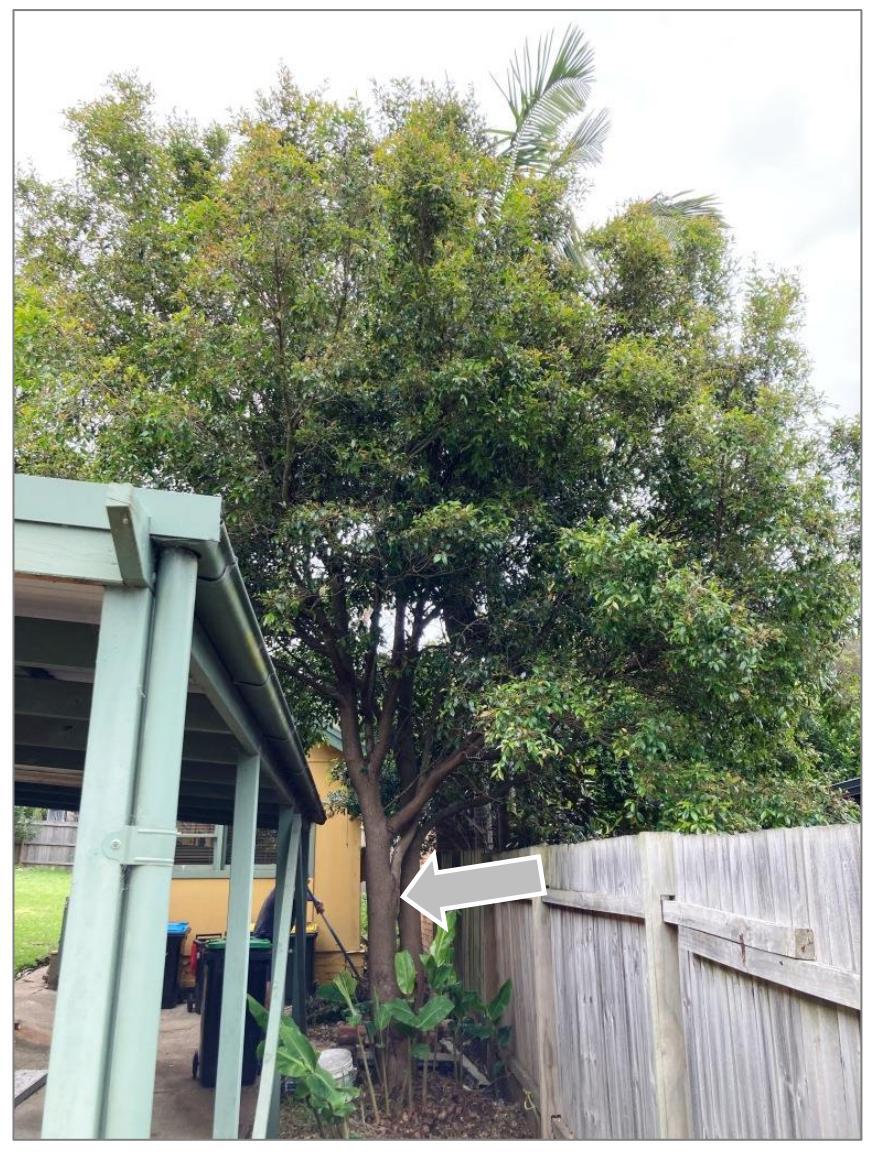
<u>Plate 3</u> – Tree 6 – Care when removing the carport will be required given the low canopy.

- Some pruning may be required to ensure branches are not torn during demolition of the existing carport.
- 3.2.7 <u>Tree 10</u> Snow in Summer located on subject site.

- 5.3.4 <u>Tree 6</u> Common Lilly Pilly– located on subject site.
 - Protect Tree 6 by placing temporary fencing and signage a minimum 3m from the tree stem outside active work zones.

- Any ground level changes within the calculated TPZ the subject tree are to be supervised by the Project Arborist/Council.
 - Any required canopy pruning shall be carried out by an AQF Level 3 Arborist and to a maximum 10% of the total live canopy.

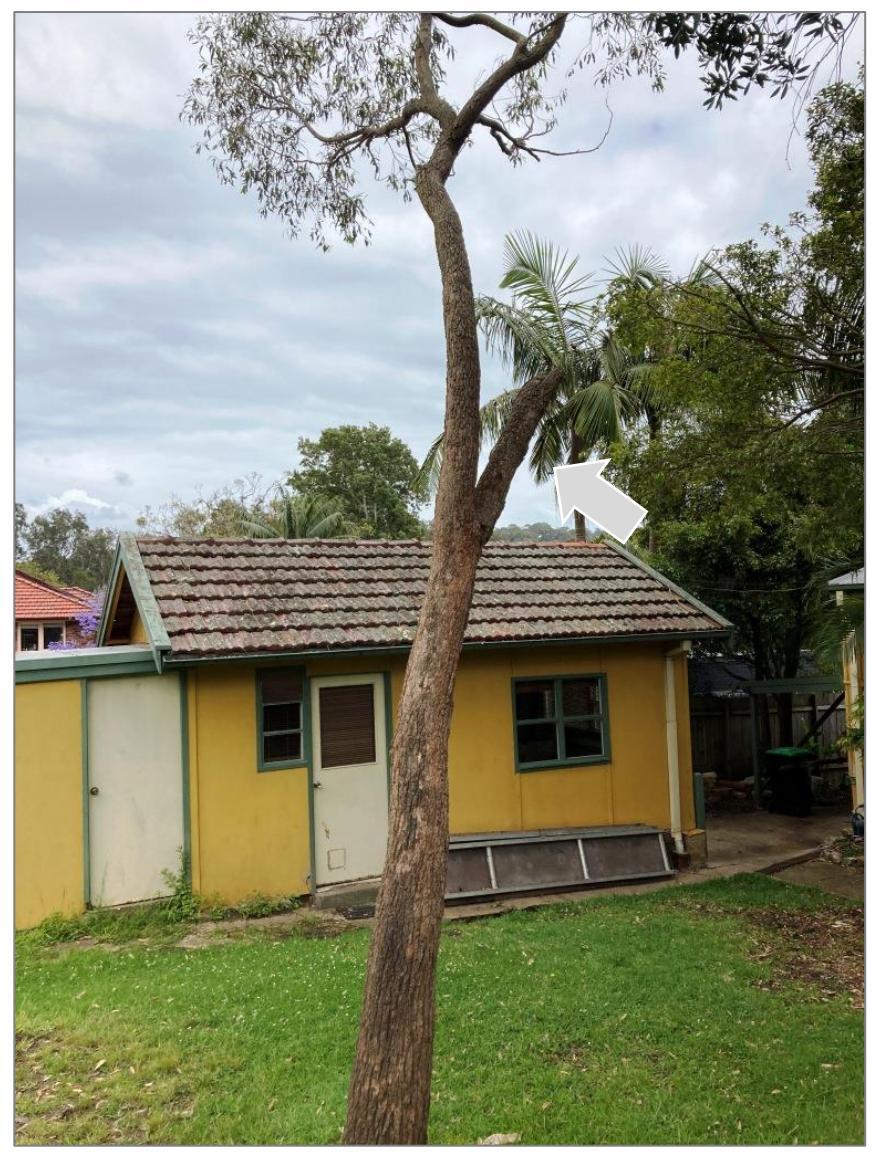
<u>Plate 4</u> – Tree 9 – Proposed for removal, recently lost low limb during a storm (noted with arrow).

- <u>Tree 9 Eucalyptus botryoides (Bangalay)</u> the canopy of this specimen is orientated to the west low over the proposed dining area and would require significant pruning, the proposed decking will fall within the calculated SRZ of this specimen. Removal of this low Retention Value (RV) tree would facilitate ease for design and adequate usable lawn area for the rear yard.

- 5.1.1 Three (3) trees (Tree 7, 9 & 13) will require removal to accommodate the proposal.
- 5.1.2 Tree removal is at the discretion of Council approving such, no work should be carried out prior to approval.
- 5.1.3 Tree removal works are to be carried out by an AQF Level 3 Arborist.
- 5.1.4 Tree removals are to be undertaken in accordance with the NSW WorkCover Code of Practice for the Amenity Tree Industry (1998) and Safe Work Guide to Managing Risks of Tree Trimming and Removal Work 2016.
- 5.1.5 Tree removals shall be in accordance with the Work Health and Safety Act 2011 and the Work Health and Safety (WHS) Regulations 2011.

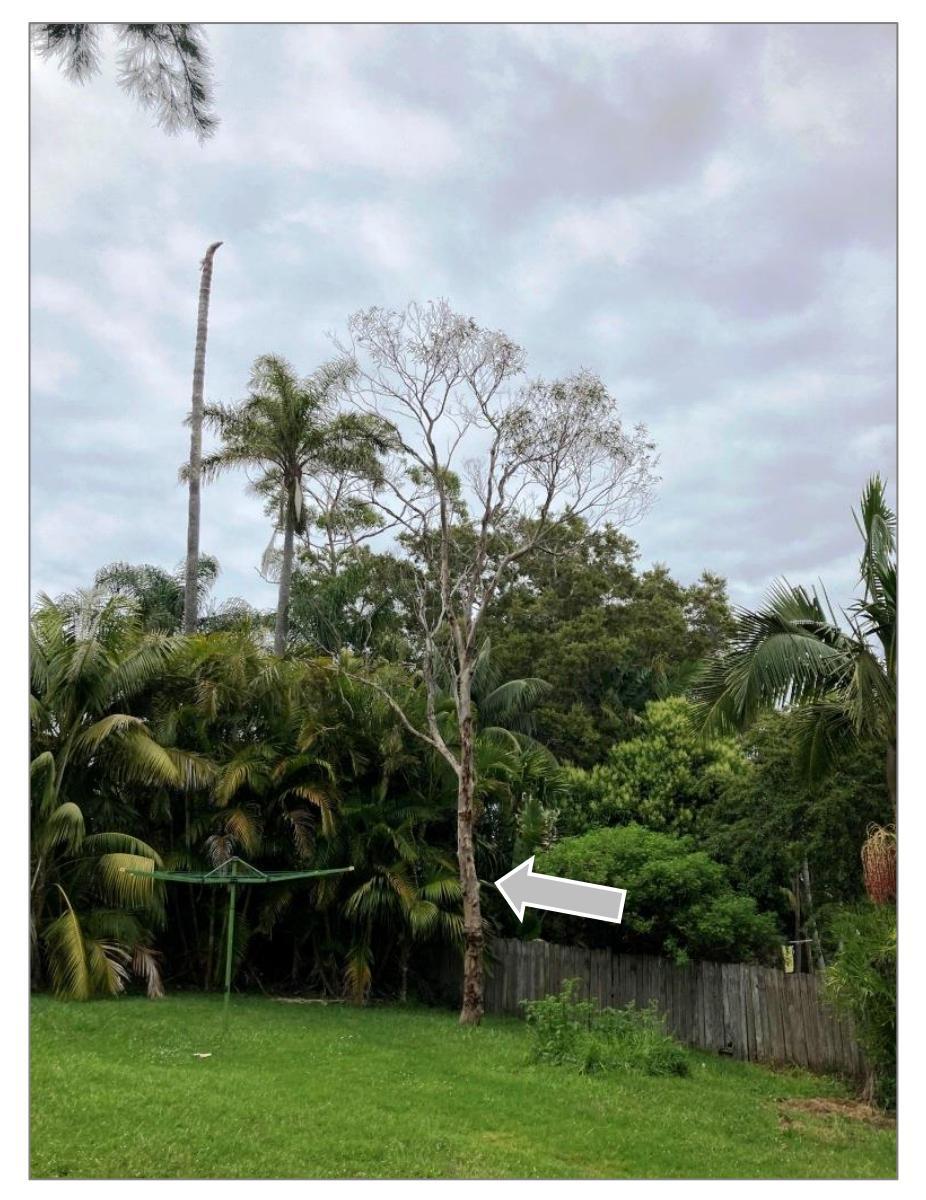
<u>Plate 5</u> – Tree 12 – Proposed for removal, tree almost dead.

- <u>Tree 13 Eucalyptus punctata (Grey Gum)</u> this tree is almost dead and should be removed irrespective of the subject site proposal.

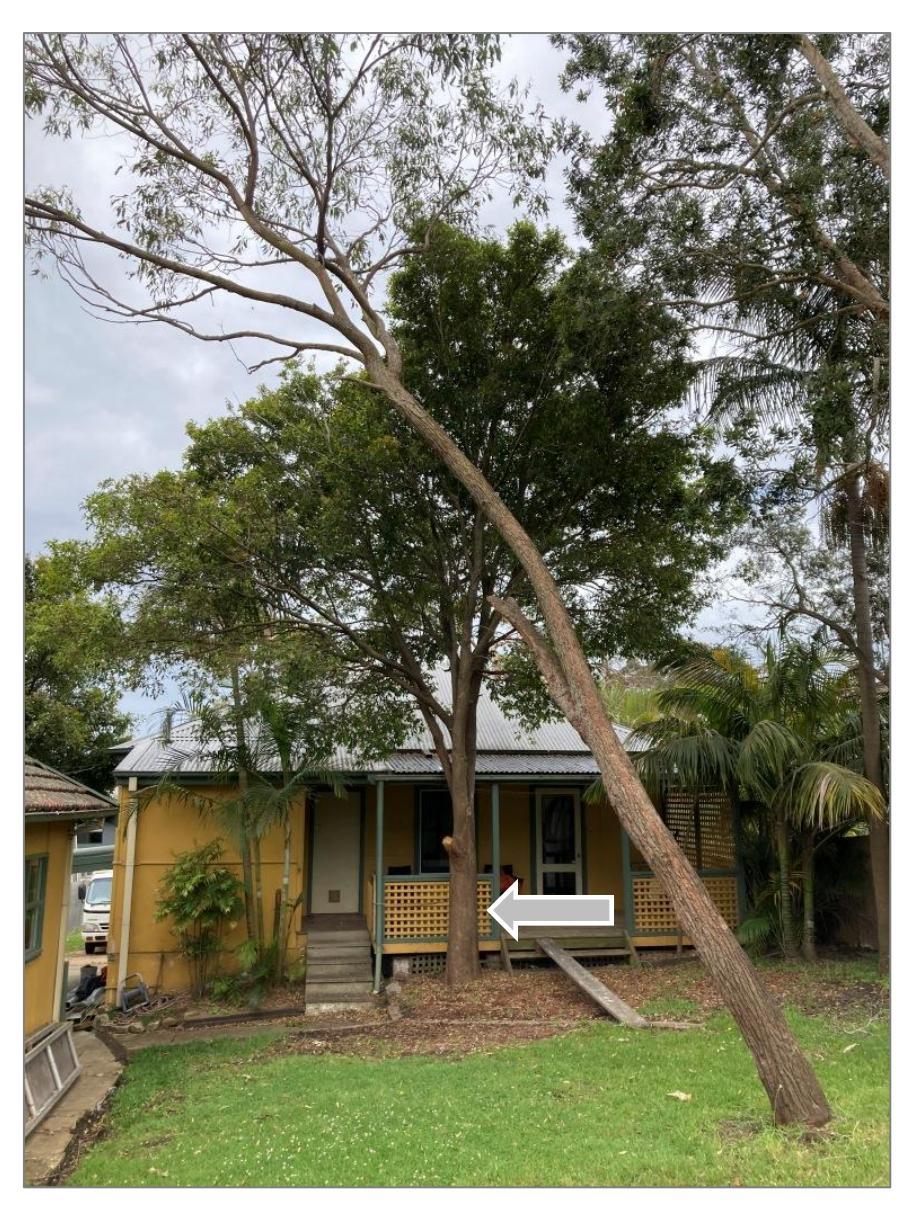
<u>Plate 6</u> – Tree 9 (foreground) & Tree 7 – Arrow notes Tree 7 that requires removal to accommodate works. Tree 9 in foreground requires removal also and is in poor condition.

- 3.1 Potential Required Removal of Prescribed Trees
 - 3.1.1 Three (3) trees would be required to be removed to accommodate the proposed works:
 - <u>Tree 7 Syzygium smithii (Common Lilly Pilly)</u> located just over 1m from the internal refiguration for the main subject site dwelling, the excavation for footings will fall well within the Structural Root Zone (SRZ) of this specimen. This tree would require removal to accommodate the proposal.

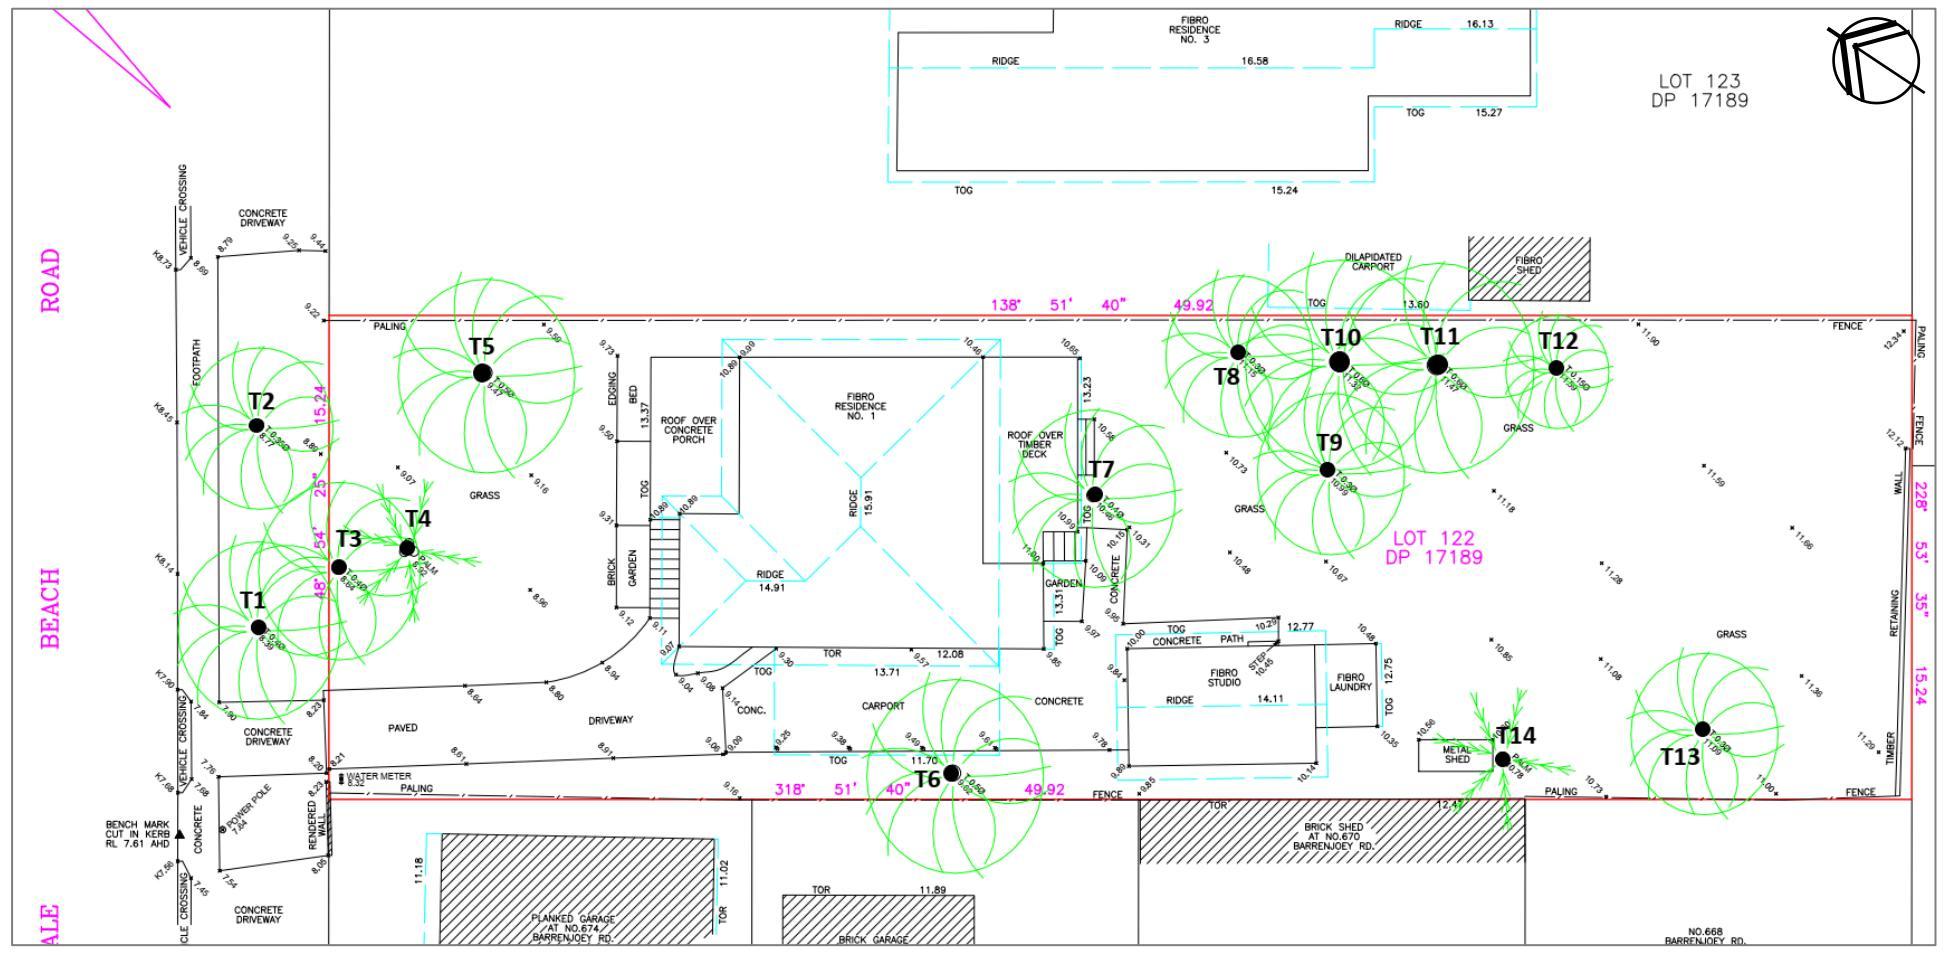
Appendix 7 – Tree Location Plan.

NOT TO SCALE. Marked up by C. Hughes 8 December 2020. Survey Plan excerpt authored by DP Surveying, dated 17 September 2020.
