LOT 7, 10 COURTLEY ROAD-BEACON HILL ARBORICULTURAL IMPACT ASSESSMENT

date	revision	prepared	checked
18/09/18	Issued Development Application	GO	AM

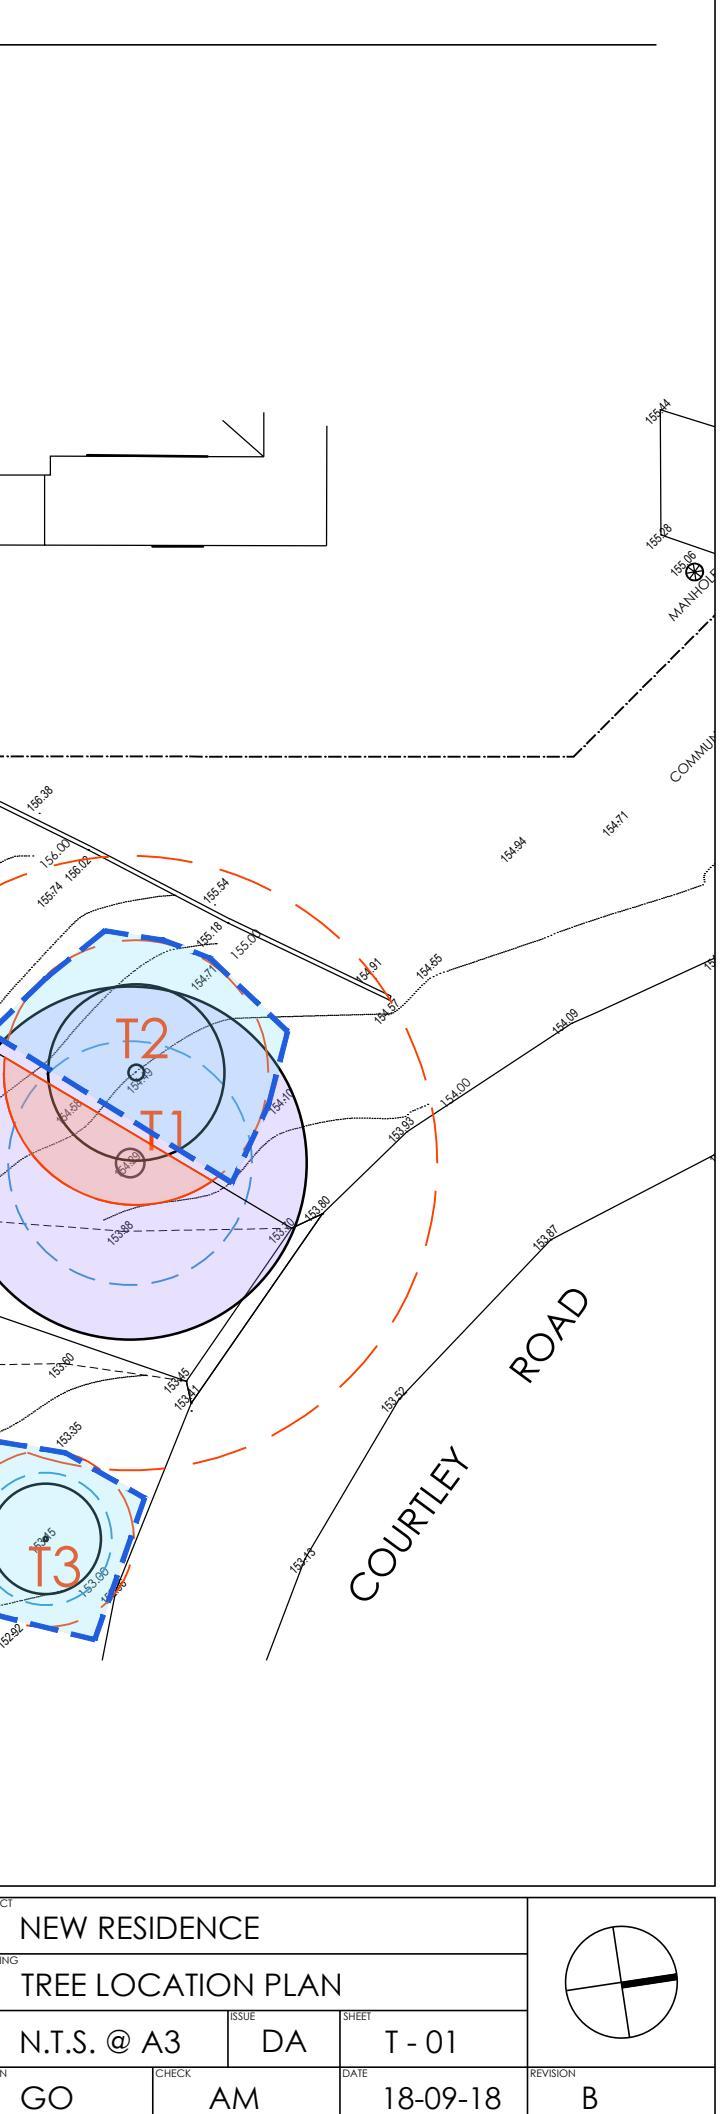
The physical data for tree locations, crown width and DRB is schematically described in **9. Tree Location Plan** (page 20).

Generally the site's vegetation was observed to have a mix native/exotic tree canopy, with an exotic shrub midstorey and an exotic turf groundcover layer. The existing surveyed trees are shown at **9**. Tree Location Plan (page 20).

• /	Assessed tree within development footprint Cut - encroachment in Tree Protection Zone	 Arc to	chontophoenix cunninghamiana Bangalow Palm - exempt from protection under Council DCP		33.785 33.785 180°27'20'' 2.5m Magnolik exempt from protection un 3.5m Syagrus rom exempt from protection 3r exempt from protection 3r exempt from protection	a x soulangeana der Council DCP nanzoffiana Cocos Palm – tion under Council DCP m Cyathea cooperi Soft Tree Fern – m protection under Council DCP	and
		Indicative location of Tree Protection Fencing	g			1	\ f ^ø	
A B	DESCRIPTION SUBMITTED TO CL SUBMITTED TO CL	ENT FOR COMMENT ENT FOR COMMENT	DRAWN CHECK DATE GO AM 05- GO AM 18-0	09-18 D9-18	PO Box 8136, Baulkham Hills, NSW 2153 Ph: (02) 9680 7713 Fax: (02) 9680 7705 Email: info@arboreport.com.au Web: www.arboreport.com.au Member of the Institute of Australian Consulting Arboricul	turists (IACA)	AD (LOT 7), BEACON HILL	DRAWIP SCALE

• Tree 2 is located in the council verge 1.2m from the proposed driveway crossover, providing a 24.7% encroachment within the TPZ. This tree is considered to be of low significance.

Tree 1 is a street tree located within the proposed driveway and crossover footprint. This tree is considered to be of low significance, of fair health its crown somewhat sparse. Extensive redesign of the proposed driveway and crossover layout and associated transitions would be required to retain this tree. We understand this would require also redesign of the proposed dwelling and garage. It cannot be retained if the development is approved in its current form. As the tree is considered to be of low significance, consideration should be given to remove it.

Tree 3 is located within the road reserve, near the front boundary. It is located in a position that will allow its retention without impact from the proposed constructed elements. As much as practicable of the TPZ should be enclosed by tree protection fencing to reduce risk of damage from activities associated with construction activities (mechanical damage to trunk and soil compaction from such activities as materials delivery, people and machinery accessing the site and storage of materials).

- Trees 4, 5 & 6 are located within a neighbouring property in positions that will allow their retention without impact from the proposed development.
 Stormwater pipes and pits should be installed as close to the building as possible to avoid encroachment within the TPZ of these trees.
- A number of trees not assigned numbers have been annotated on the tree location plan. They are exempt from protection under the Warringah Development Control Plan Section E1 Preservation of Trees or Bushland Vegetation
