Arboricultural Impact Assessment For Proposed Residential Development (Strata Subdivision & Seniors Living) At 9-11 Birdwood Avenue COLLAROY

Ref: 2652AIA

April 2020

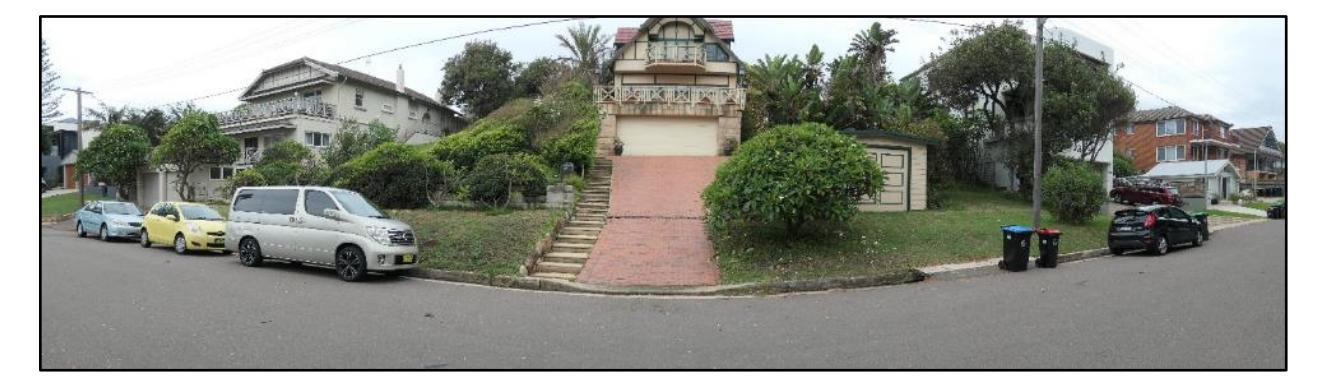
**Photo A:** Subject site and adjoining properties showing general (distorted) view of the existing landscape features.

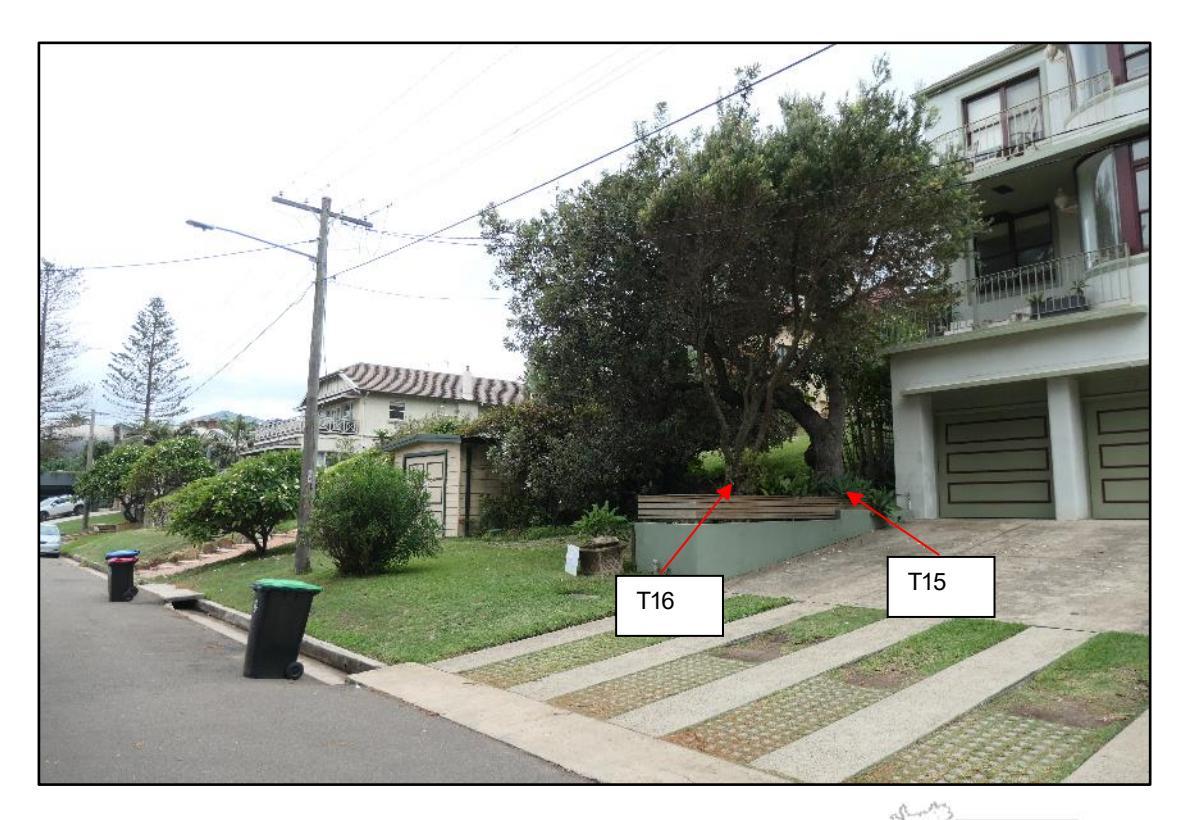
Photo C: Trees 15 and 16 to be retained on adjoining property #7 Birdwood Avenue.

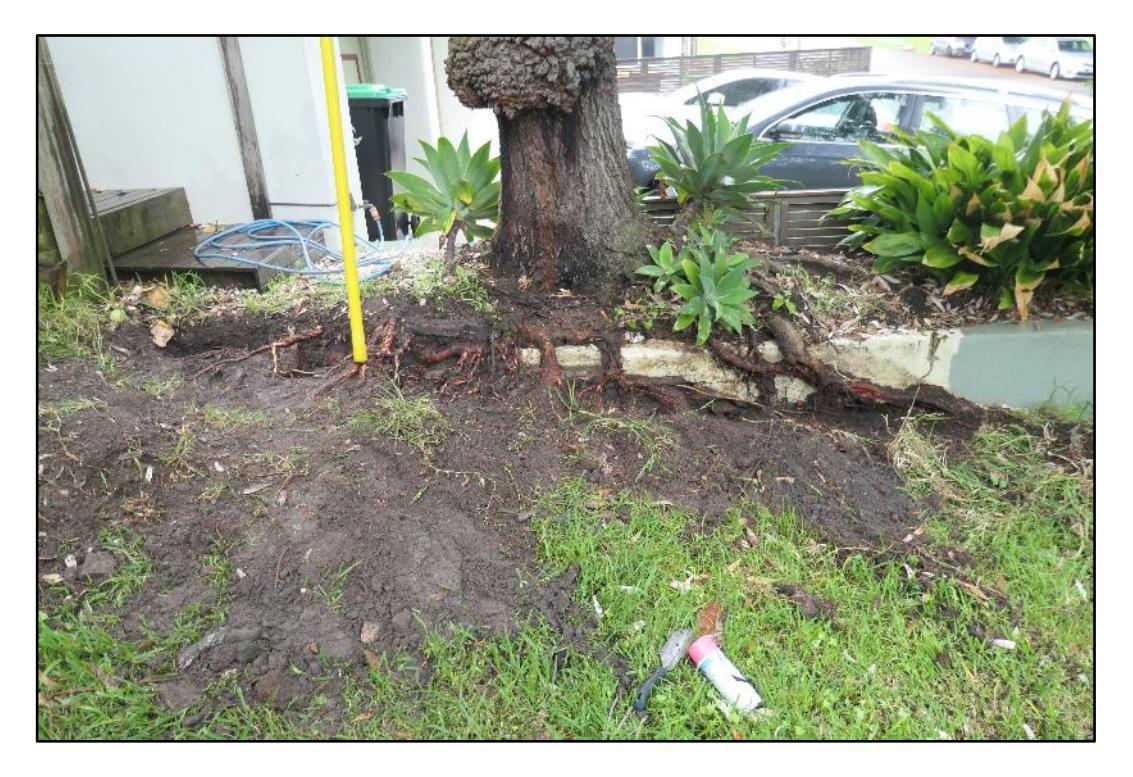
Photo D: Tree 15 Coast Banksia located at #7 Birdwood Avenue showing roots which have grown beyond the masonry planter and into the subject site.

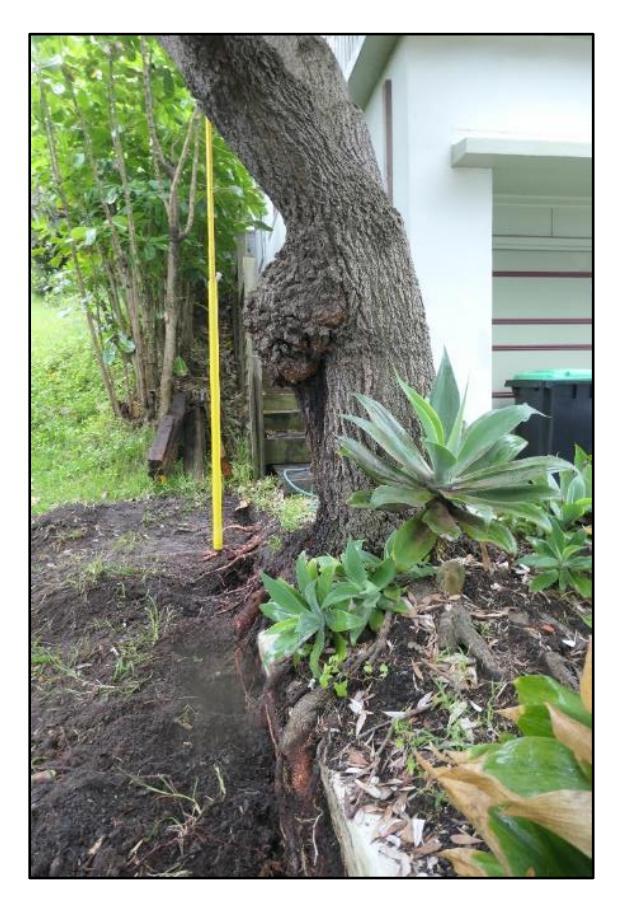
Photo E: Tree 15 Coast Banksia located at #7 Birdwood Avenue showing roots which have grown beyond the masonry planter and into the subject site.

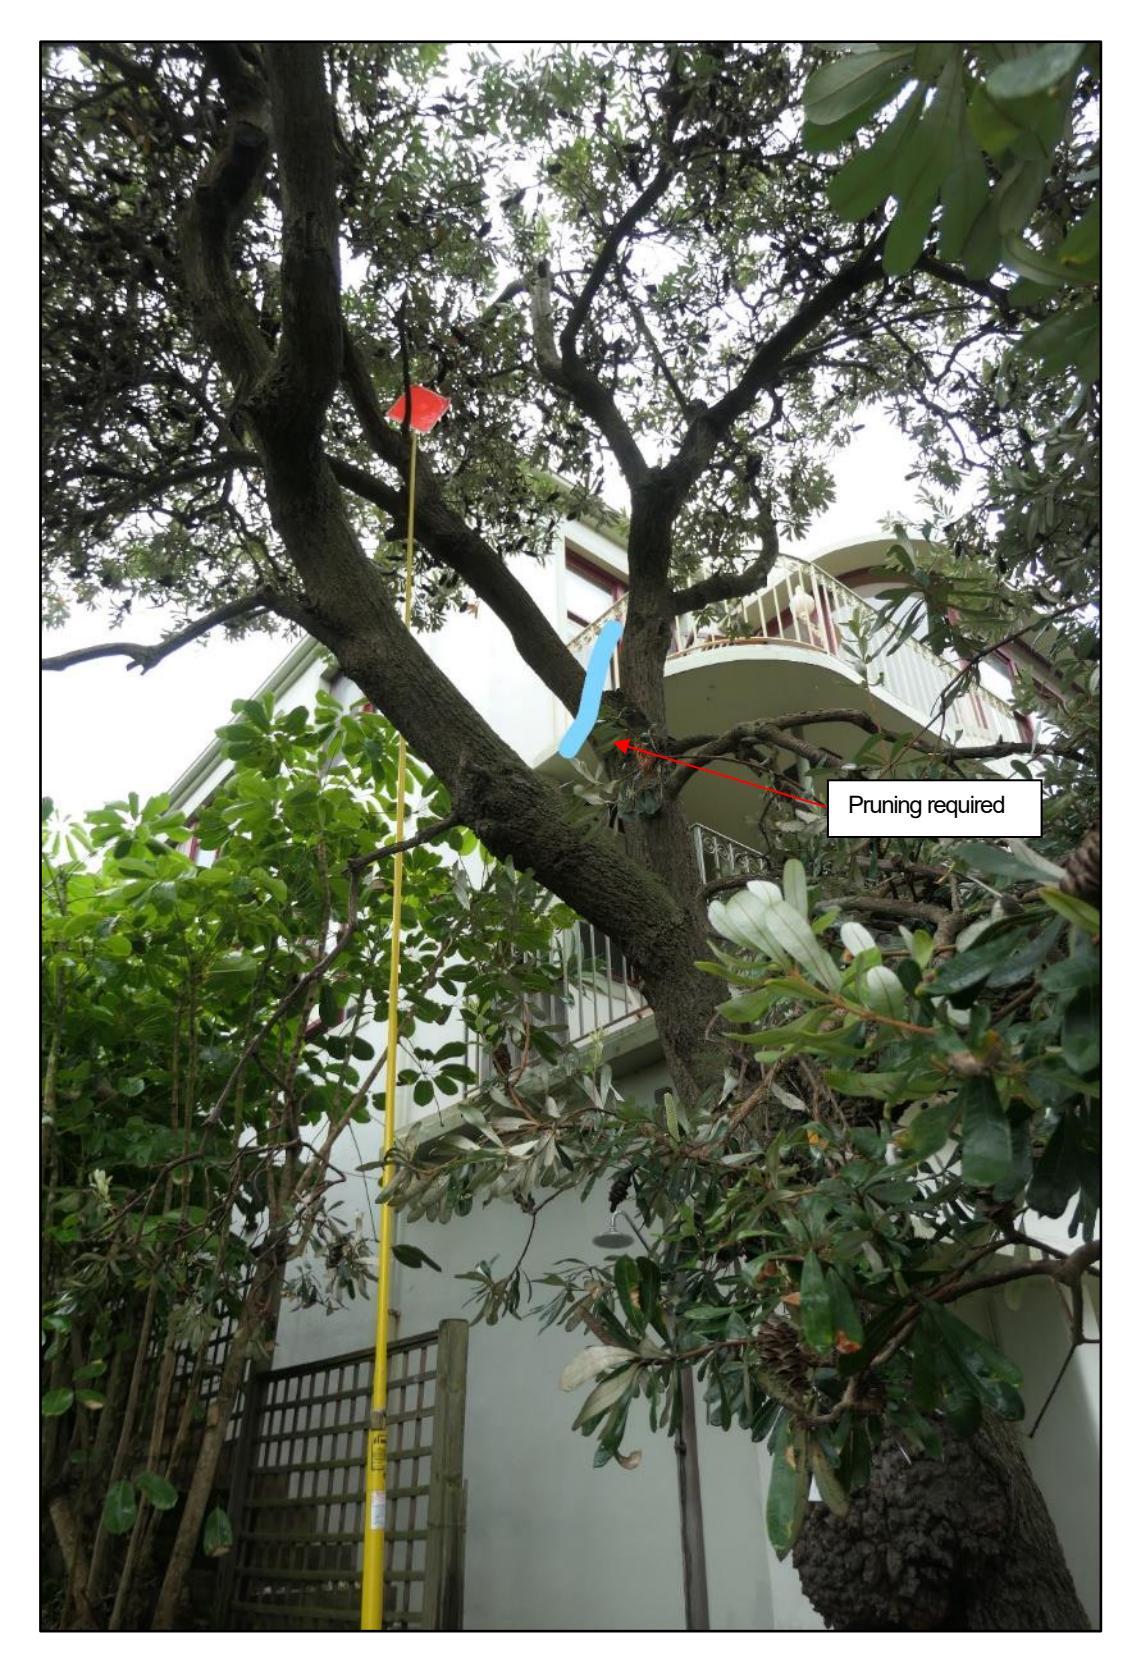
**Photo F:** Tree 15 Coast Banksia located at #7 Birdwood Avenue showing crown pruning required for construction. The height staff is at the corner of the Lower Roof at approximately RL11.4 at 1.8m from centre of trunk.

- 1.2.5 Tree 15, Coast Banksia, *Banksia integrifolia* located at #7 Birdwood Avenue is the only assessed ©Retention Value A tree and it is to be retained and protected. The pedestrian entrance adjacent Tree 15 has been amended to be suspended within the SRZ/TPZ. The roots which have grown onto the subject site (Photos D & E) are to be retained and protected. Minor crown pruning is required as illustrated in Photos F and G.

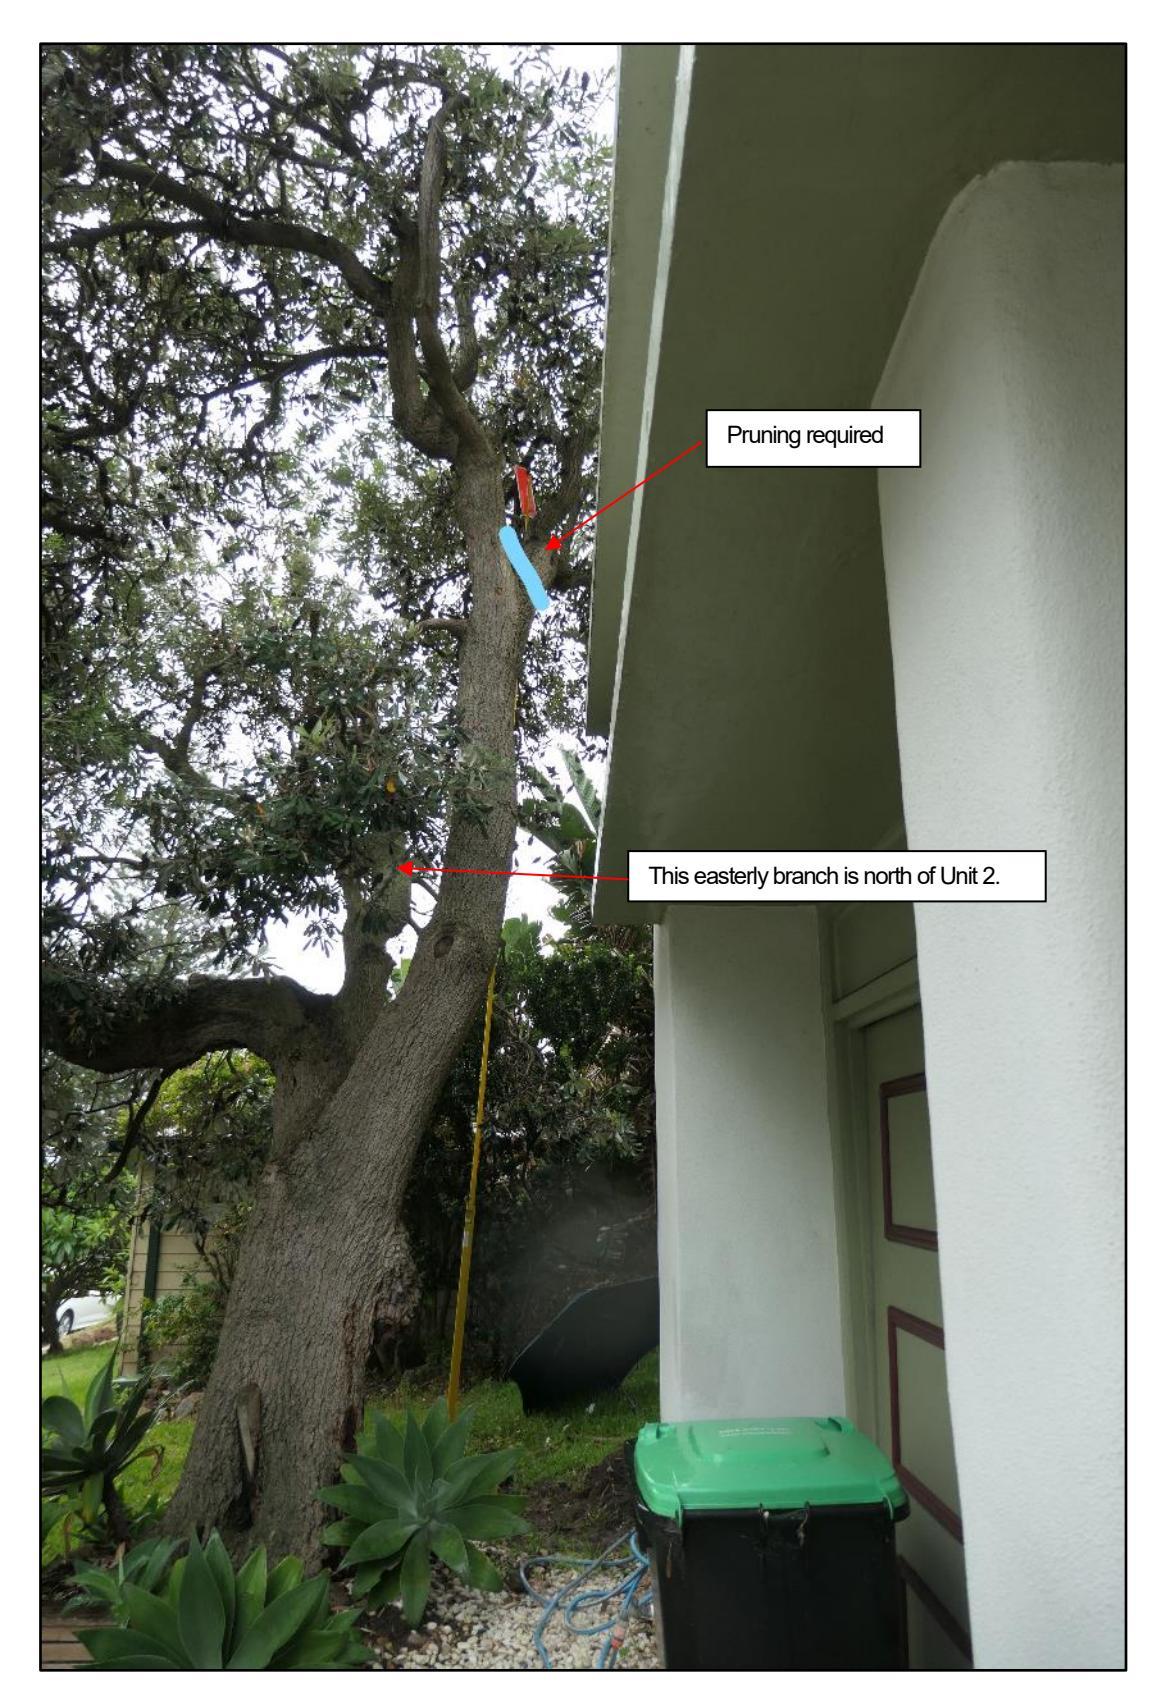
Photo G: Tree 15 Coast Banksia located at #7 Birdwood Avenue (looking east) showing crown pruning required for construction. The height staff is at the corner of the Lower roof at approximately RL11.4 at 1.8m from centre of trunk.
