# GEOTECHNICAL INVESTIGATION REPORT FOR THE PROPOSED ABSORPTION TRENCH

17 Bilberry Avenue, Bilgola Plateau

**Project Number: G2031**

November 2020

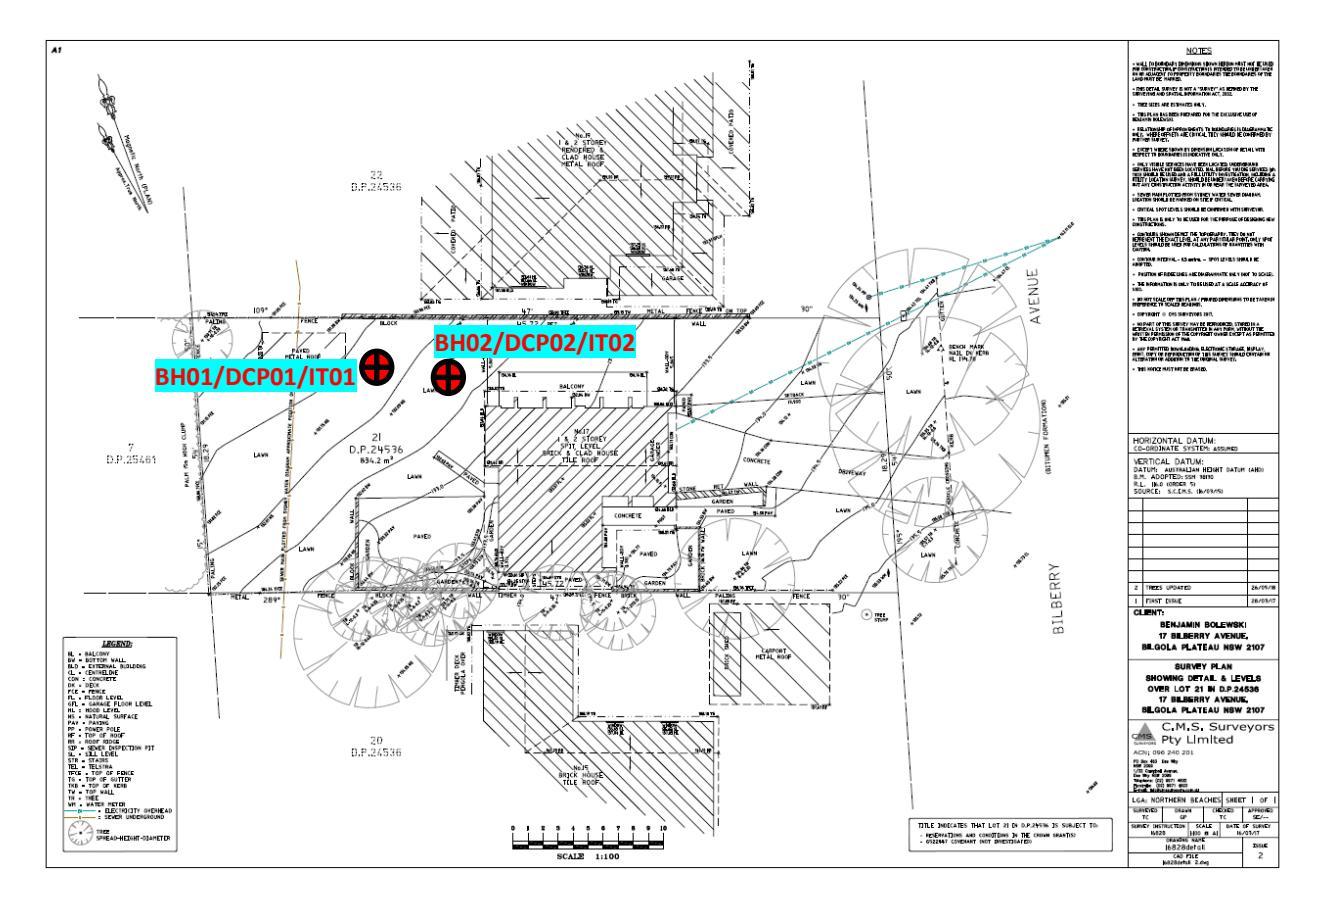
Figure A DCP, Bore Hole and Infiltration Test Locations

### Appendix A: DCP, Borehole and Infiltration test locations

Dynamic Cone penetration (DCP) test was carried out in accordance with Australian Standard AS 1289, 'Methods of Testing Soil for Engineering Purposes.' The DCP test location is shown in Appendix A and the results are shown in Appendix B.

The locations of boreholes are presented in Appendix A.

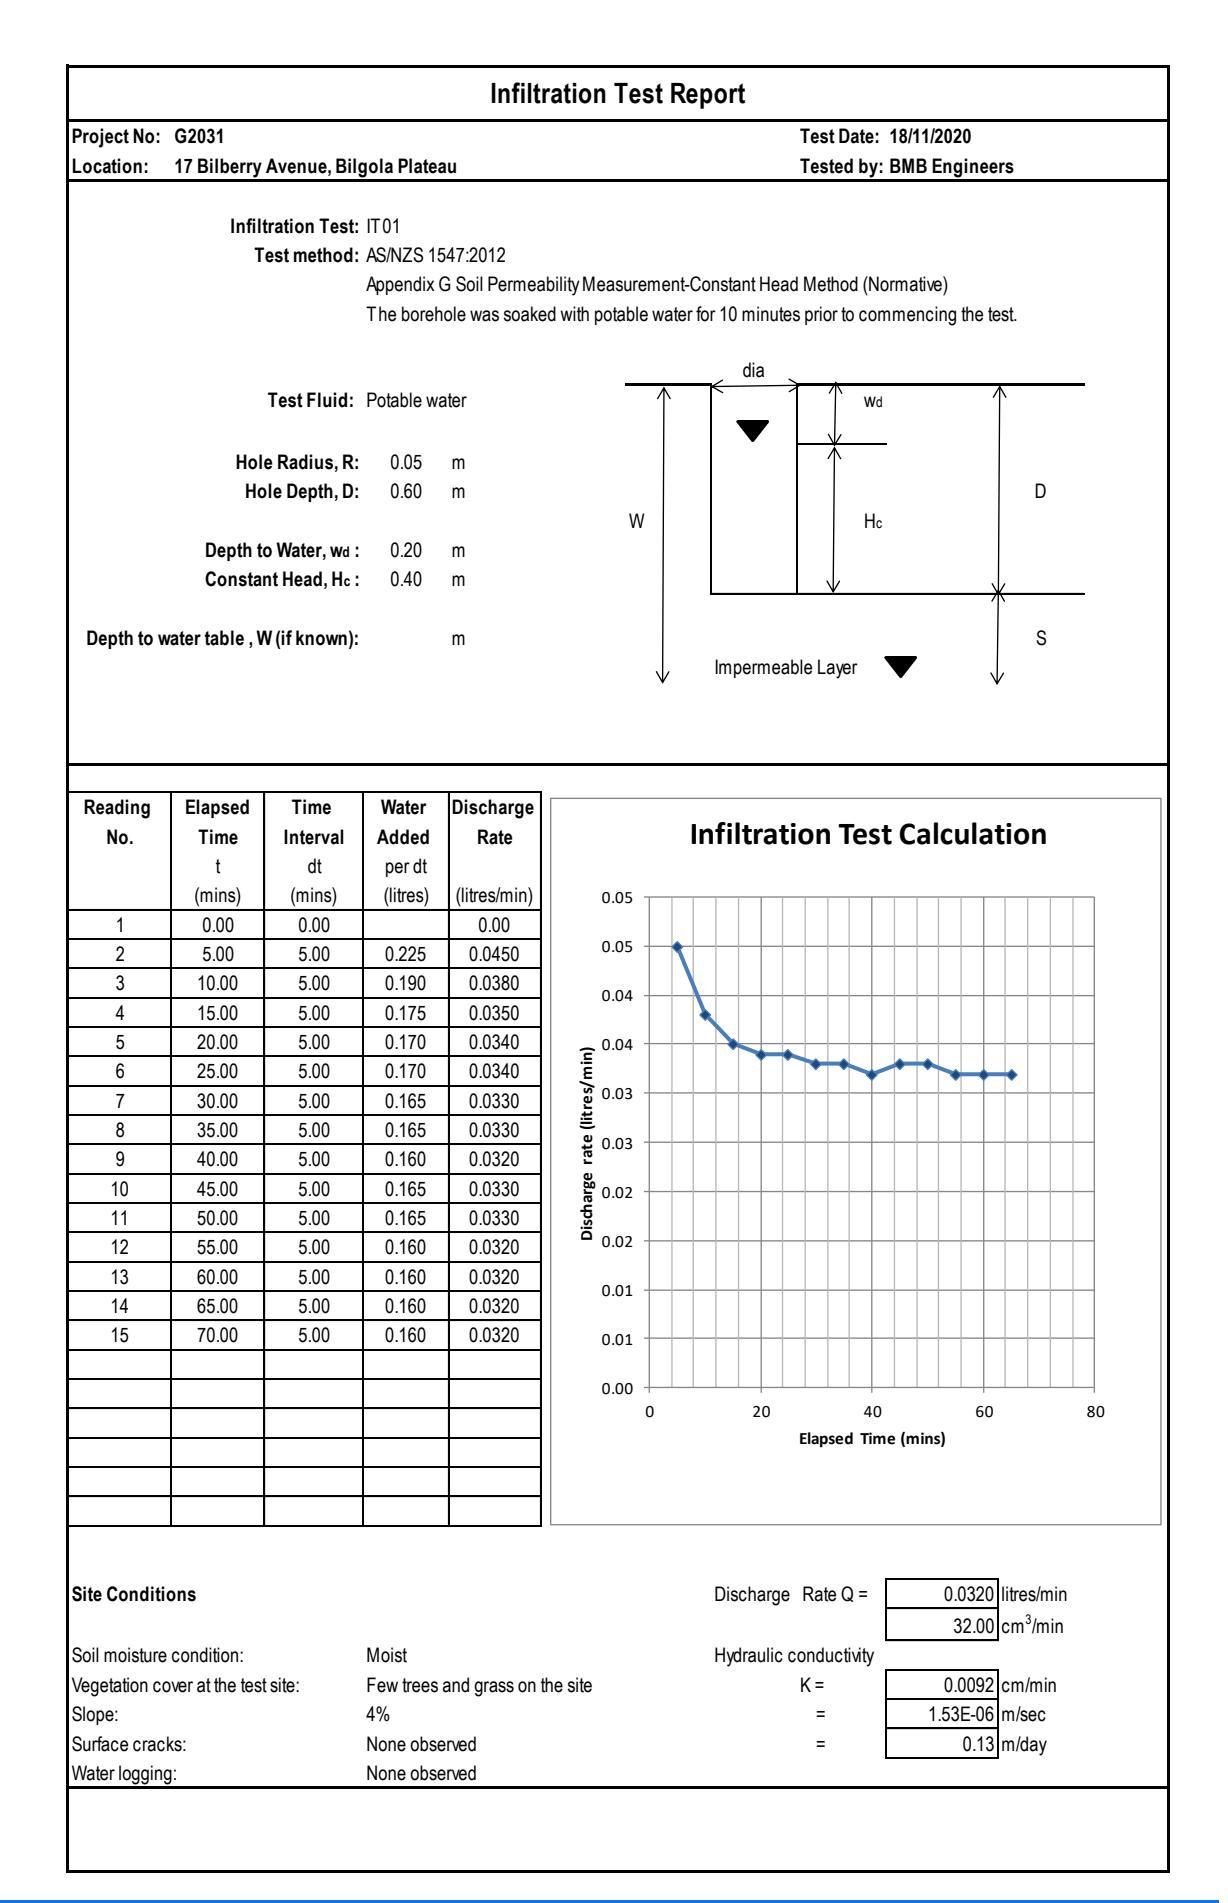
Appendix D: Infiltration Test Results

| | | | | Infilt | ation Test Report | |
| | | est methou. | Annendix | G Soil Permea | hility Measurement-Constant Head Method (Normative) | |
| | | | | | Discharge Rate Q = 0.0300 litres/min | |
| Soil moisture<br>Yegetation co<br>Yope:<br>Surface crac | ons<br>condition:<br>over at the test<br>ks: | :site: | Moist<br>Few trees<br>4%<br>None obse | and grass on t | Hydraulic conductivity<br>he site K = 0.0086 cm/min<br>= 1.44E-06 m/sec<br>= 0.12 m/day | |

The infiltration test (IT) was undertaken in two boreholes to determine the coefficient of permeability (K) of the soil. These tests were undertaken on the site in accordance with AS/NZS: 1547-2012 on-site domestic wastewater management. Based on the infiltration rate tests, the permeability of the site has been estimated as 0.12 m/day. The absorption rate of site soil is estimated as 0.07 L/s/m<sup>2</sup>.

The infiltration test results are included in Appendix D.
