# GEOTECHNICAL AND ACID SULFATE INVESTIGATION REPORT

1127 Barrenjoey Road, Palm Beach NSW 2108

Dr J & R Kennedy – February 2021

Report reference: 2001056GTRpt01FinalV02\_15Feb21

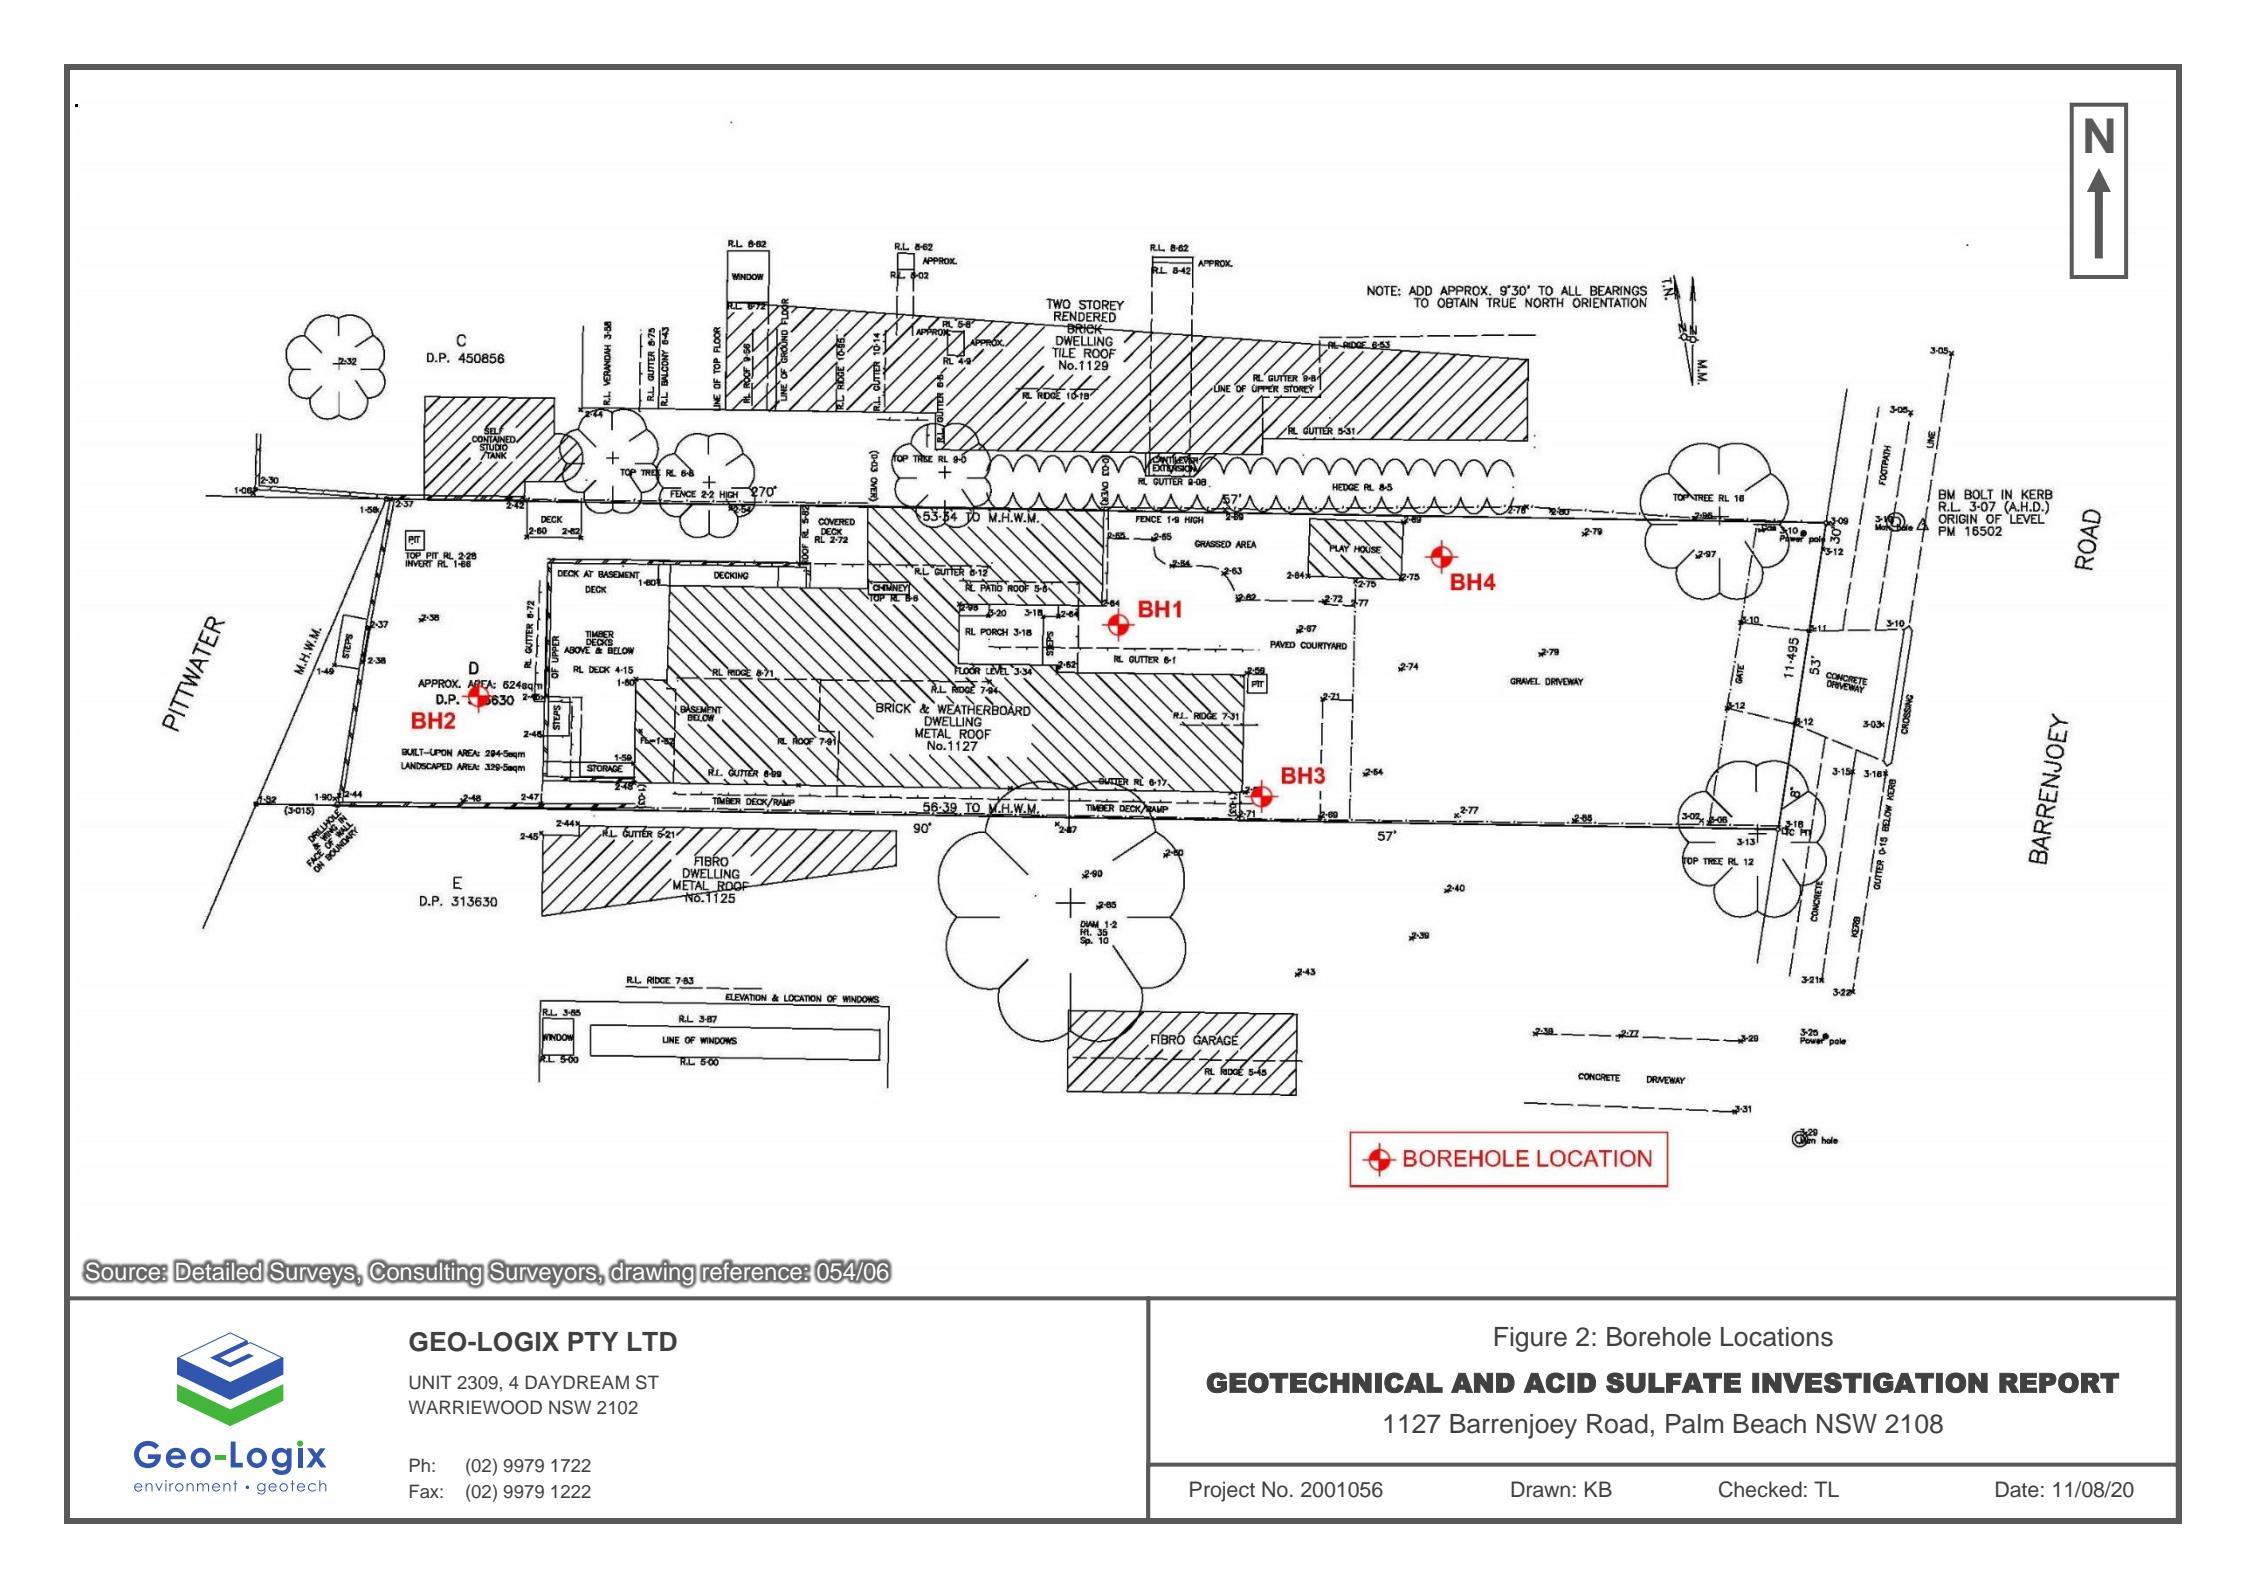
Figure 1: Site Locality
Figure 2: Borehole Locations

- Review of the ASS and geological maps for the area;
- Visual appraisal of the site conditions and locality;
- Drilling of four borings (BH1–BH4) spread across the site including the footprint of proposed excavation by push tube and solid stem auger to a maximum of 8.1 metres below grade (mbg) or refusal on bedrock. (Figure 2);
- Logging of the soil borings in accordance with the Unified Soil Classification System (USCS);
- Collection of soil samples every metre or at changes of soil type;
- Perform field pH and oxidised pH screening on each collected soil sample to assess the presence of ASS;
- Submit one sample from each boring for laboratory assessment for ASS via Chromium Reducible Sulfur Analysis;

- Backfilling of the borings with onsite soils;
- Dynamic Cone Penetrometer (DCP) testing adjacent to the boring locations BH2 and BH3 to assess the relative density and/or consistency of the subsurface soils, and
- Provision of this report detailing the results of the above investigation, recommendations for design and construction of the proposed development.
