arboricultural impact assessment – 5 florida road, palm beach

17th July 2019

prepared by Melanie Howden - Ass. Dip. Hort. (Haw. Ag. C.), SoA. Arb. MAIH, MIACA

cover sheet

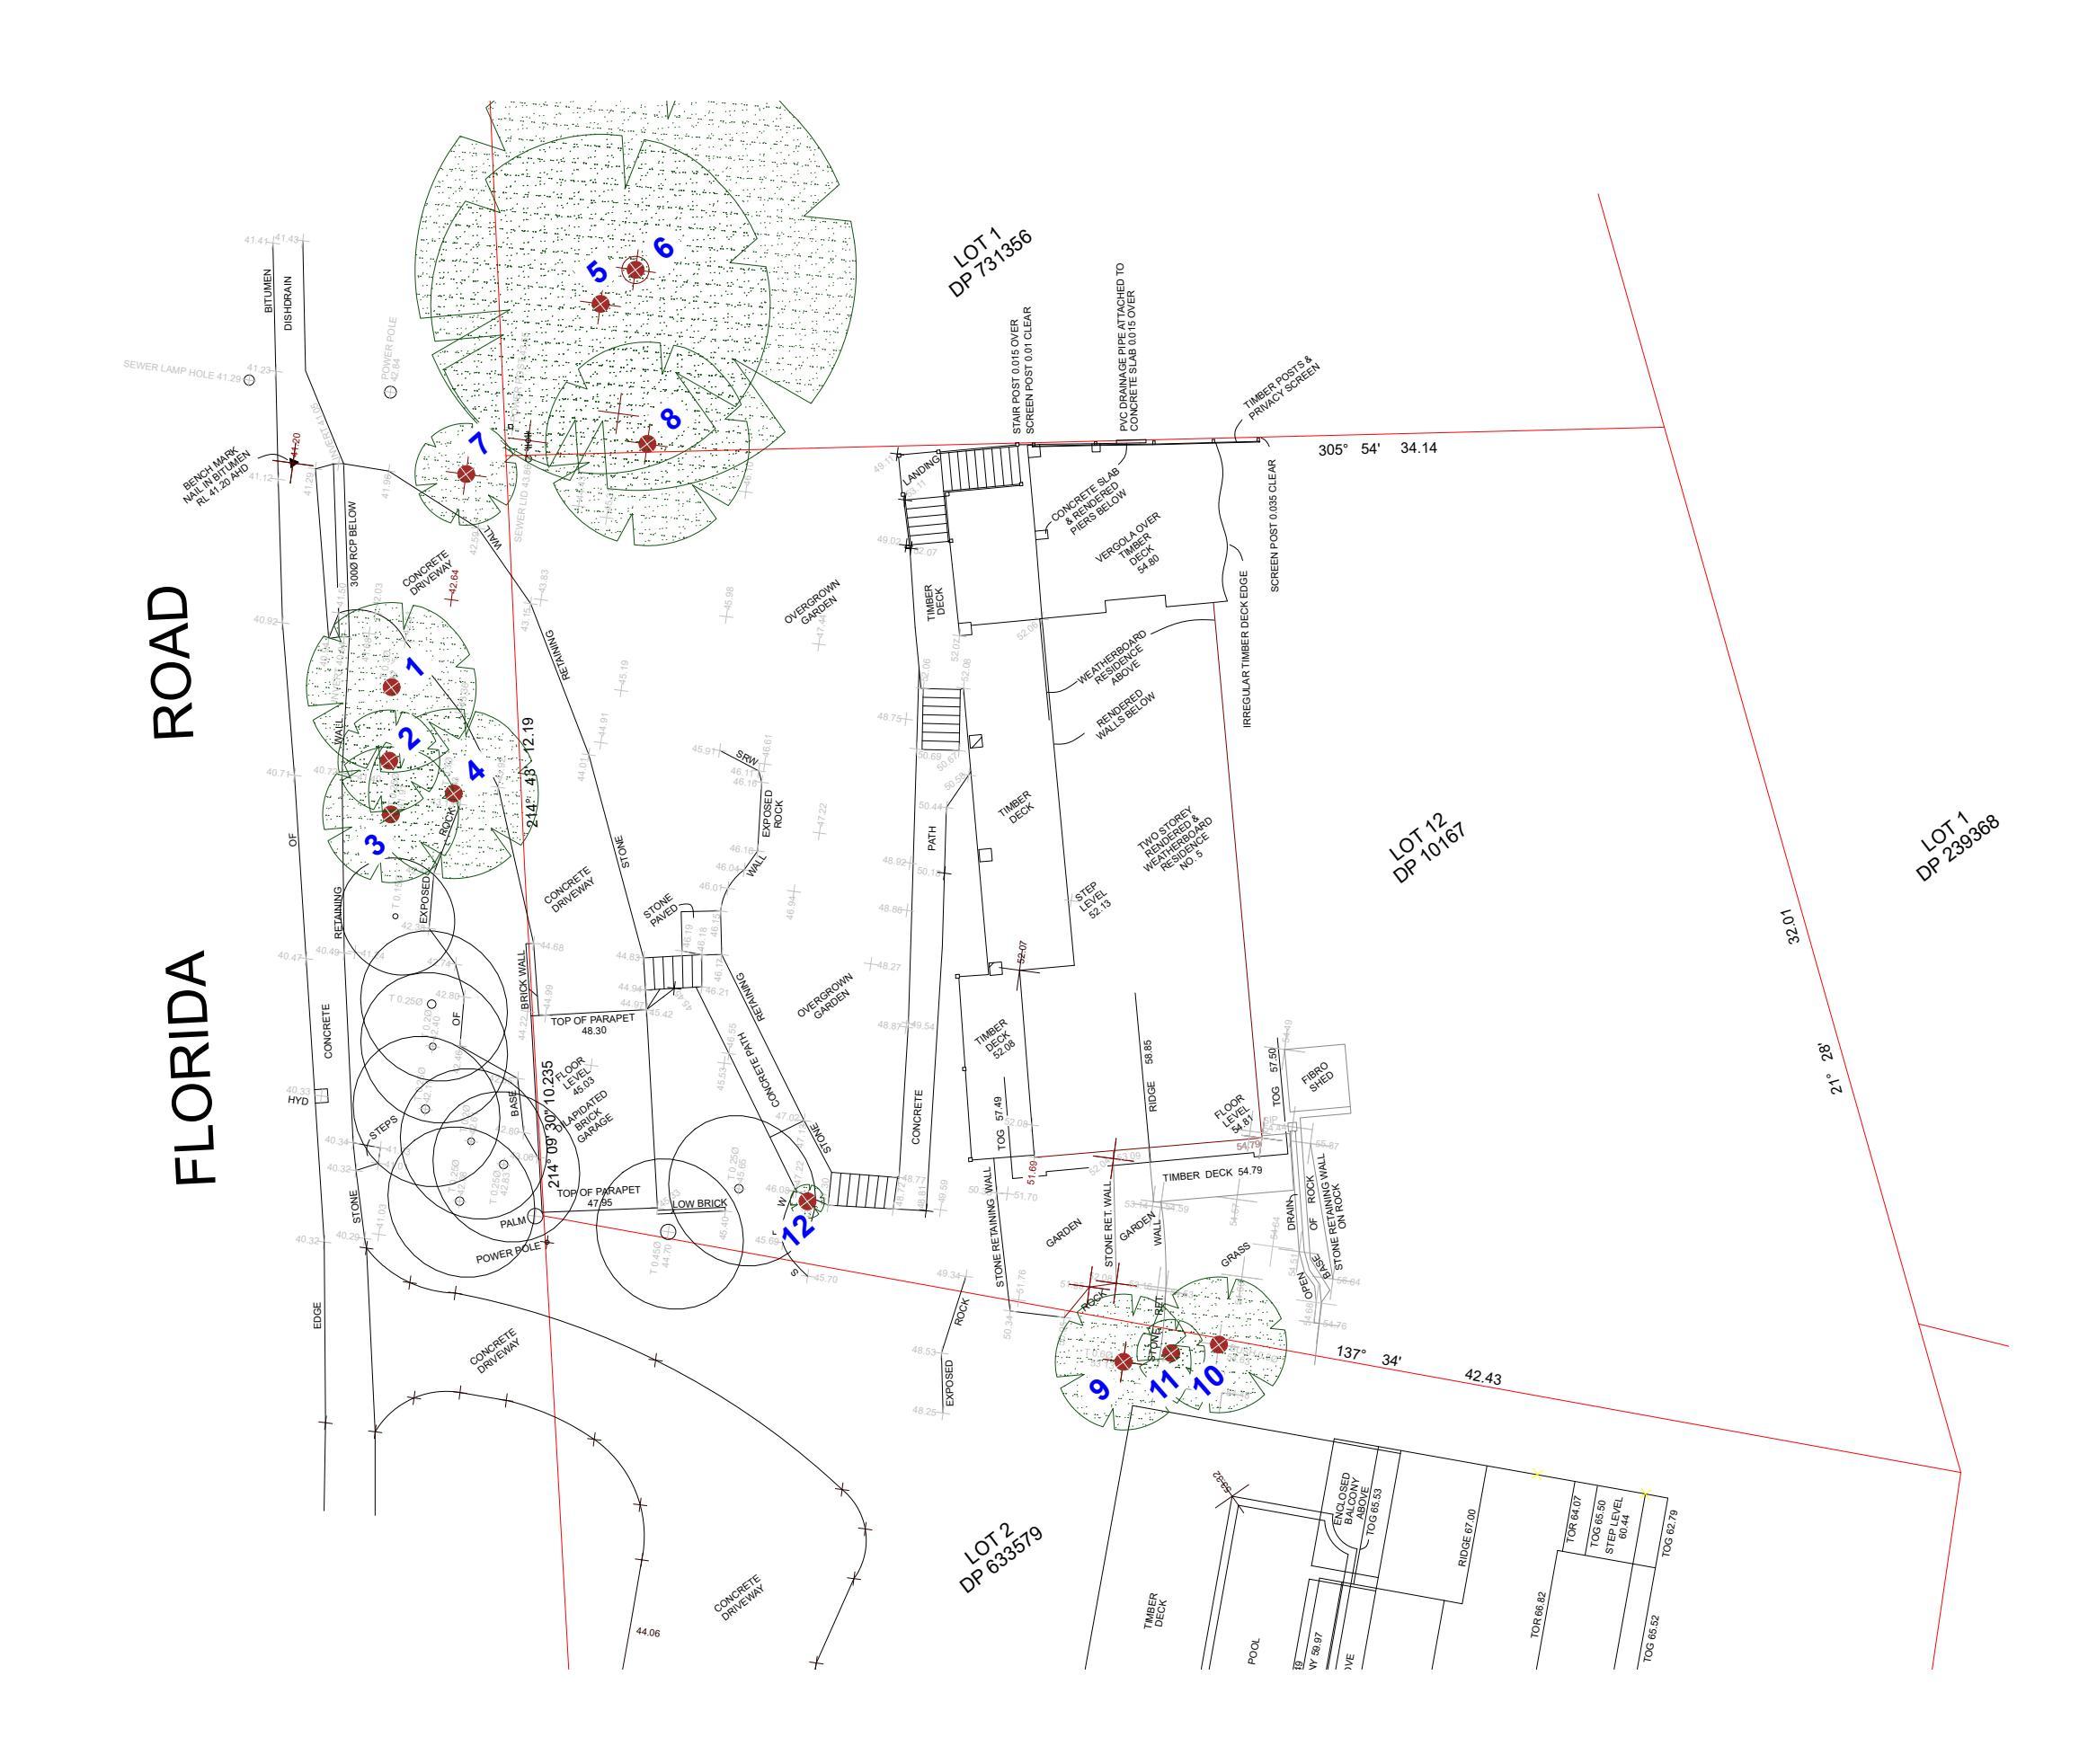
drawing title

In addition to the trees identified on the survey 2 trees have been added to this plan. The additional trees are Tree No's 2 & 11 and their locations, whilst based upon surveyed features, are approximate.

The tree canopy spreads on this plan have been adjusted from those on the survey to better reflect the actual canopy spreads however they remain as indicative graphics.

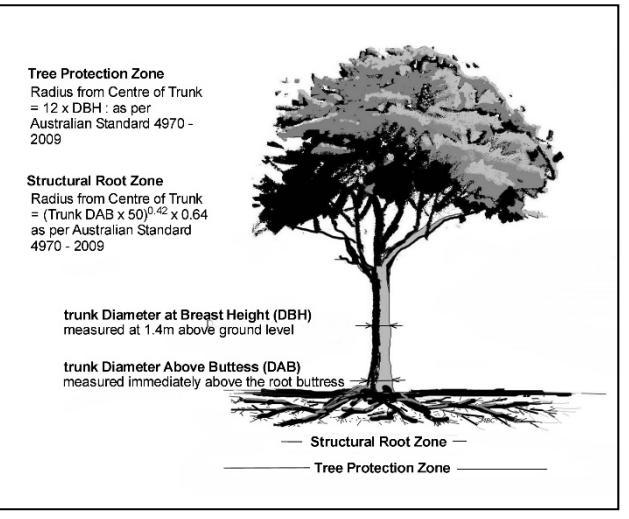
Figure 3.1 Typical diagram of a Tree Protection Zone & Structural Root Zone of a tree based upon AS 4970 – 2009

Based upon the Australian Standard for Protection of Trees on Development Sites, AS 4970 – 2009, the radius of the Tree Protection Zone (TPZ) is calculated as: TPZ = 12 x DBH with a minimum 2.0m radius and a maximum 15m radius.

The Structural Root Zone is the area surrounding the tree where the severance of roots and excavation is likely to affect the structural stability of the tree and is likely to have a significant detrimental impact on the health & condition of the tree. Based upon AS 4970 – 2009 the radius of a tree's Structural Root Zone (SRZ) is determined by measuring the diameter of the trunk immediately above the root buttress (DAB) and calculated by: SRZ = (DAB x 50) 0.42×0.64 .

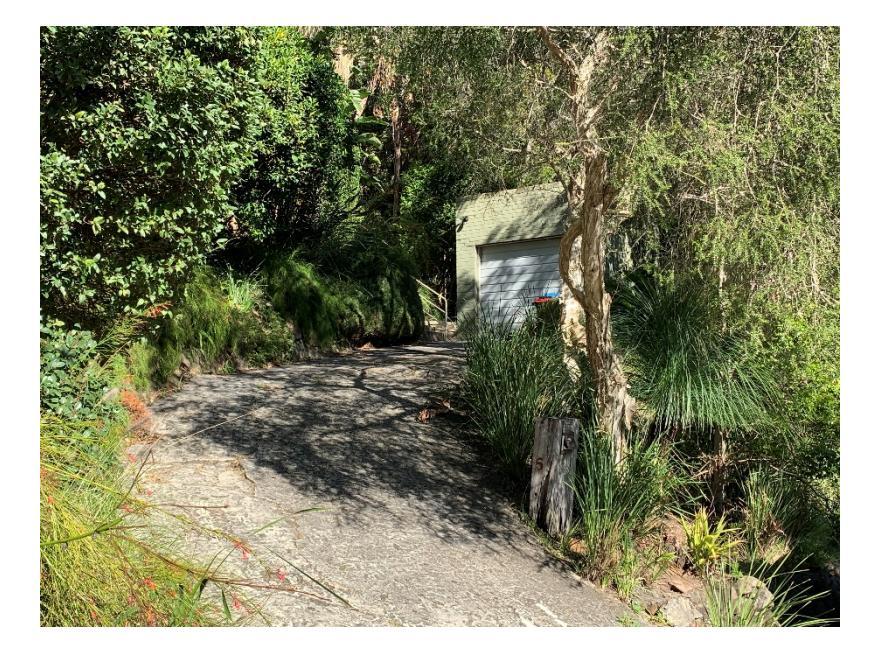
Figure 4.1 Site frontage on Florida Road, Palm Beach with Tree No. 1 adjacent (right) of the existing driveway

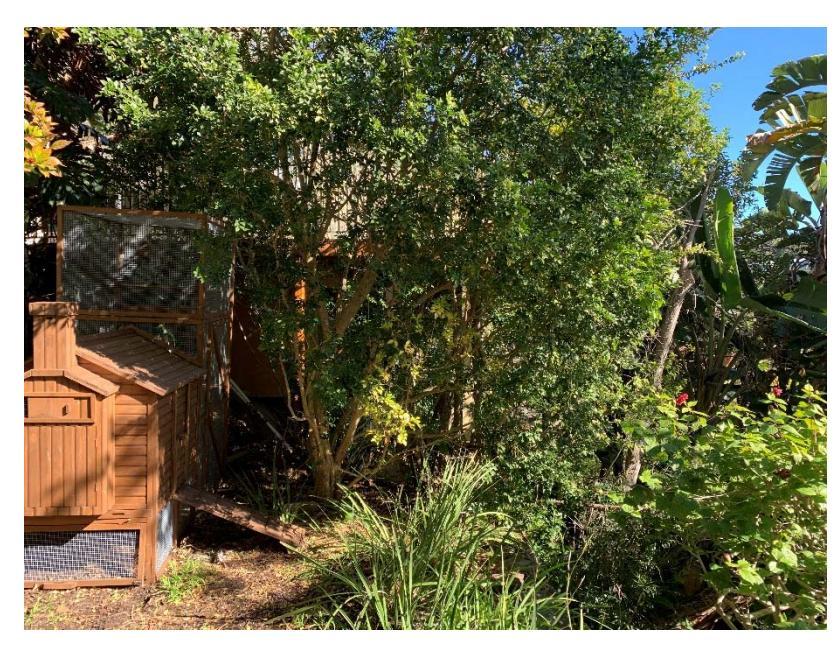
Figure 4.2 The site of the upper building extension looking south west with Tree No. 10 (centre of photo) in the background

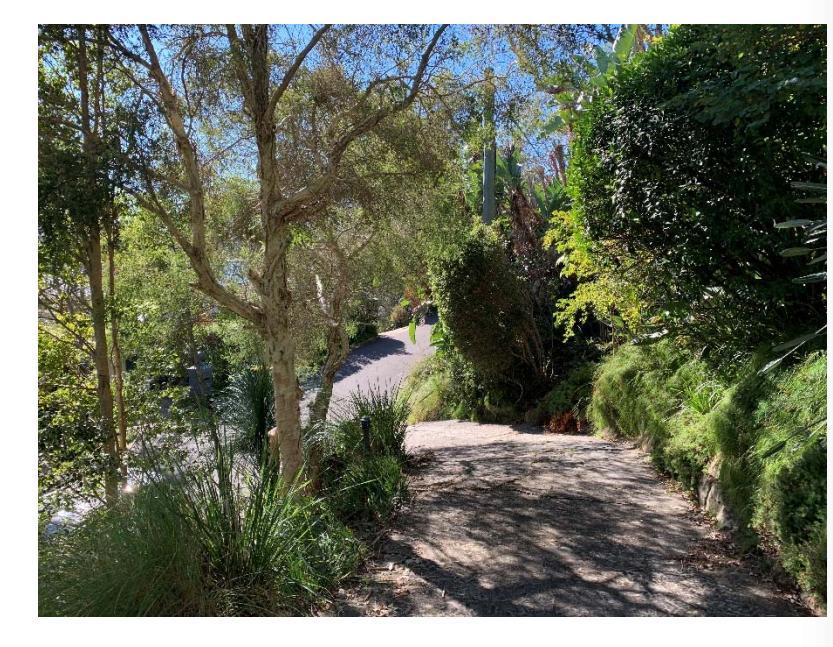
Figure 4.3 Looking down the existing driveway to Florida Road with Tree No's 4 (foreground left) 3, 2 & 1 (background left) and Tree No. 7 (rear right)

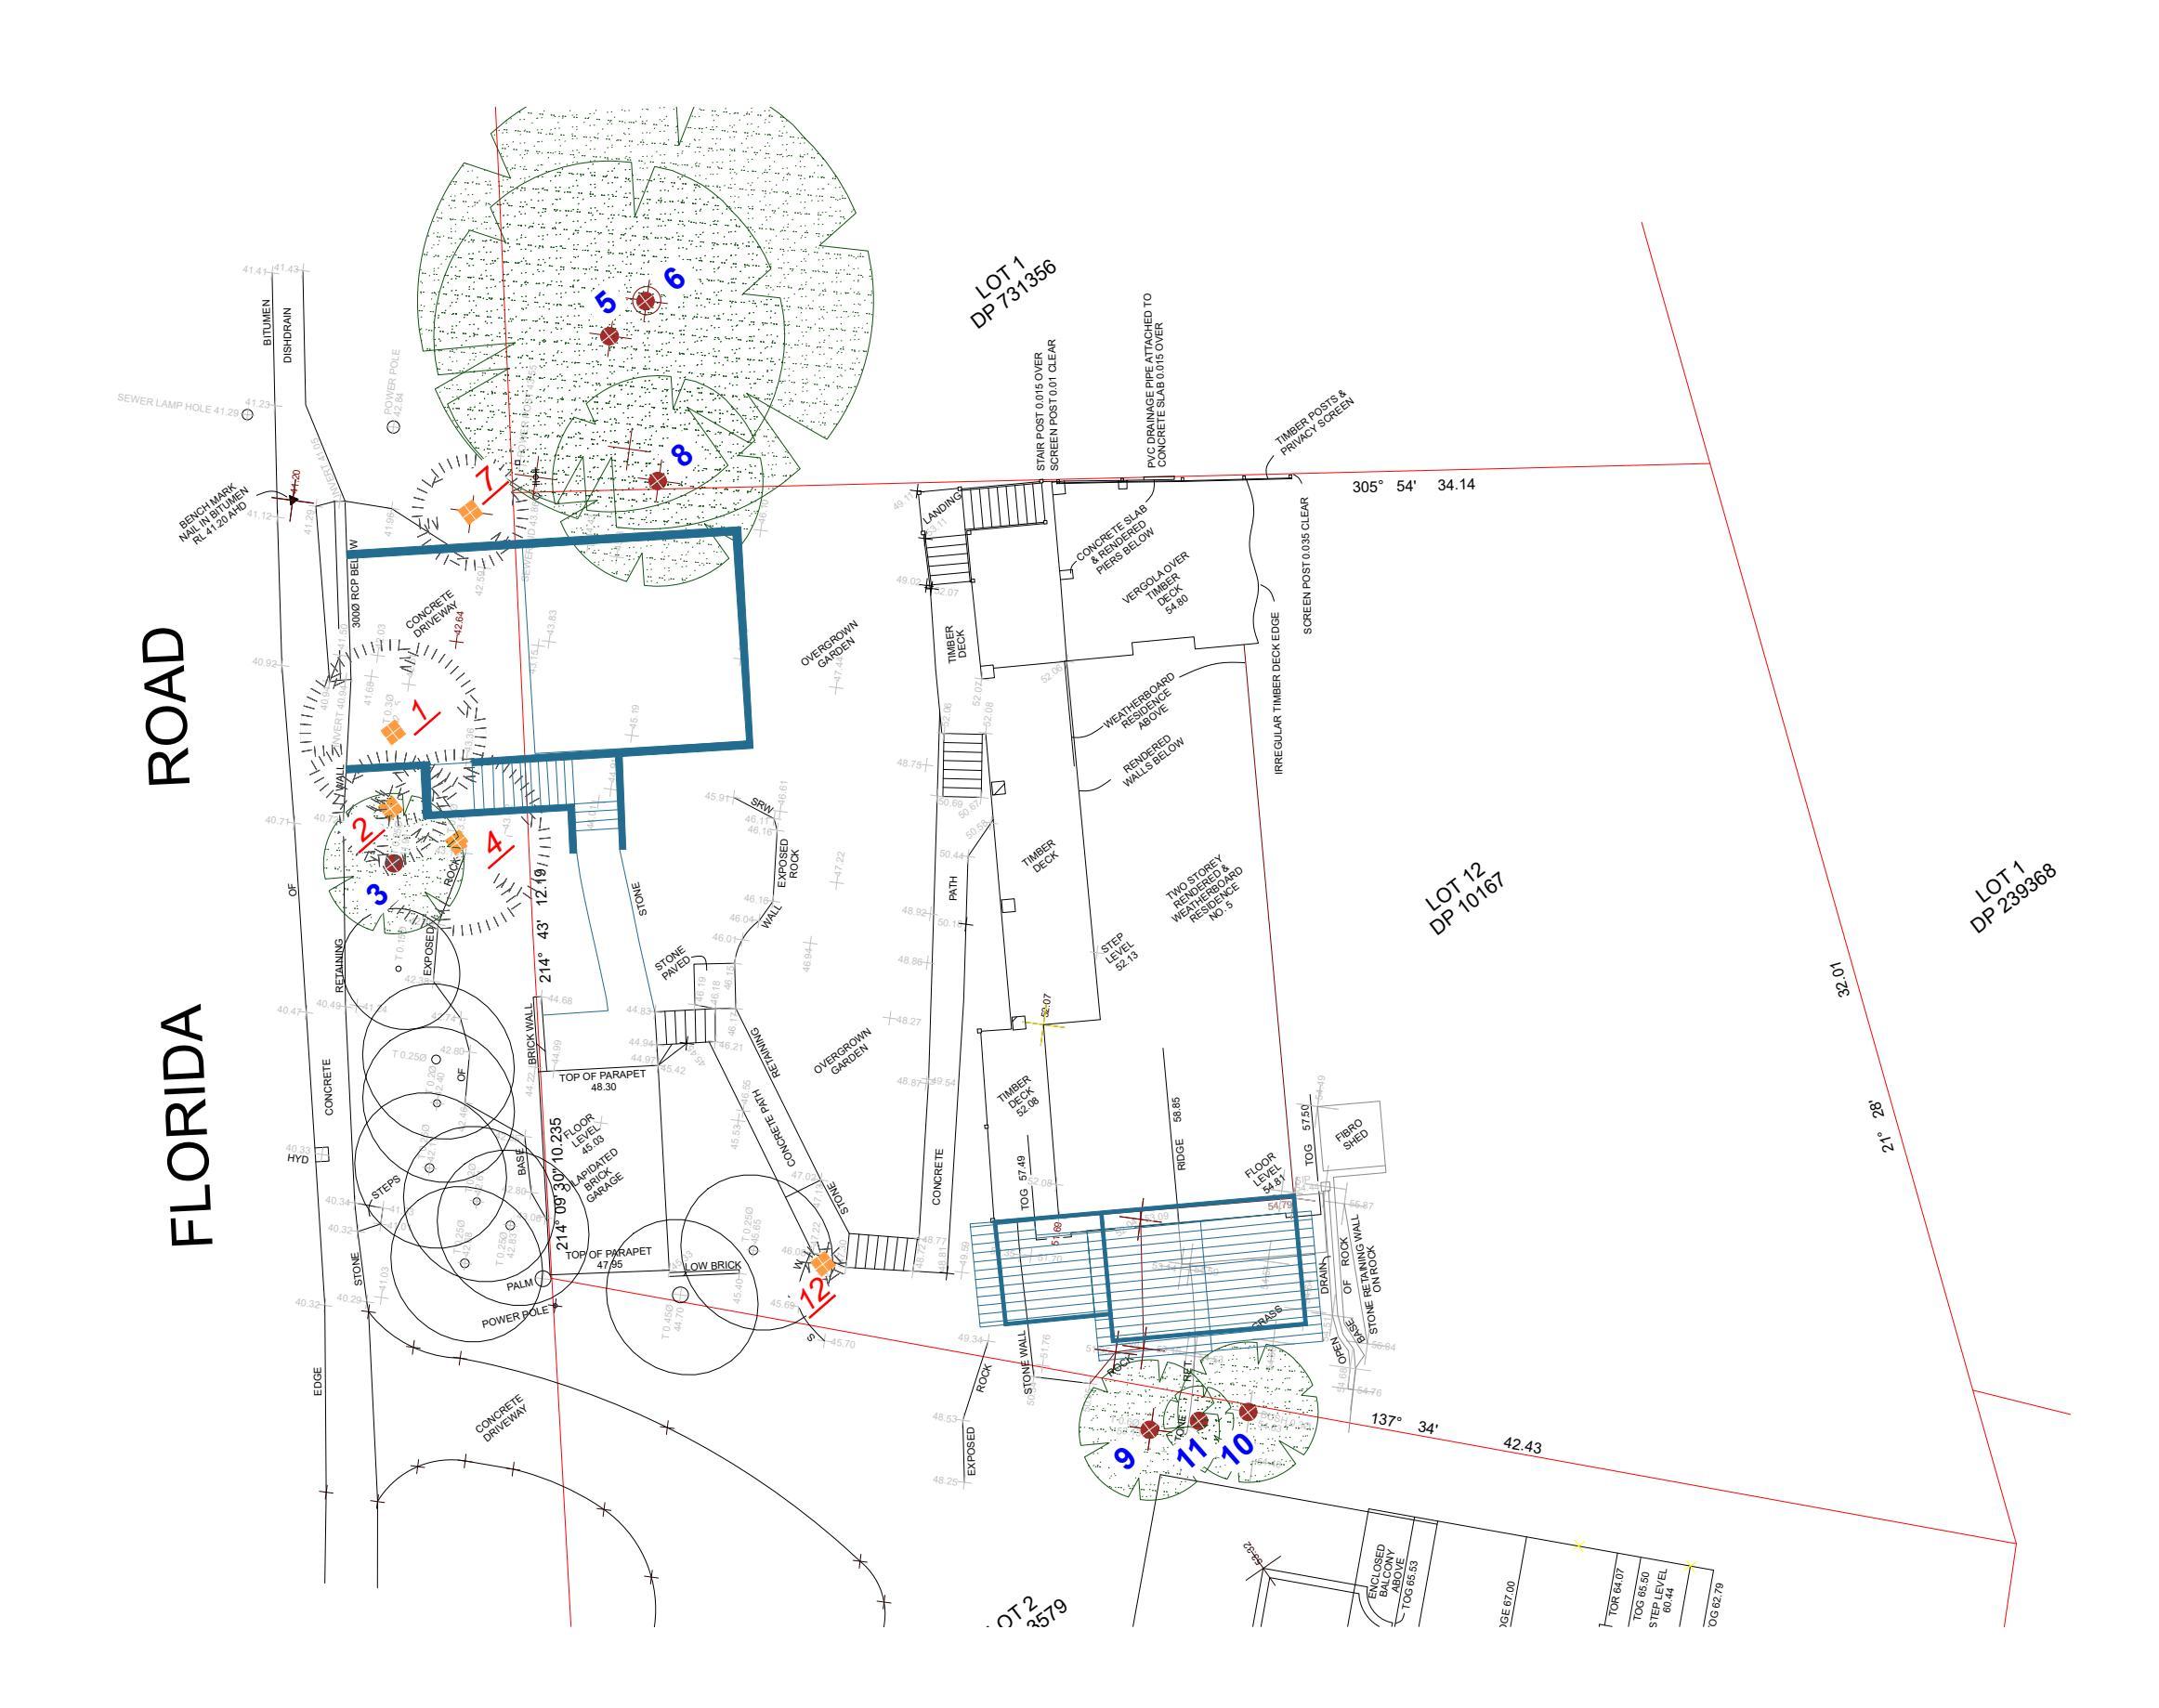
IIn addition to the trees identified on the survey 2 trees have been added to this plan. The additional trees are Tree No's 2 & 11 and their locations, whilst based upon surveyed features, are approximate.

The tree canopy spreads on this plan have been adjusted from those on the survey to better reflect the actual canopy spreads however they remain as indicative graphics.

4	Melaleuca styphelioides	280	390	2	Moderate L/scape Sig.	3.40	2.4	2.2	The proposed entrance stairs are within 0.7m (east) of the tree.	Excavation is likely to involve severance of significant tree roots resulting in the decline of the tree and/or rendering it unstable.	To be Removed	Within road reserve
5	Angophora floribunda	490	650	3	High L/scape Sig.	5.90	4.1	2.8	The proposed garage is within 5.6m (south west) of the tree.	No significant impact with appropriate Tree Protection Measures.	Retained with General Tree Protection Measures	On adjacent allotment
6	Eucalyptus haemastoma	610	790	4	High L/scape Sig.	7.30	5.1	3	The proposed garage is within 6.5m (south west) of the tree.	No significant impact with appropriate Tree Protection Measures.	Retained with General Tree Protection Measures	On adjacent allotment
7	Viburnum tinus	100	200	3	Low L/scape Sig.	2.00	1.4	1.7	The proposed driveway crossing is within 0.8m (south west) of the tree.	Excavation is likely to involve severance of significant tree roots resulting in the decline of the tree and/or rendering it unstable.	To be Removed	Within road reserve

11	Hibiscus sp.	80	250	4	Low L/scape Sig.	2.00	1.4	1.8	The proposed building footprint is within 2.3m (north east) of the tree.	No significant impact with appropriate Tree Protection Measures.	Retained with General Tree Protection Measures	On adjacent allotment
12	Corymbia gummifera	220	290	Unstable	Low L/scape Sig.	2.60	1.8	2	No proposed works within the tree's Tree Protection Zone.	No significant impact however, the tree is considered to be unstable.	To be Removed	On site

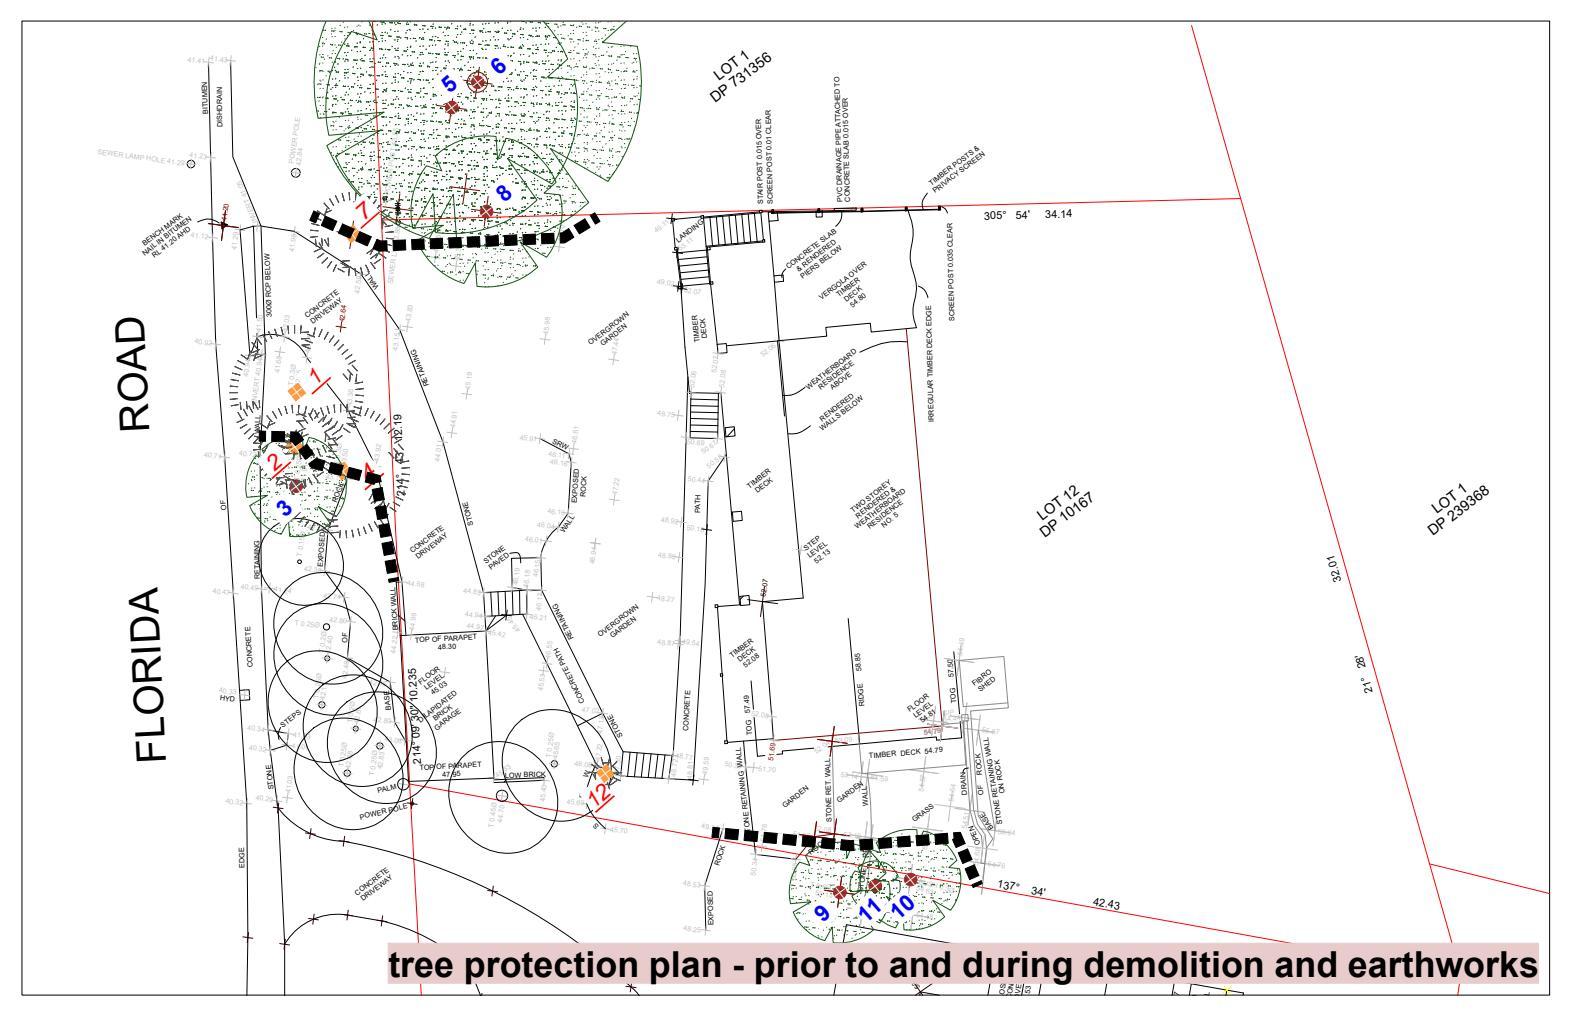
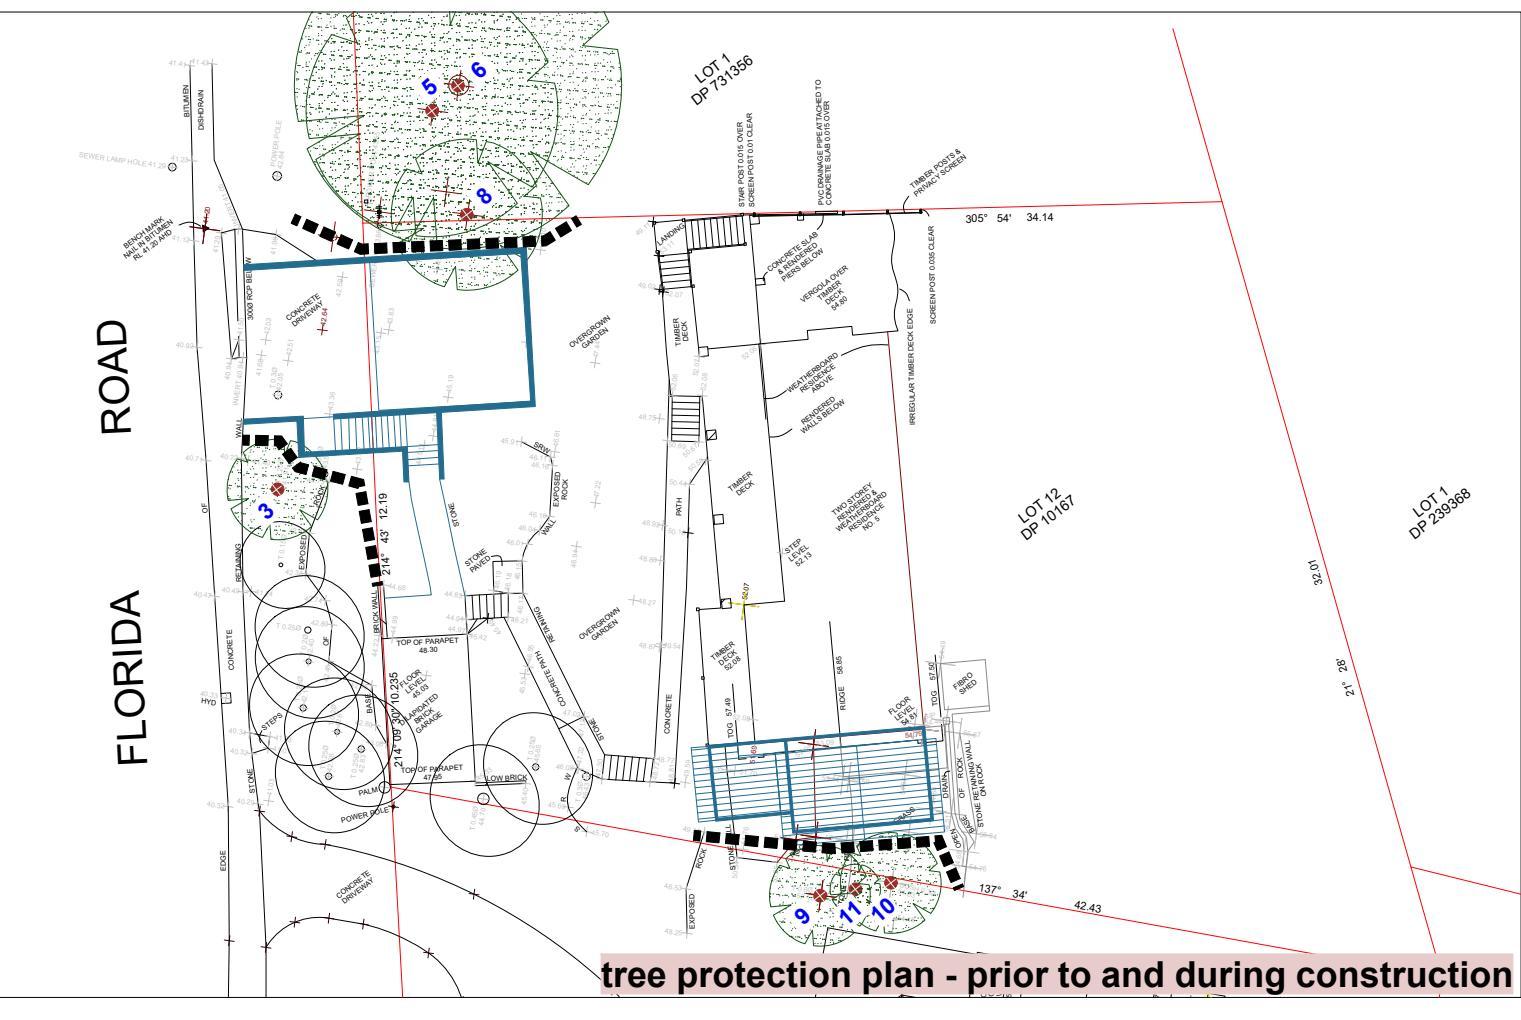
tree protection plan prior to & during excavation and construction

In addition to the trees identified on the survey 2 trees have been added to this plan. The additional trees are Tree No's 2 & 11 and their locations, whilst based upon surveyed features, are approximate.

The tree canopy spreads on this plan have been adjusted from those on the survey to better reflect the actual canopy spreads however they remain as indicative graphics.

Given the steep topography of the site and the scope of the development tree protection webbing shall be installed in lieu of fencing. Prior to demolition, tree protection webbing shall be erected as shown on the Tree Protection Plan Prior to & During Demolition (refer sheet 8) in accordance with the specifications below.

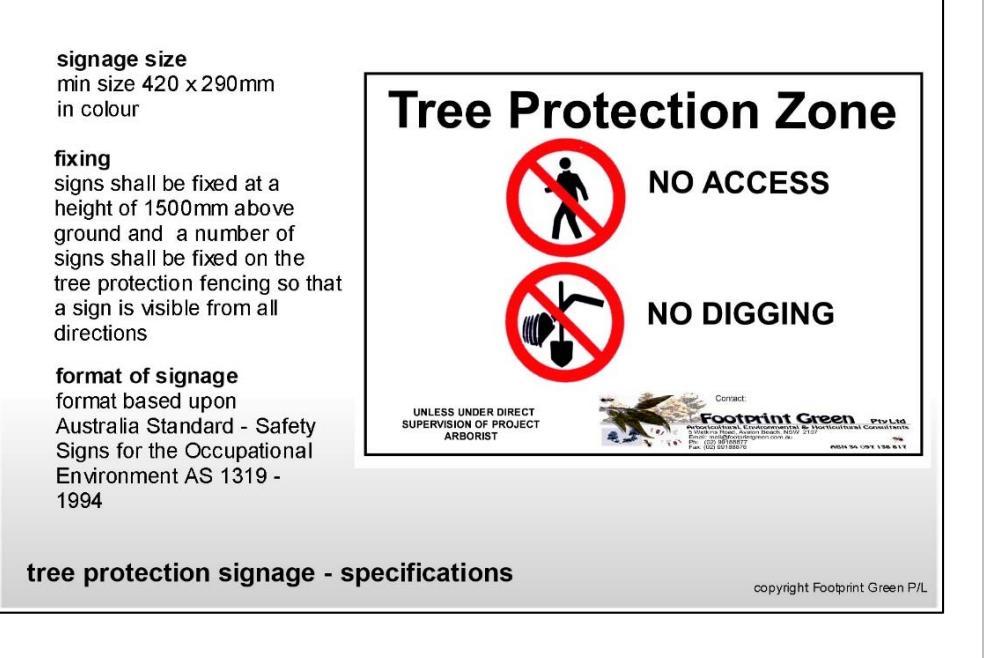
tree protection signage

Tree Protection Signage is to be installed on fencing and shall be installed at maximum 15m intervals and at changes in the fencing direction (refer specification below).
