Arboricultural Impact Assessment

Proposed Alterations & Additions at

28 Pacific Road, Palm Beach

Client: Hayden and Danielle Cox Date: January 2021 Author: Alexis Anderson Qualifications: -Diploma Horticulture (Arboriculture) –AQF Level 5. Bachelor of Applied Science (CM) Membership: -Arboriculture Australia-Member No.2268 International Society of Arboriculture –Professional Member A.B.N: 989 613 015 96 Contact: 0431 286 080 info@bluegumarborist.com.au

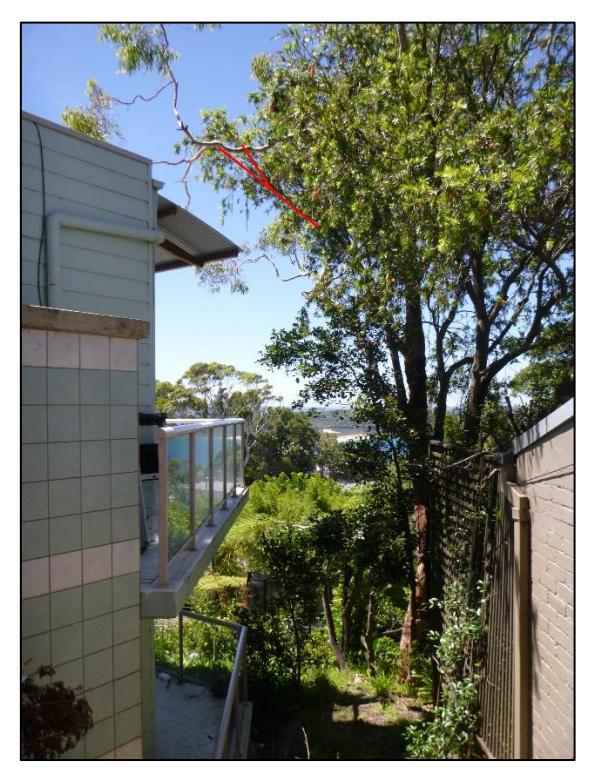
Photo A: Tree 20. Branch that may require removal (red line).

Canopy Pruning (Tree 20, 29, 30): Canopy pruning will be required to allow roof-line clearance. Canopy pruning should be undertaken by an AQF Level 2 (minimum) Arborist in accordance with AS4373-2007-*Pruning of Amenity Trees,* Section 7.2.4 (Selective Pruning). No more than 15% of the canopy volume will need to be removed.

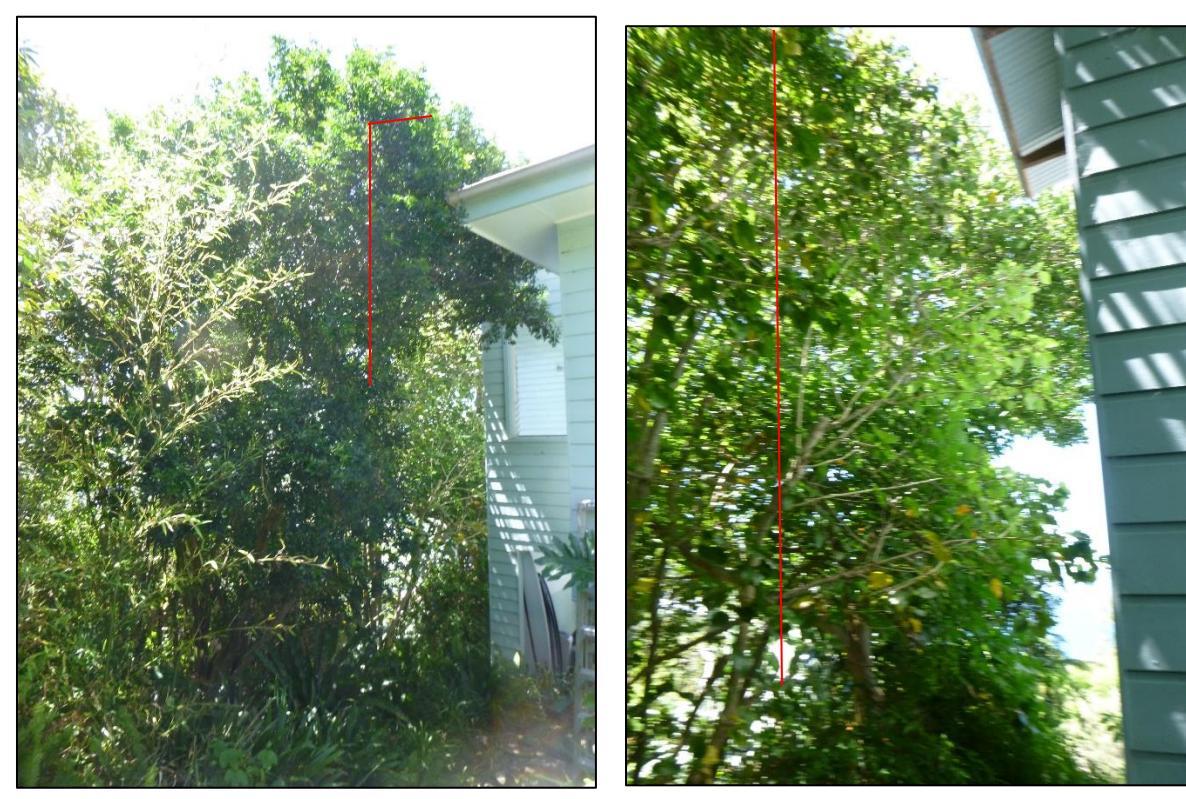
Photo B and C: Tree 29 (above) and Tree 30 (right). Approximate area of canopy to be removed (red lines). BLUEGUM - Tree Care and Consultancy

27	High	Internal alterations are proposed are proposed within the TPZ. No impact is expected.
20, 29, 30	Medium	Canopy pruning will be required to accommodate the roof extension. Less than 15% of the total crown volume would be removed (refer to the recommendations). Each of these trees is in good health and vitality and a species that is generally tolerate of pruning. These trees are expected to remain viable in the long-term.

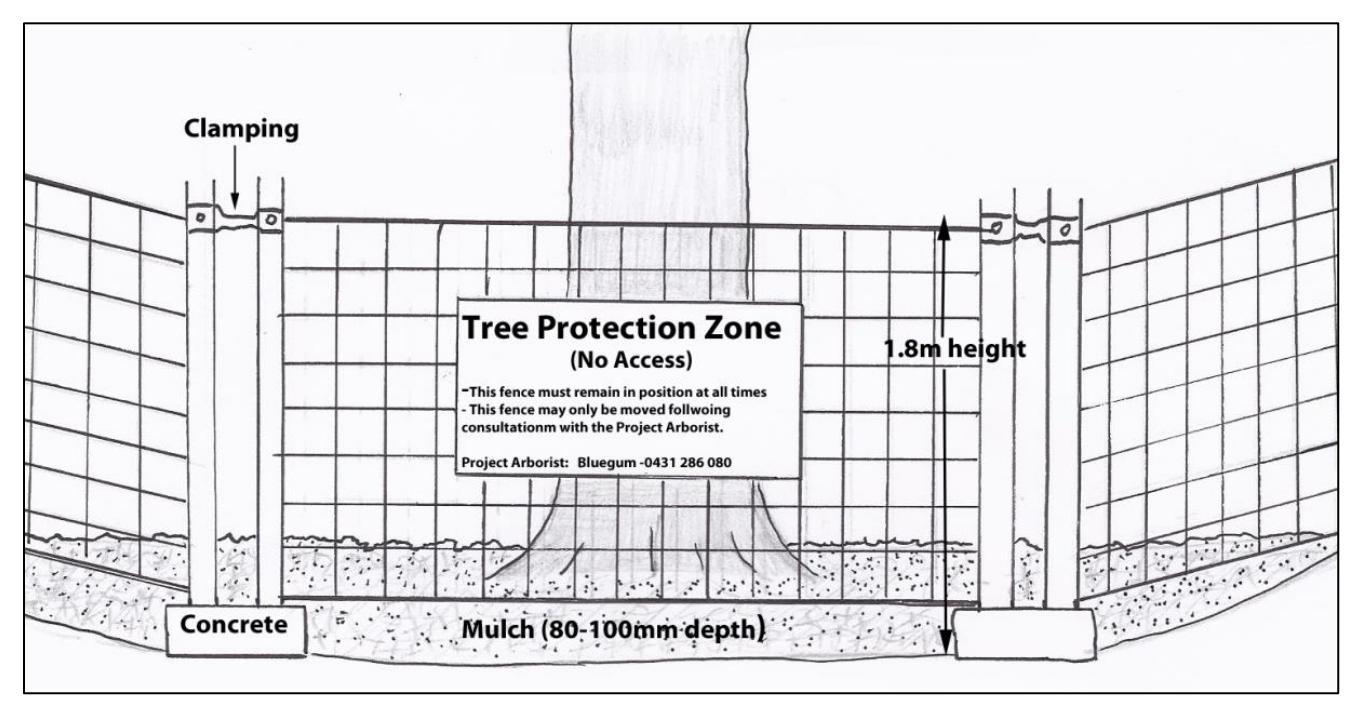
Figure A: Example of adequate tree protection fencing

Tree Protection Fencing: Tree Protection Fencing should be installed prior to any machinery or materials being bought on site and remain in position throughout the entire project. Tree Protection Fencing should be erected around the Tree Protection Zones as defined in the Tree Protection Plan (Attachment C). Tree Protection Fencing should consist of 1.8 metre high chainlink panels on moveable concrete pads. Tree Protection Fencing should be clamped at each panel junction.

In areas where the slope is too steep for standard temporary fencing, starpickets (1.8m) and web-mesh or shadecloth could be used as an alternative.

Tree Protection Fencing should not be moved at any time without consultation with the Project Arborist. An example of adequate tree protection fencing is detailed below.

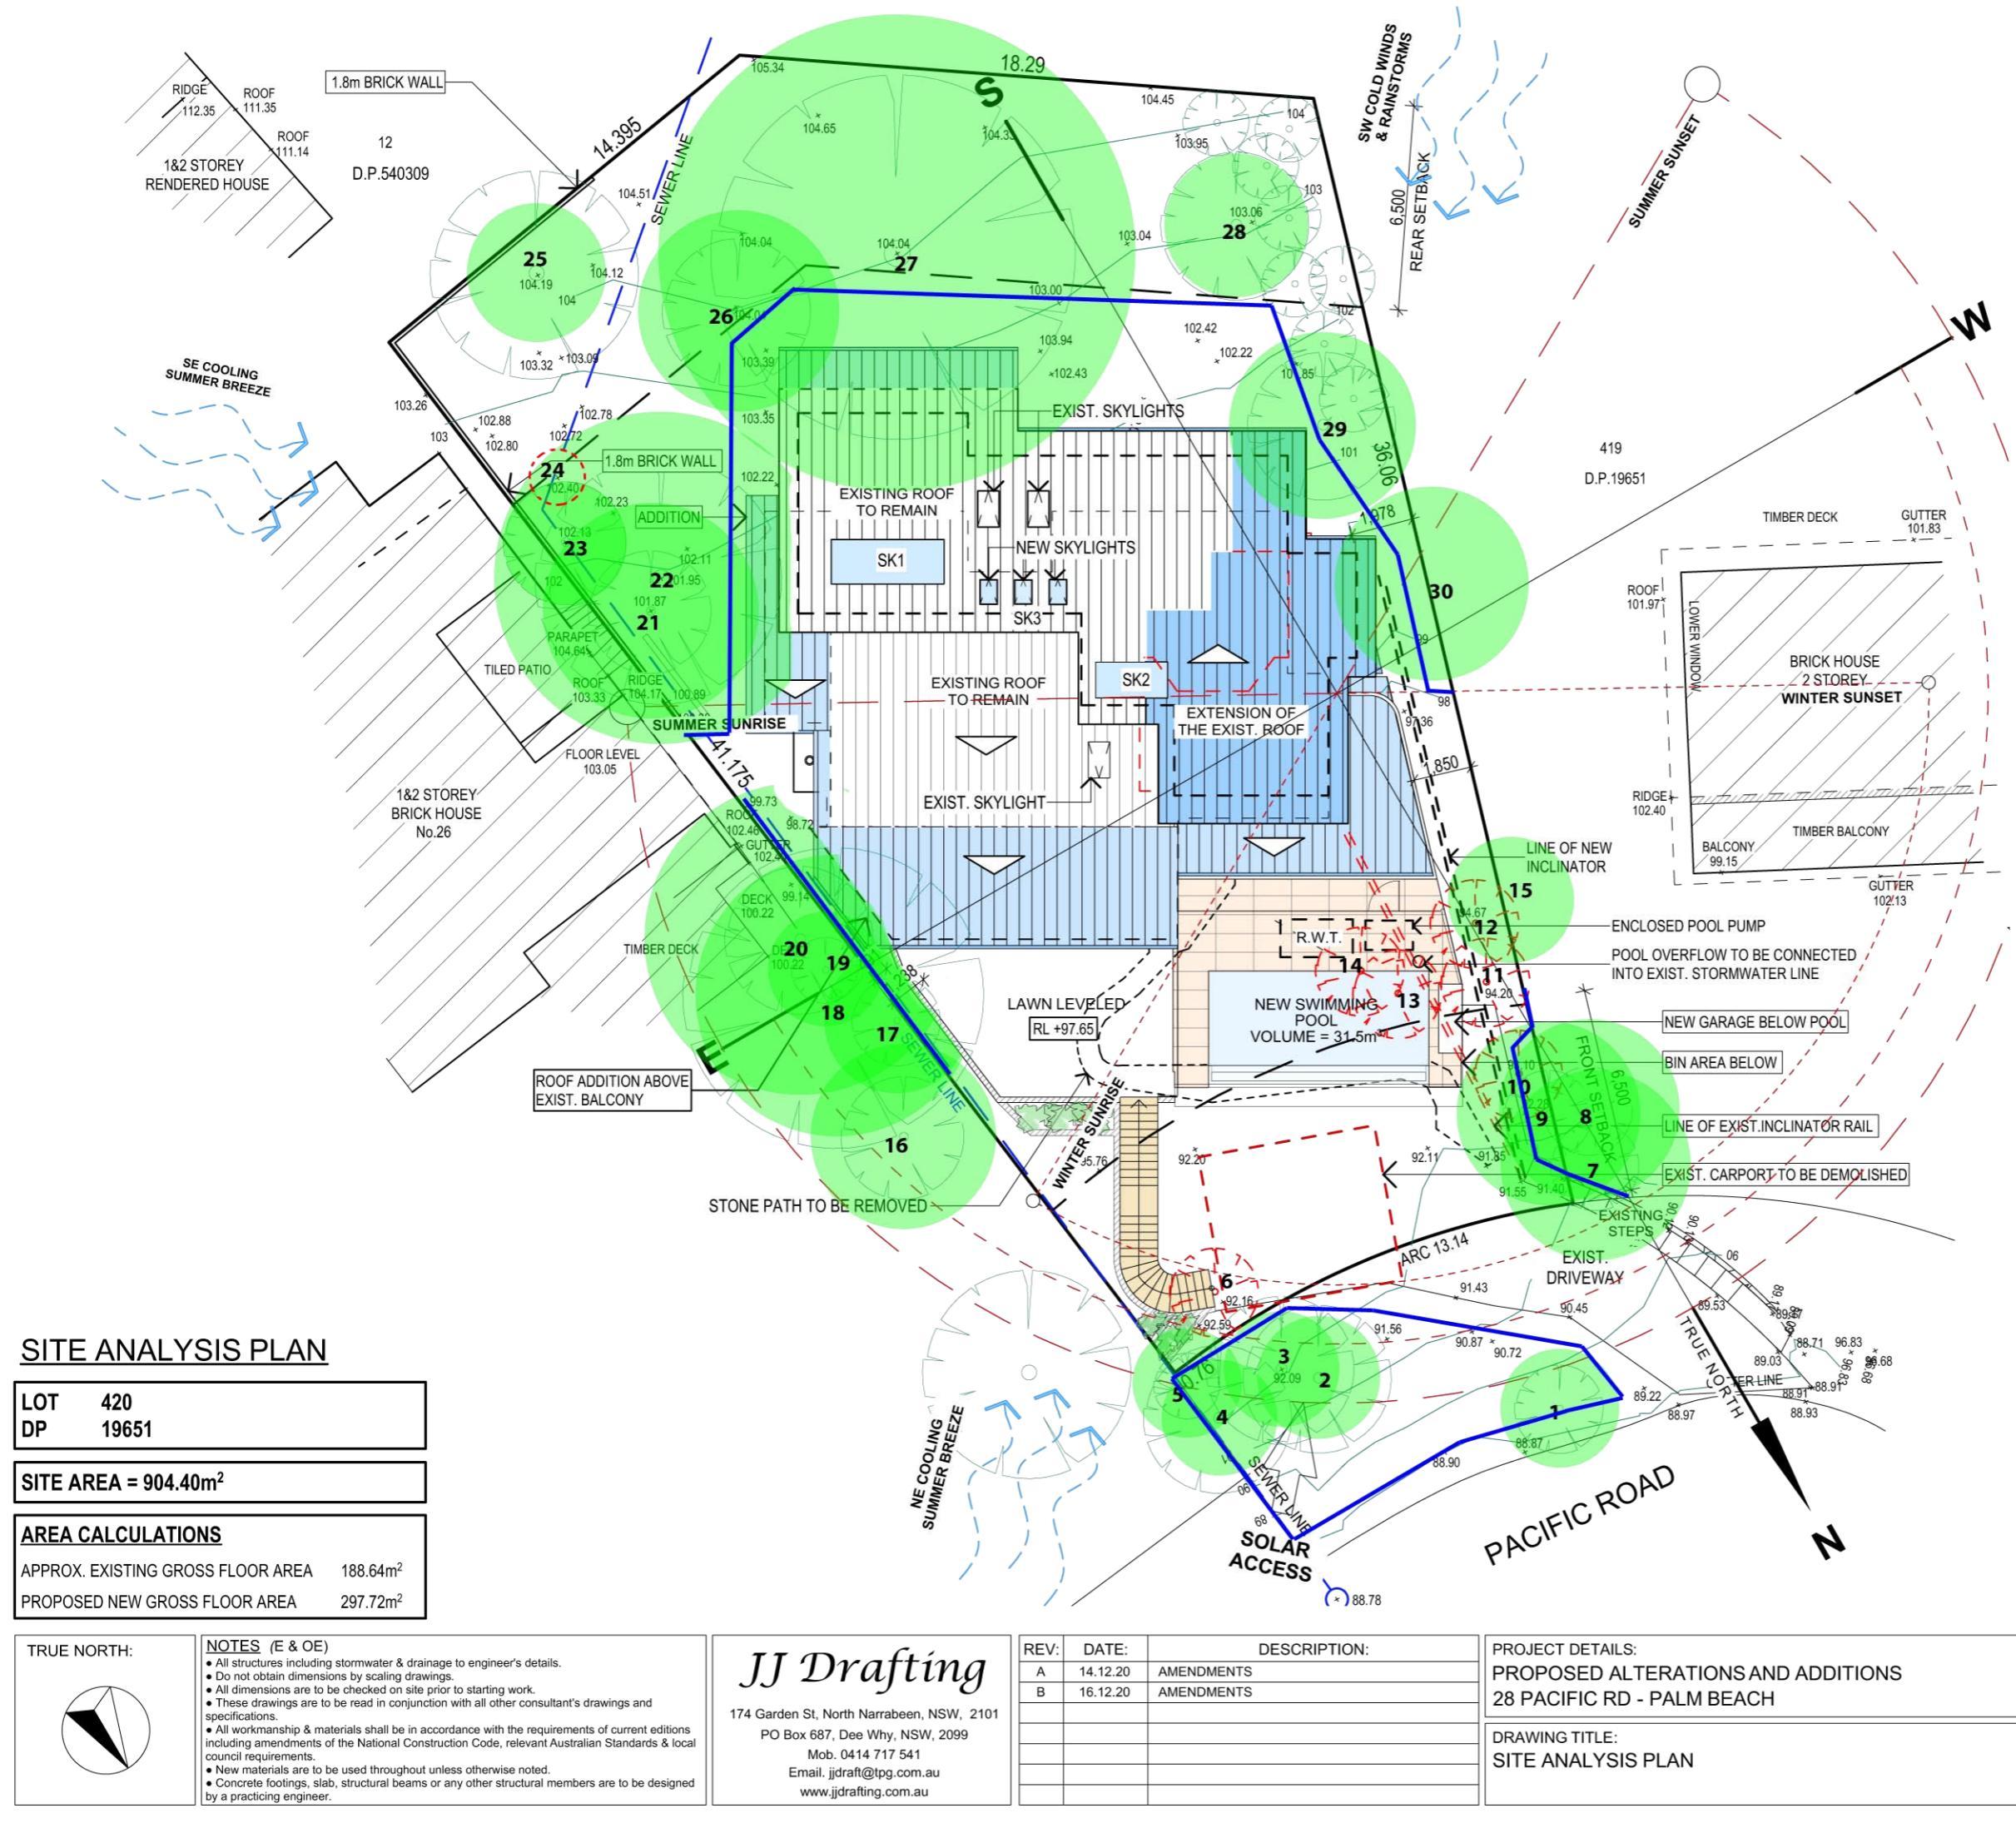
Bluegum Tree Care and Consultancy®							
Tree Protection							
Plan							
28 Pacific Road, Palm Beach							
This plan is to be read in conjunction with the Arboricultural Impact Assessment report prepared for this site, January 2021.							
This plan has been prepared using the Site Analysis Plan- JJ Drafting, as a base.							
Tree protection detail is indicative only. Final positions should be determined with co- ordination between the Site Foreman and Project Arborist to allow adequate site access during construction.							
Legend							
Tree Protection Zone (retained tree)							
Tree proposed for removal							
Tree Protection Fencing
