Re: <u>Preliminary Geotechnical Assessment – Proposed Alterations & Additions at 19 Mildred</u> <u>Avenue, Manly Vale, NSW</u>

I, Edward A Bennett, practicing civil, structural, geotechnical & environmental engineer, hereby confirm that I have inspected the above site for the proposed Alterations & Additions and confirm that to satisfy the requirements of E10 Landslip Risk, under the Warringah DCP 2011, Councils' Policy, it is my opinion that a full geotechnical report will **NOT** be required.

CIVIL & STRUCTURAL ENGINEERING DESIGN SERVICES PTY. LTD. *GEOTECHNICAL REPORT*

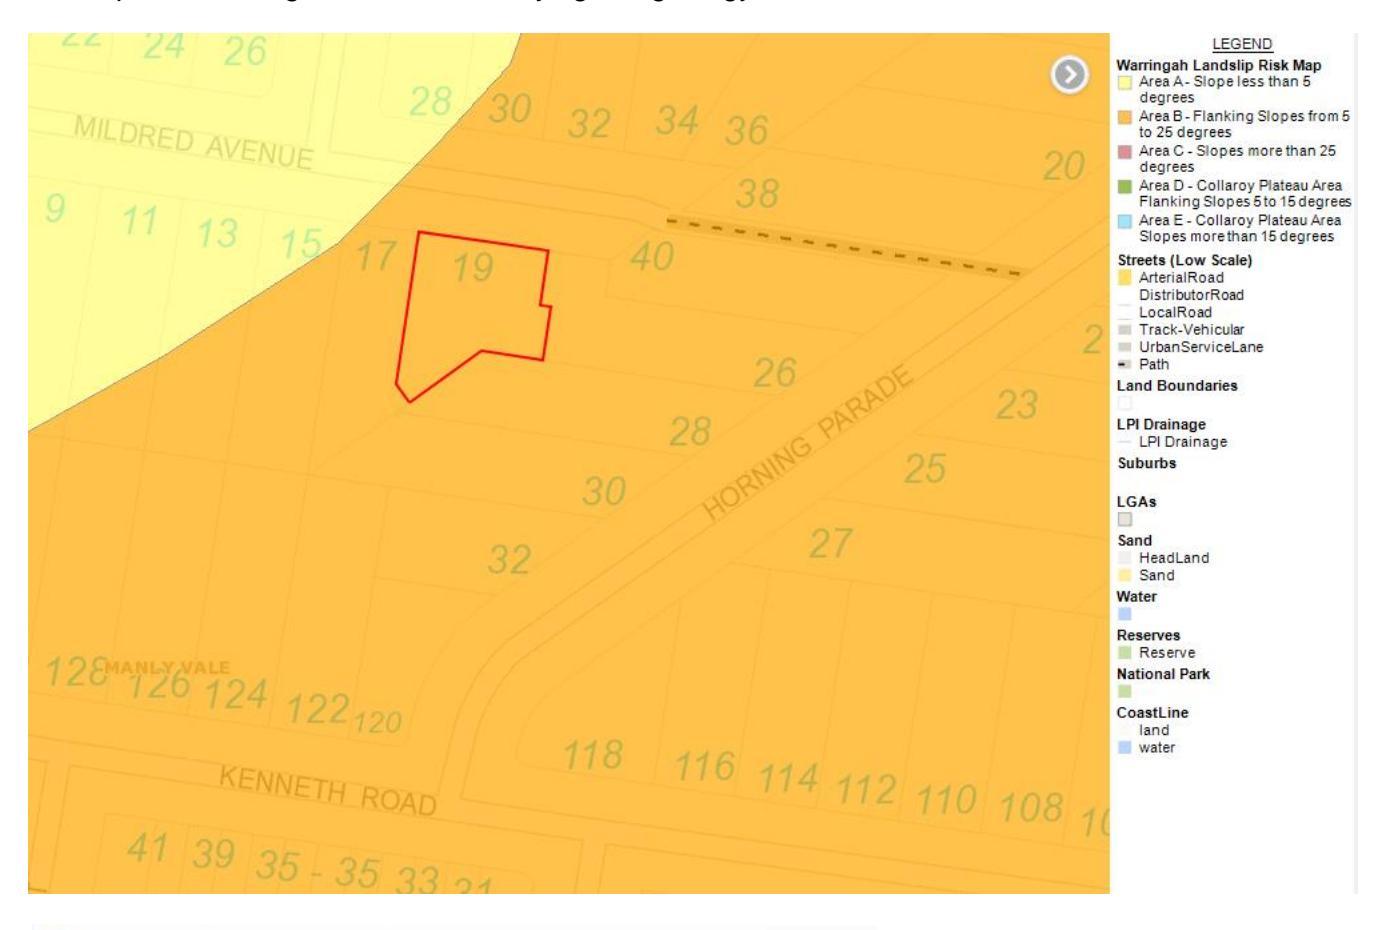
Figure 1: Land slip risk map for Mildred Avenue (site location marked in red)

The site of the new additions is in an area bounded by the front Northern/Western Boundary and the existing front portion of the existing dwelling structure. This work lies to the south of Mildred road with a downhill slope in the order of 5 to 10 degree (approximate) range. Council hazard mapping (Figure 1) places the property in land-slip risk class B (flanking slopes) – refer to Table 1 for risk class details.

- Area A Slope less than 5 degrees
- Area B Flanking Slopes from 5 to 25 degrees
- Area C Slopes more than 25 degrees
- Area D Collaroy Plateau Area Flanking Slopes 5 to 15 degrees
- Area E Collaroy Plateau Area Slopes more than 15 degrees

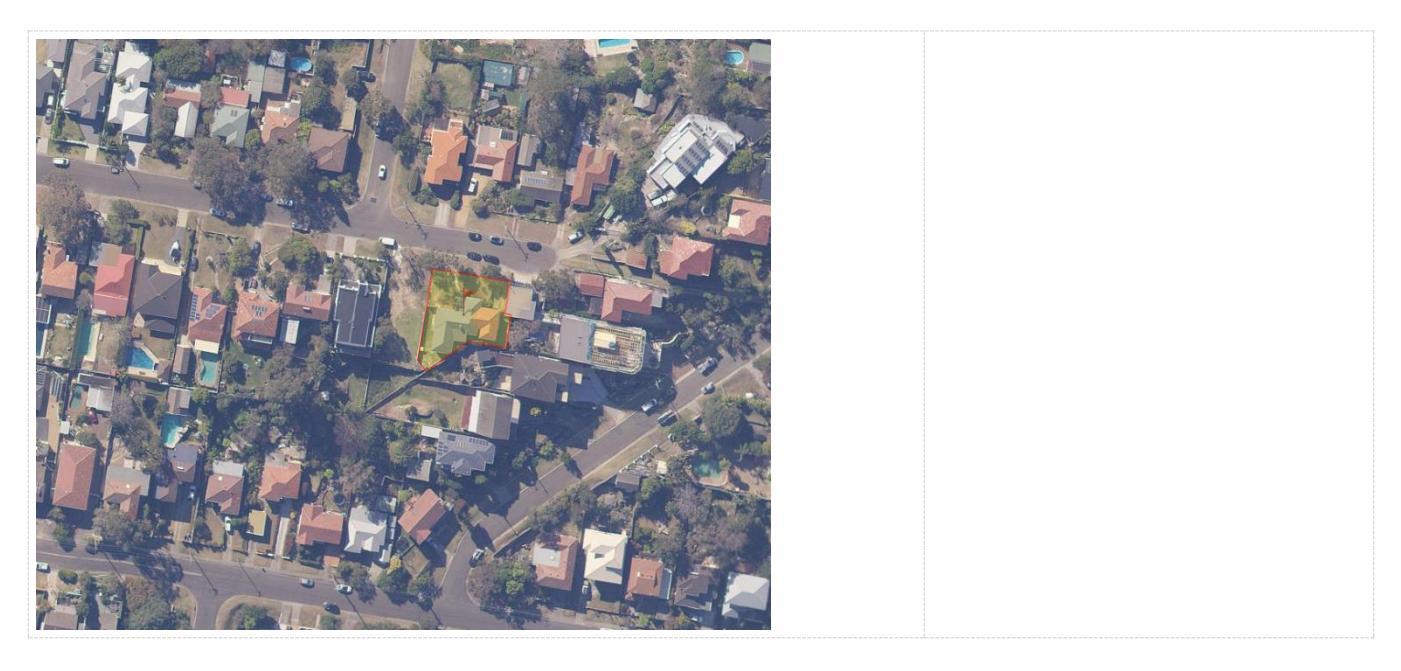
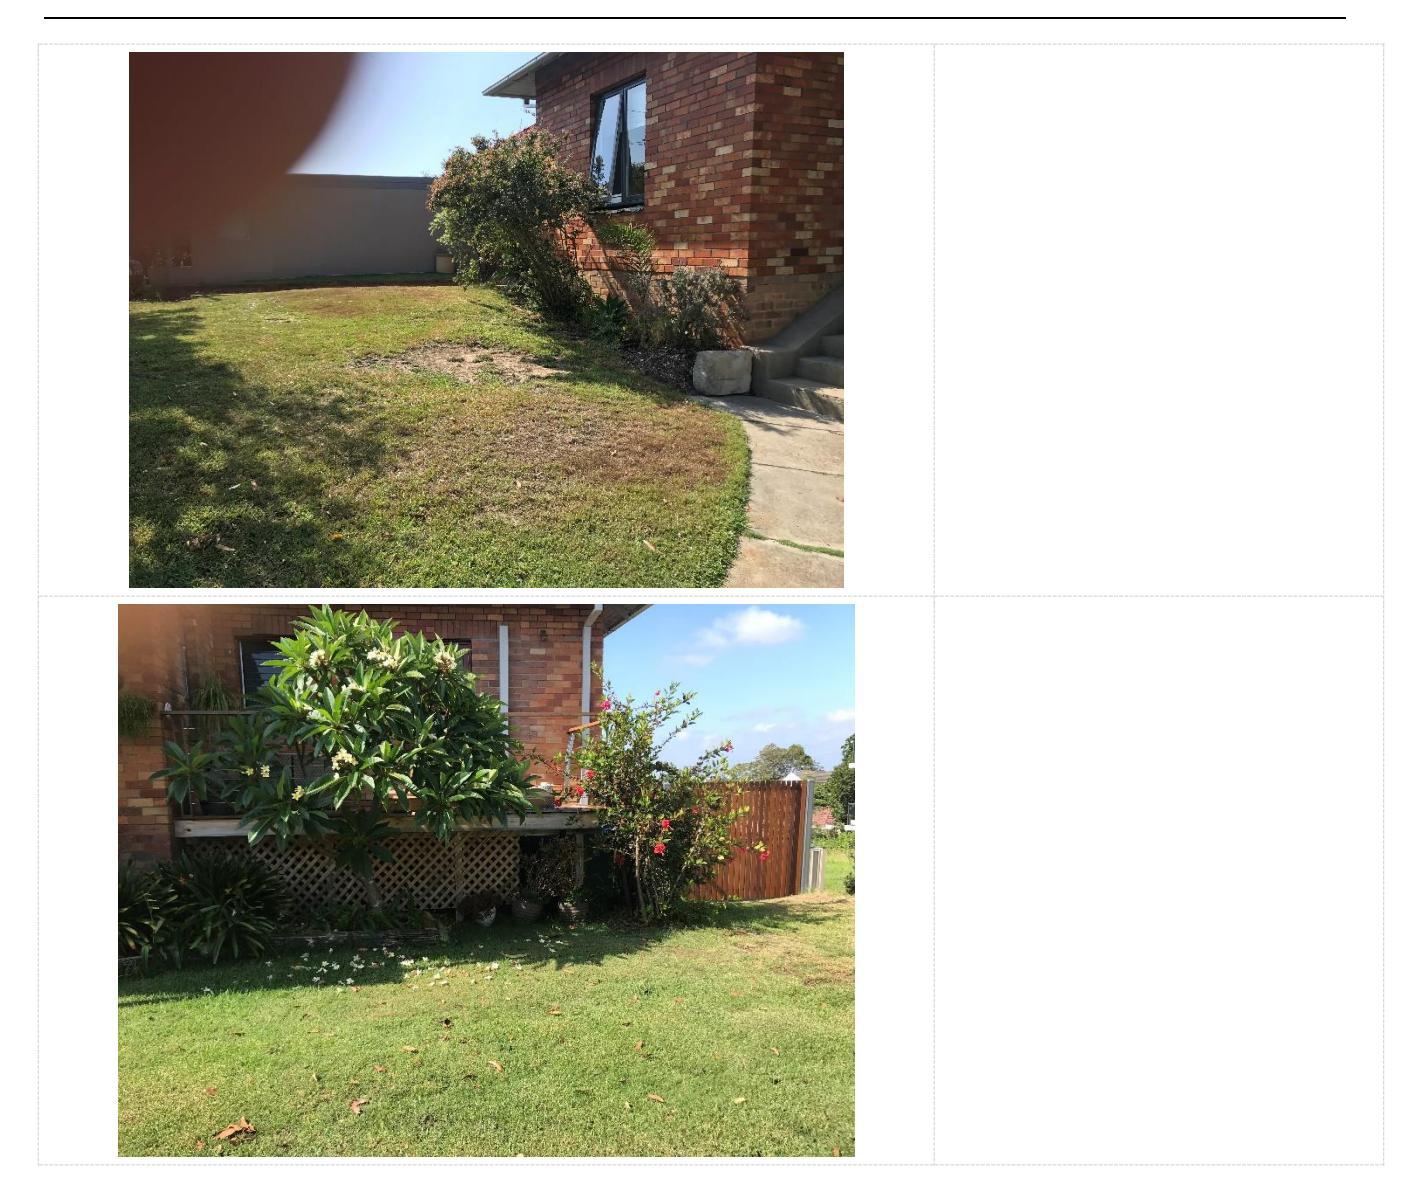
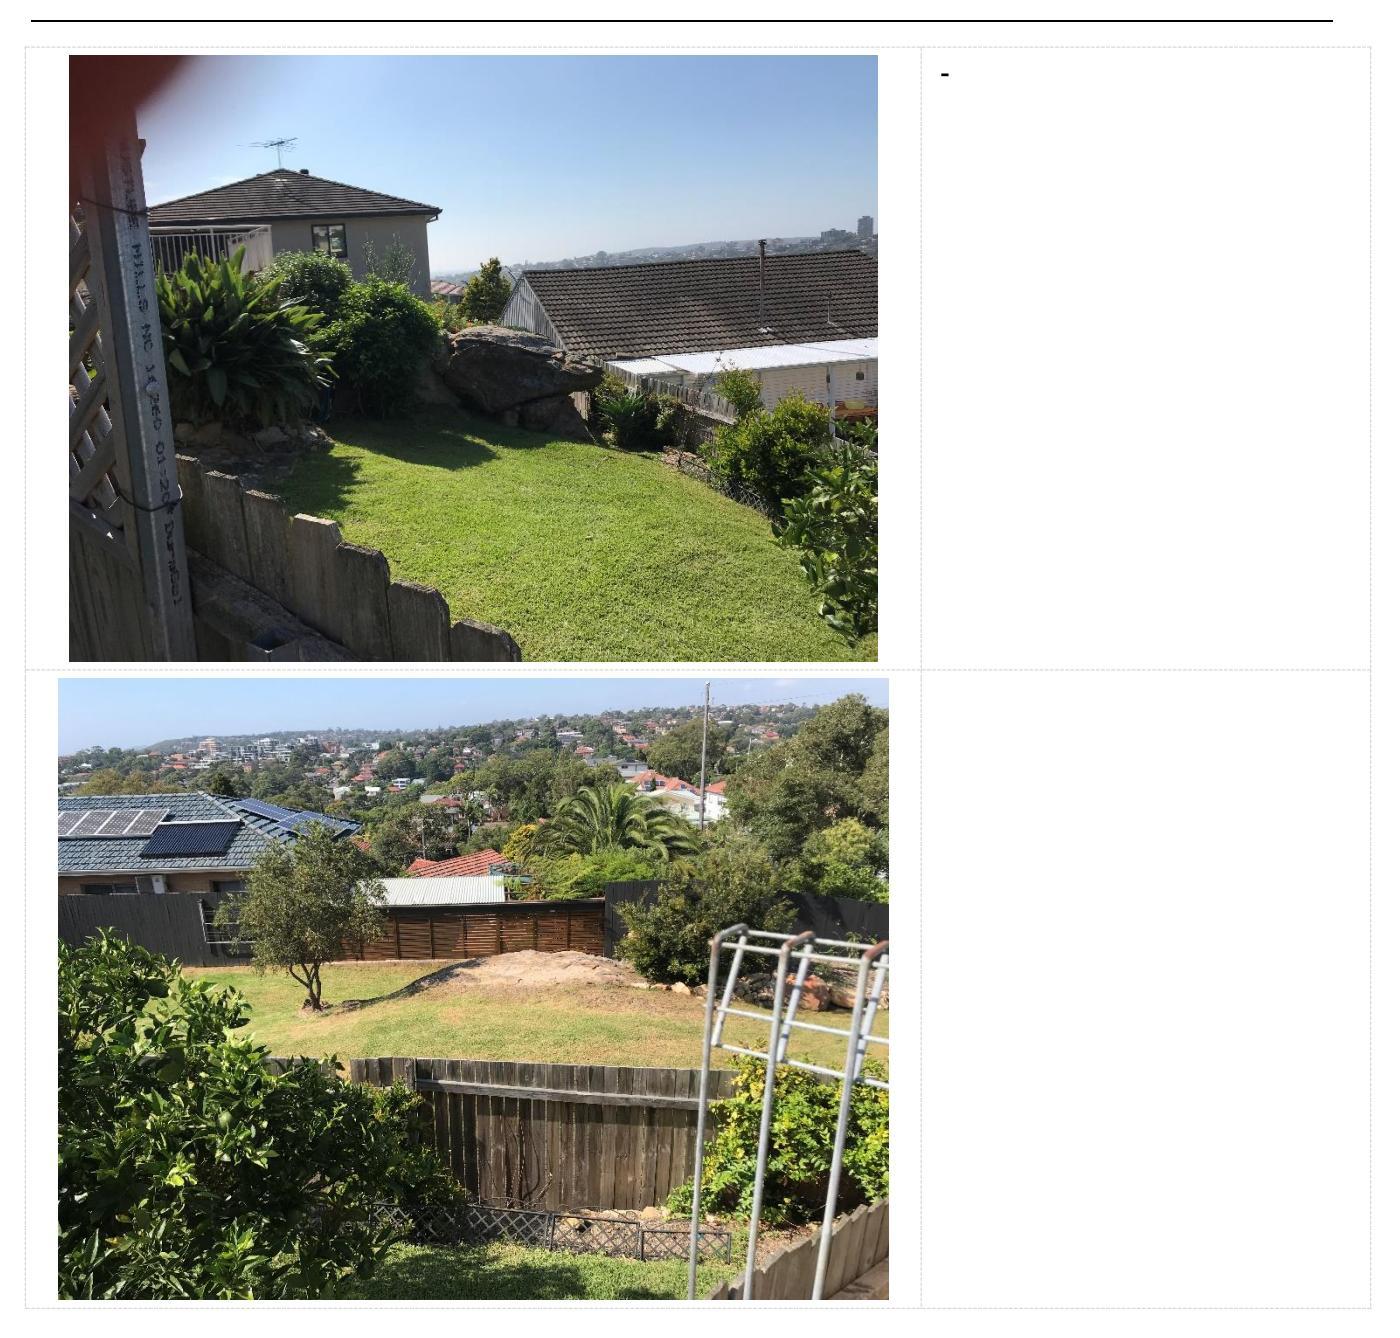
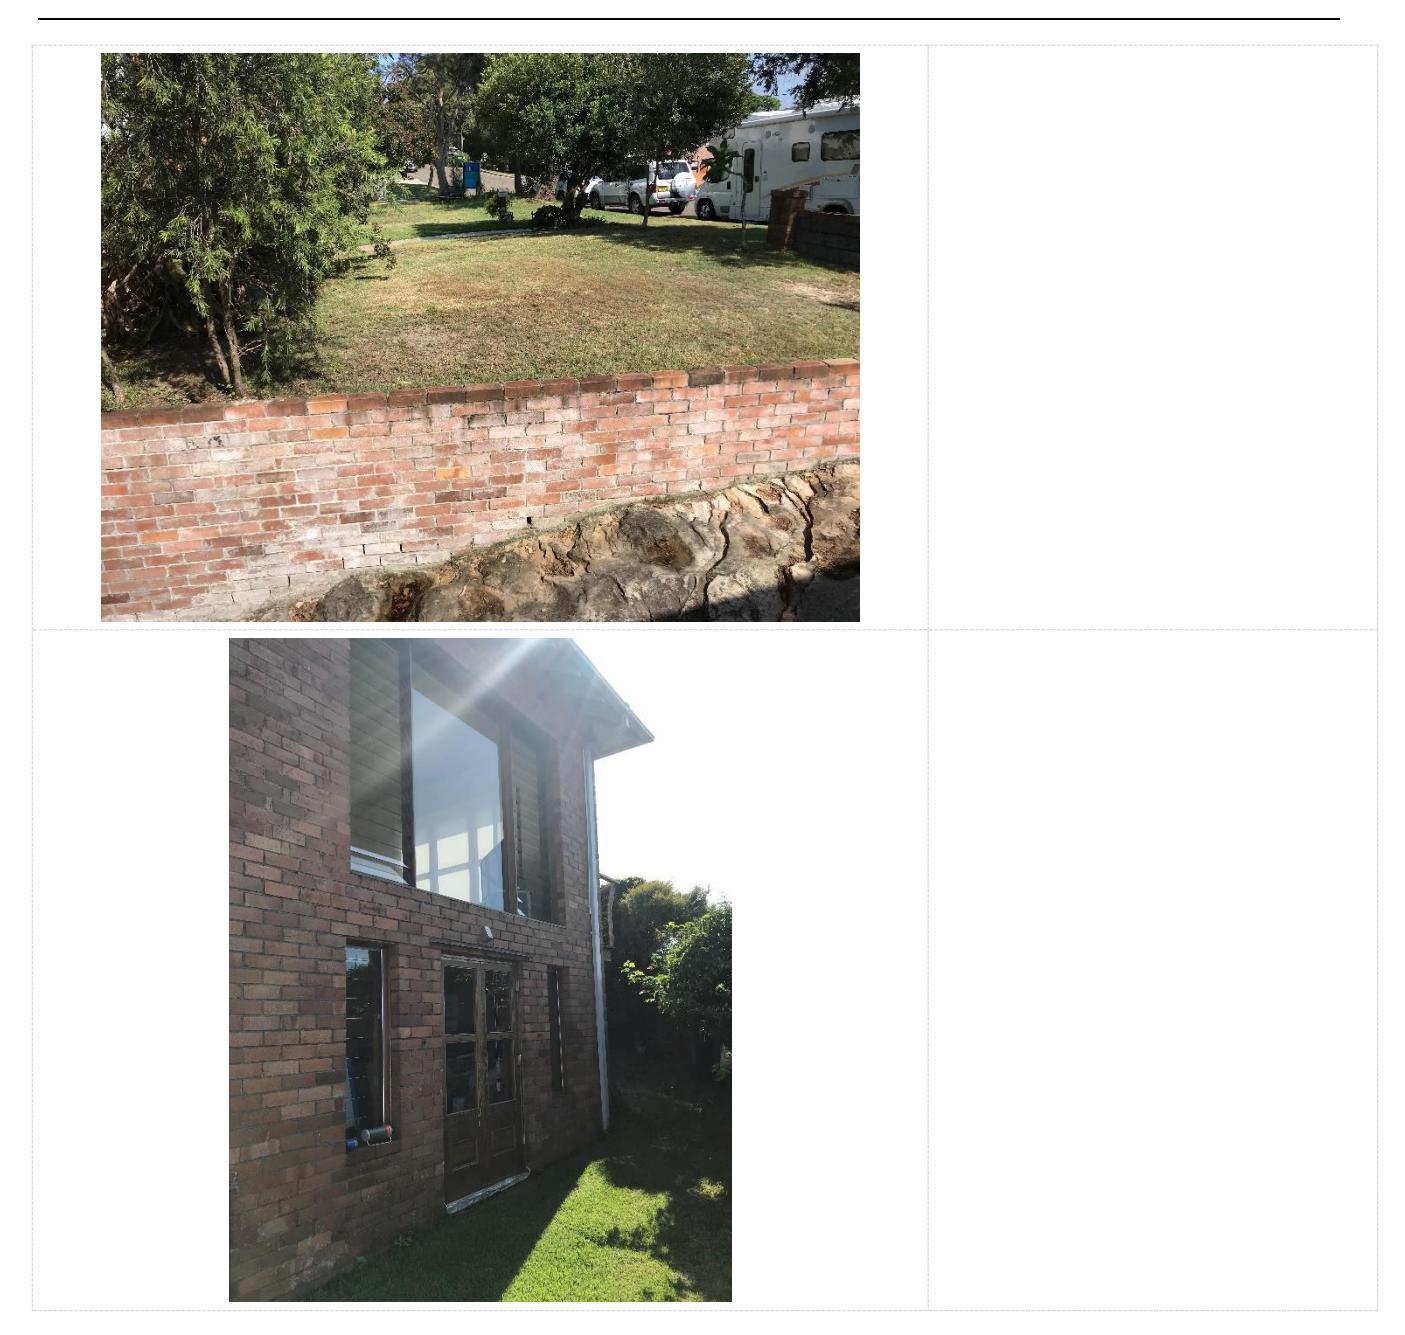
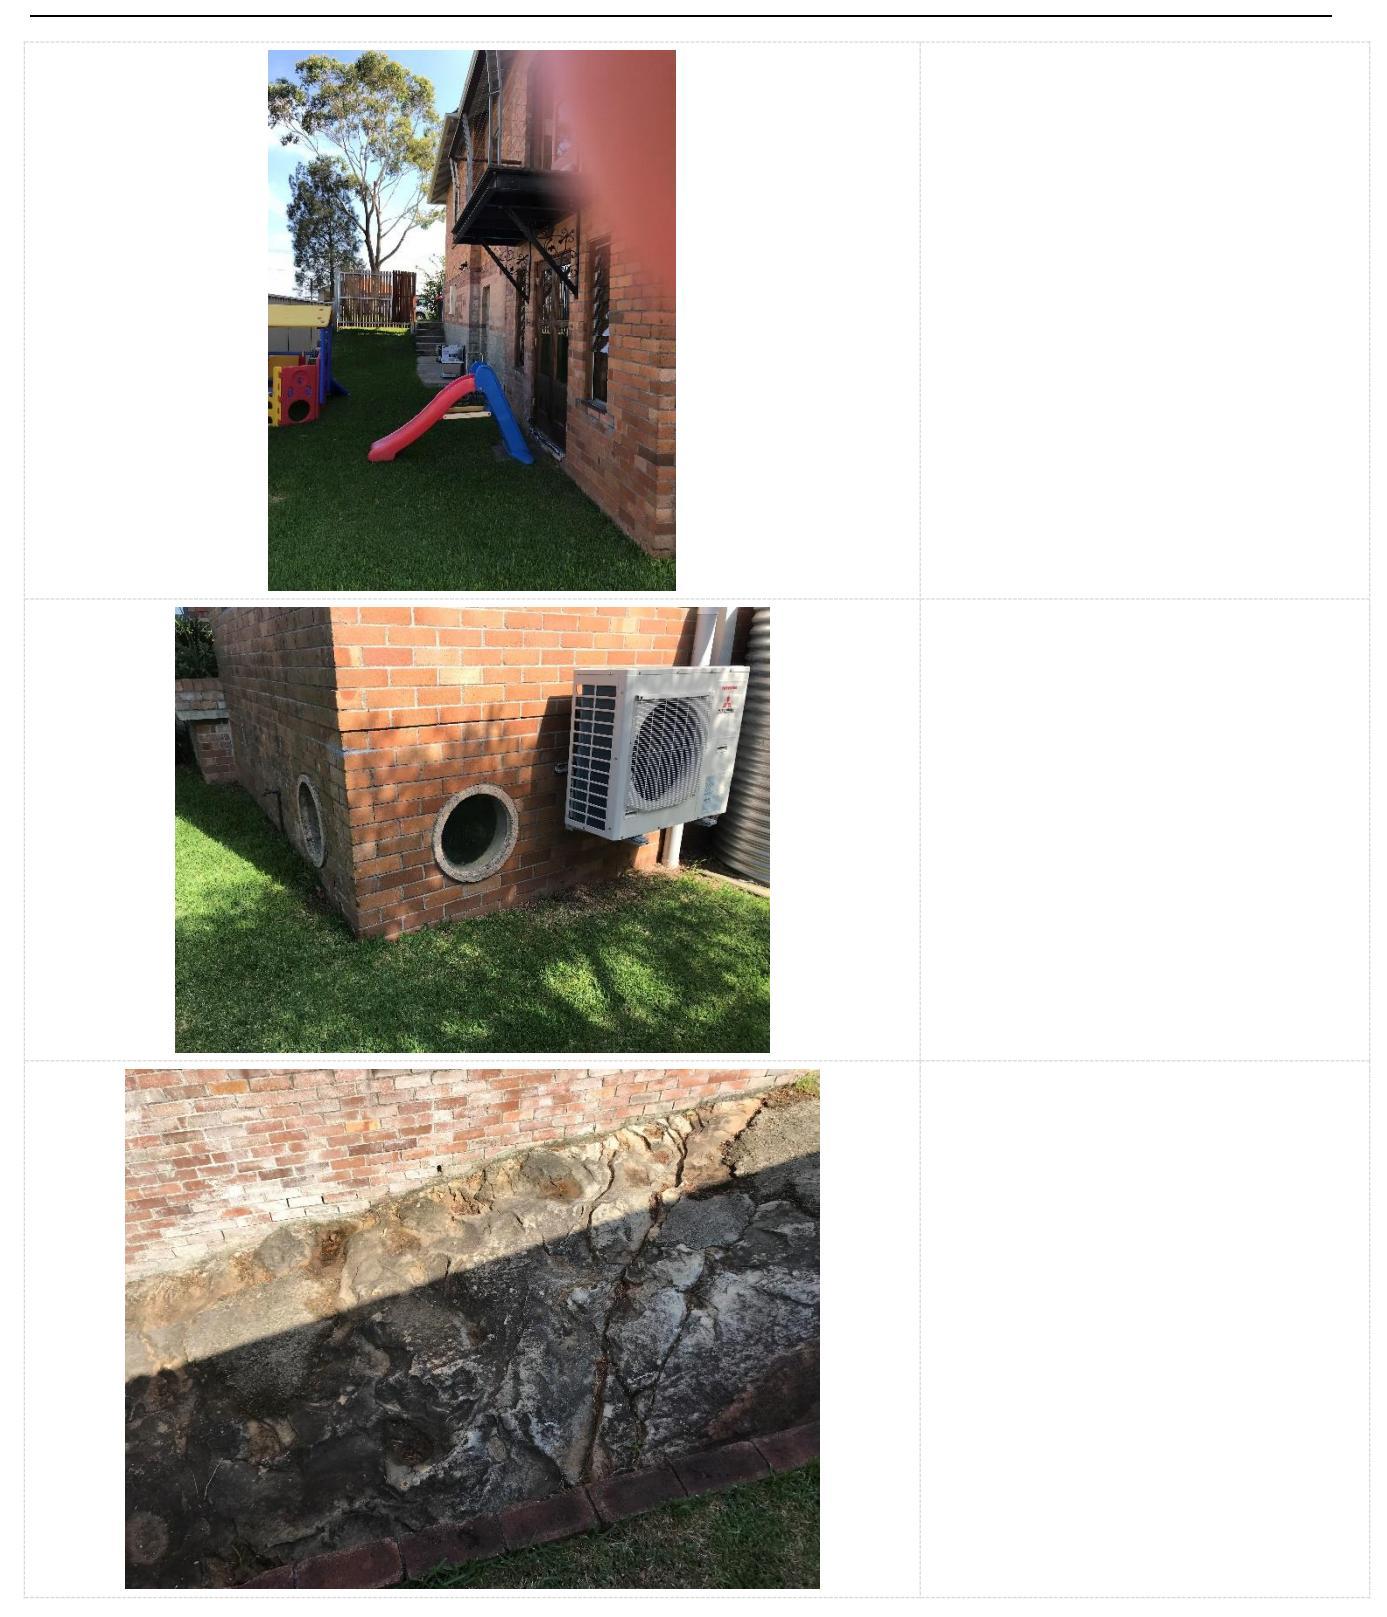
Photos from visual inspection

- The slope of the front of the property is not excessive
- Top Soil profile is residual clay overlaying sandstone, removal of unconsolidated top soil and depending on the depth to the rock layer, piering the structural footing would be required.
- No evidence of particularly high risk/hazard zones (unstable slip zones or localized areas of gradient greater than 25 degrees) across the entire site.
- The existing structure is founded on stable foundations (rock) as I observed with NO cracking of brickwork, which may have occurred if the foundations were on Swelling & Shrinking Clays

- 3.1. It is recommended that all footings for the foundations to be supported on the underlying rock using reinforced concrete piers where necessary. Allow for end bearing piers to penetrate the medium strength sandstone surface by at least 150mm. The allowable bearing capacity for the piers shall be not less than 500kPa.
