Arborist Impact Assessment for new driveway access including three(3) Street Trees.

PREPARED FOR Tanya Ward 46 Francis Street, Manly NSW 2095. Tcward186@mac.com 3/04/2018

Arborist Impact Assessment 1.0 ABSTRACT

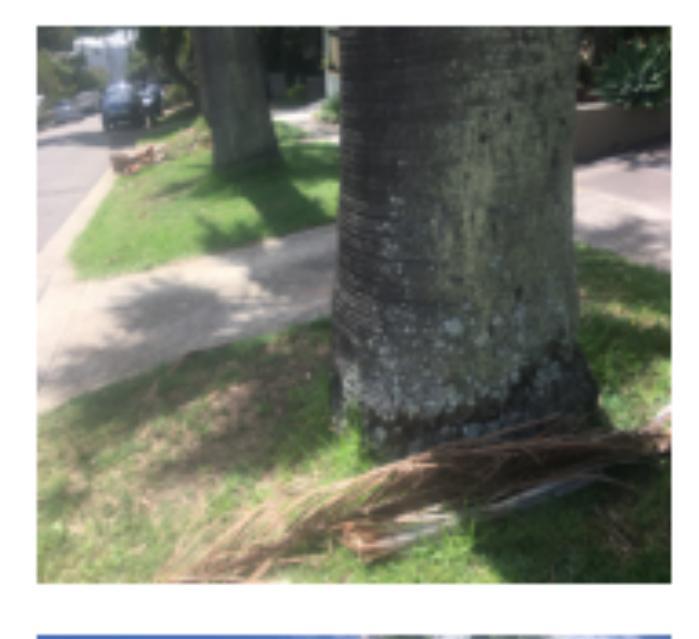
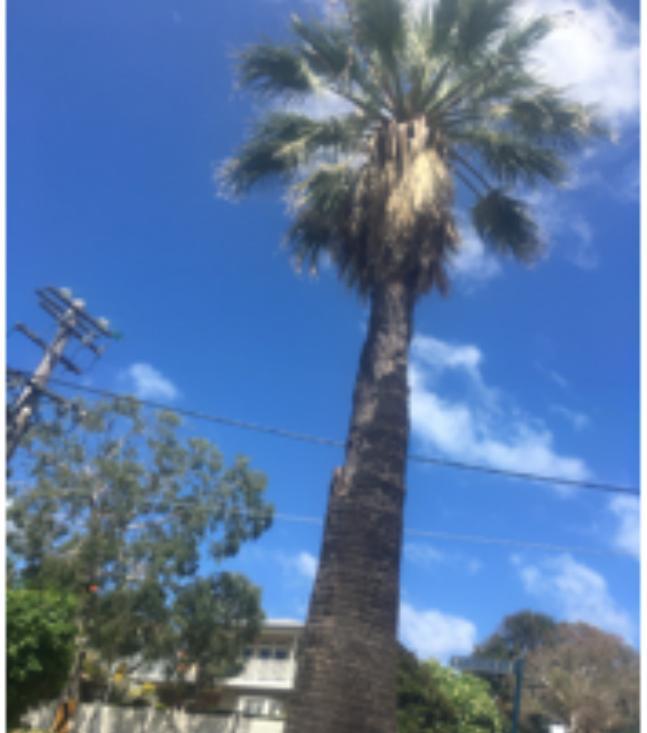
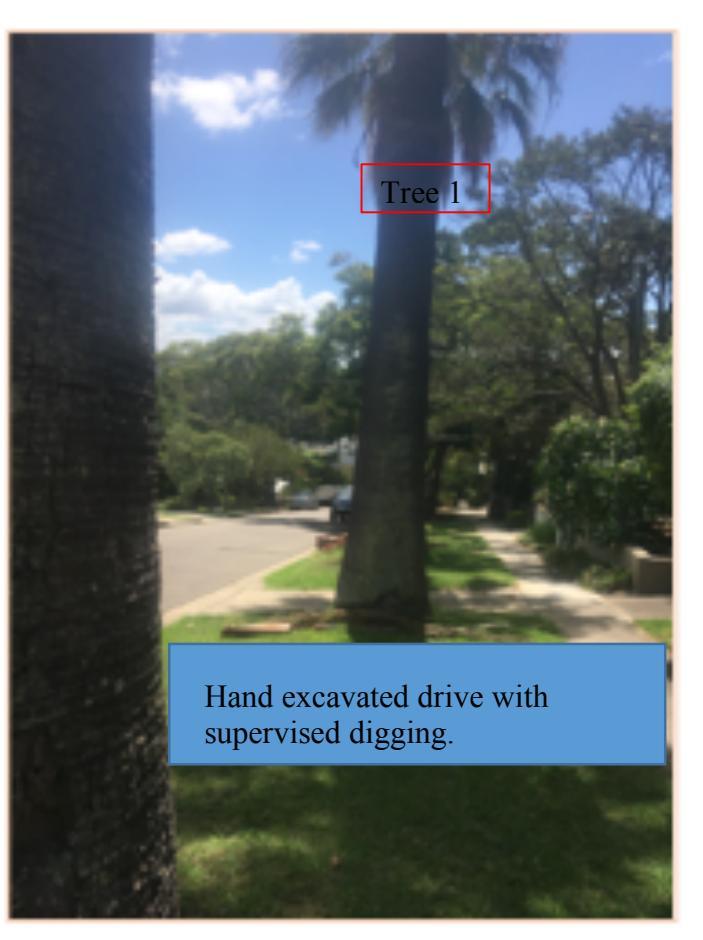
Plates 2,3,&4 presenting the two trees 1&2 within the streetscape.

11.1 Proposed is a relocation of the driveway at 46 Francis street, Manly. The driveway is proposed to be located within two large *Livingstonia australis* (Cabbage tree palms). No pruning is required for this development and trees 3,4&5 are not impacted and are retained. Rootmapping by an AQF level 5 arborist is proposed prior to any construction of the new driveway to ensure that no roots are cut greater than 40mm within the Tree Protection Zones and the driveway installation will allow the two trees numbered 1&2 to be viable.

11.2 The driveway must also be constructed reinforced concrete pier and beam, a hand dug excavation. With 100 mm (minimum) concrete laid on geo-fabric and 40ml basalt gravel to a depth of 100mm. The reinforced concrete slabs with drain holes at every 1.5m to allow water to percolate through the surface.

11.3 The driveway must have turned up edges to prevent vehicle collision with trunk and be a minimum of 1m away from tree no.1's stem. Requires approved trunk protection as seen in appendix D on the nearby trees during this development.

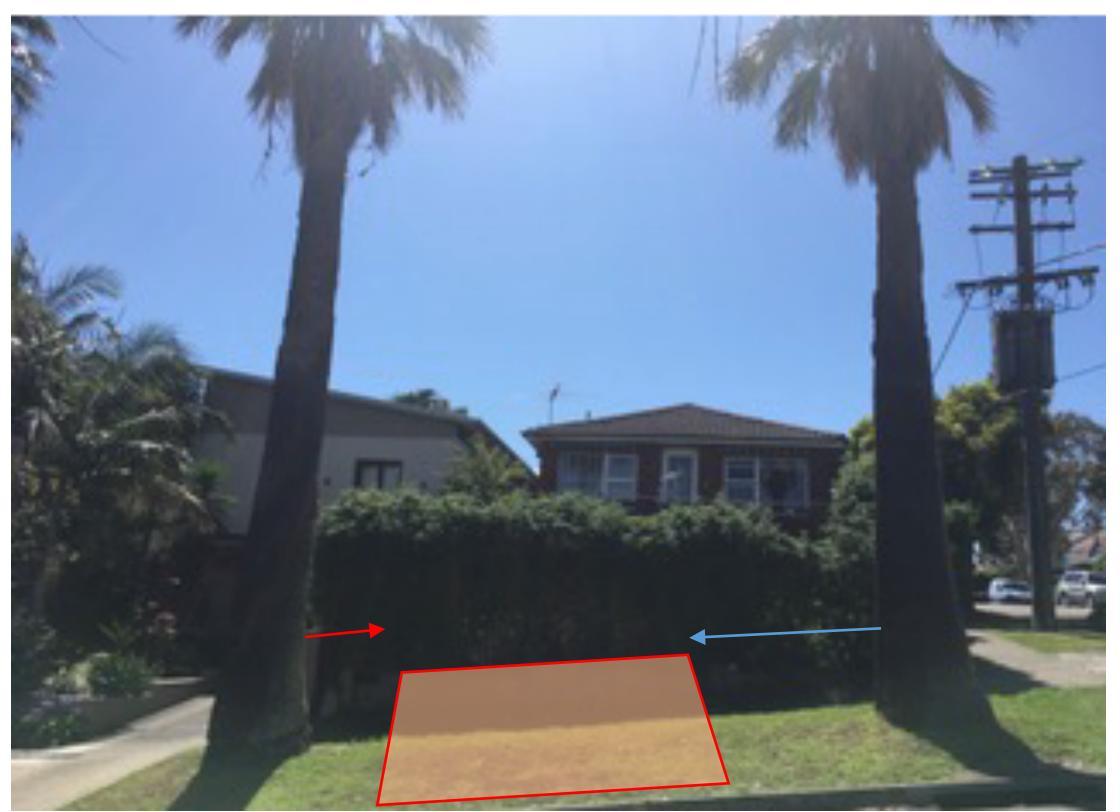
Plate 5 Streetscape view with a proposed driveway installation. Tree 1 to the left will be encroached 16% and tree 20%, therefore this triggers sensitive construction requirements as per AS4970 2009 Tree Protection on Development Sites. Driveway red arrow T1 is 1 metre from the outside of the stem. Driveway blue arrow is three metres, the arrows are not to scale.

1.0 Tree Protection of hessian or carpet underlay wrapped around the tree 1&2 trunks. Add
1.8 metre lengths of hardwood of 50x100mm width and 150mm air gaps. The vertical lengths are to be parallel to the tree trunk and secured with framing steel. See appendix D section 4.
2.0 Excavation within the TPZ of tree 1&2 for the driveway installation is to be by hand and must be supervised by the AQF level 5 arborist. Any services within the TPZ must also be supervised on there installation.

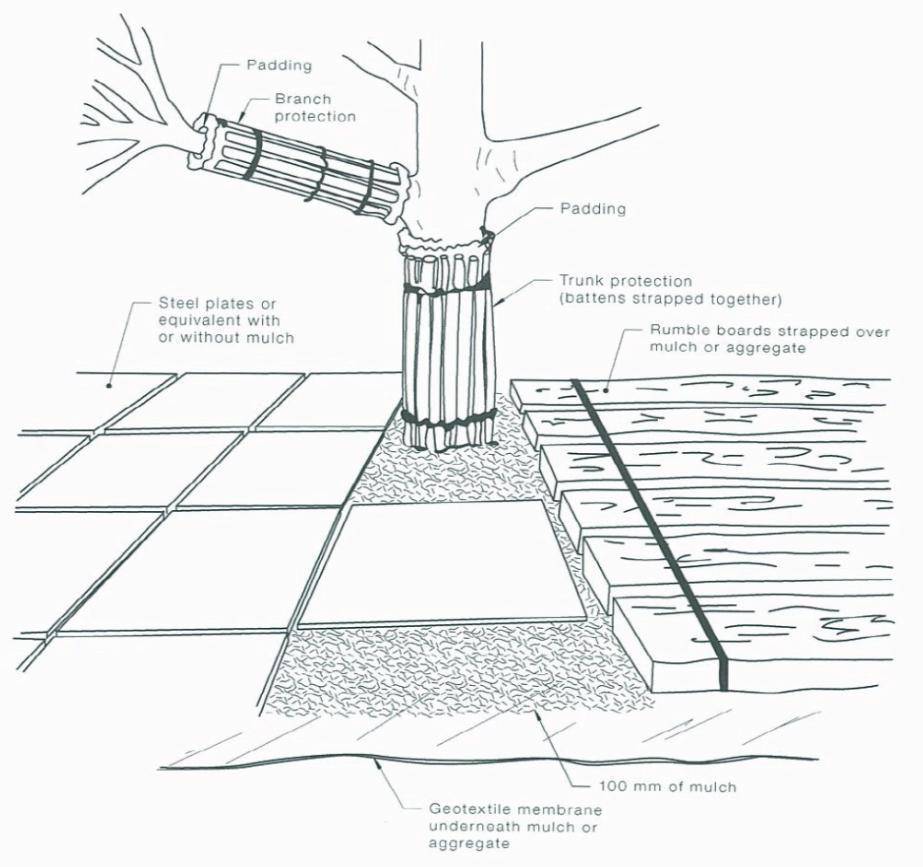
FIGURE 4 EXAMPLES OF TRUNK, BRANCH AND GROUND PROTECTION

4.5.2 TRUNK AND BRANCH PROTECTION see fig4.

If temporary access for machinery is required within the TPZ, ground protection measure will be required to prevent compaction in the root zone. Measures may include permeable membrane such as geotextile fabric beneath a layer of mulch (100mm) or crushed rock below rumble boards as per fig 4.

- 1 For trunk and branch protection use boards and padding that will prevent damage to bark. Boards are to be strapped to trees, not nailed or screwed.
- 2 Rumble boards should be of a suitable thickness to prevent soil compaction and root damage.
