35 Lodge Street, Balgowlah

22/2/DP 6154

1. Summary

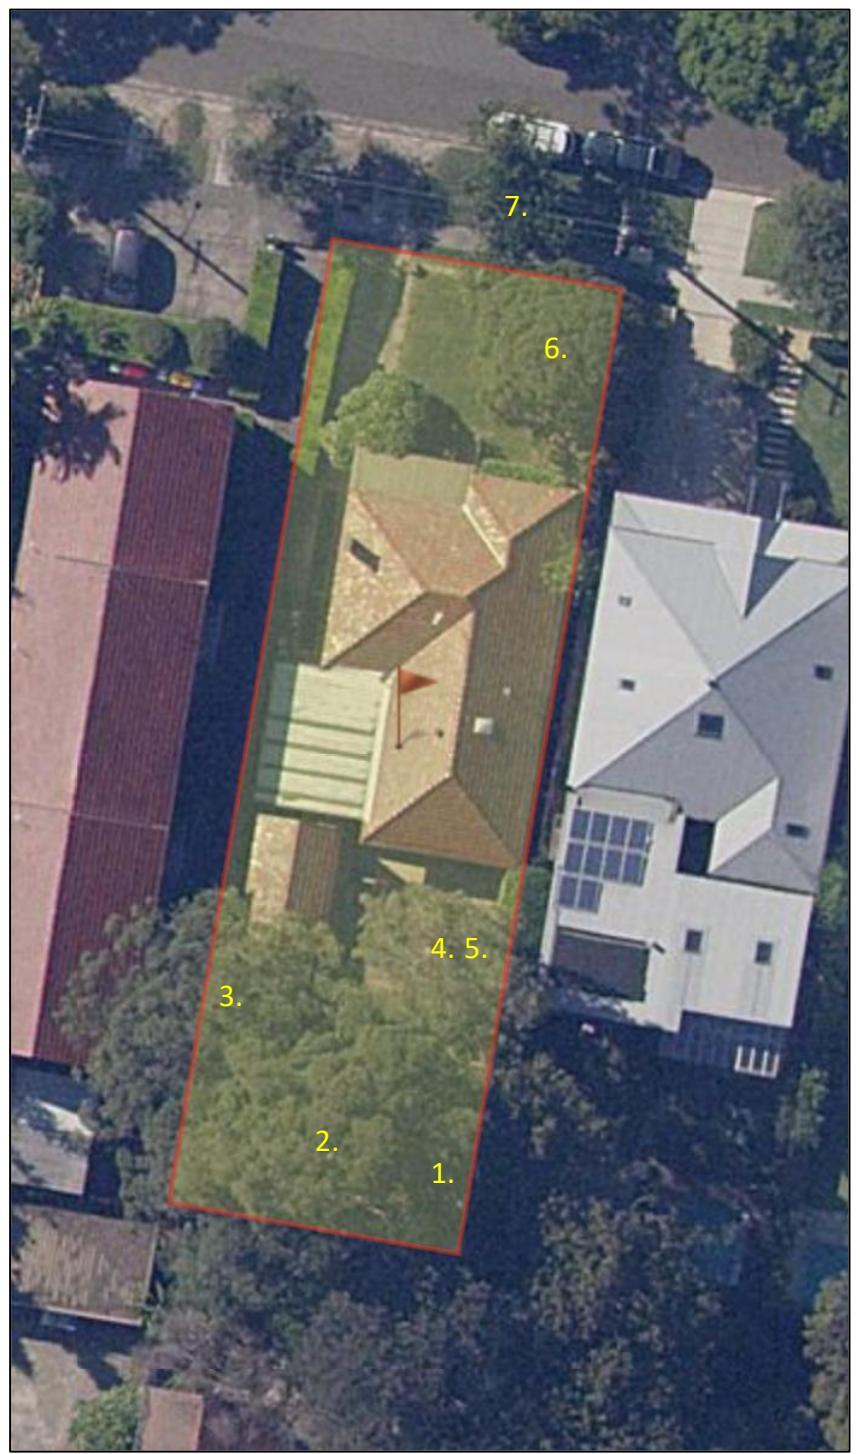
Map 2. Location of seven trees inside and within 5 metres of the property boundaries of 35 Lodge Street, Balgowlah (property boundaries in red). Image sourced from SixMaps 2019.

The majority of trees included in this assessment (Trees 1 - 5) are positioned within the property boundaries on the southern side of the existing dwelling. Tree 6 is positioned close to the north-eastern property boundary on the northern side of the dwelling. Tree 7, which is a Council tree positioned in the street verge, was the only specimen included in this assessment positioned outside the property boundaries of the subject site (Map 2).

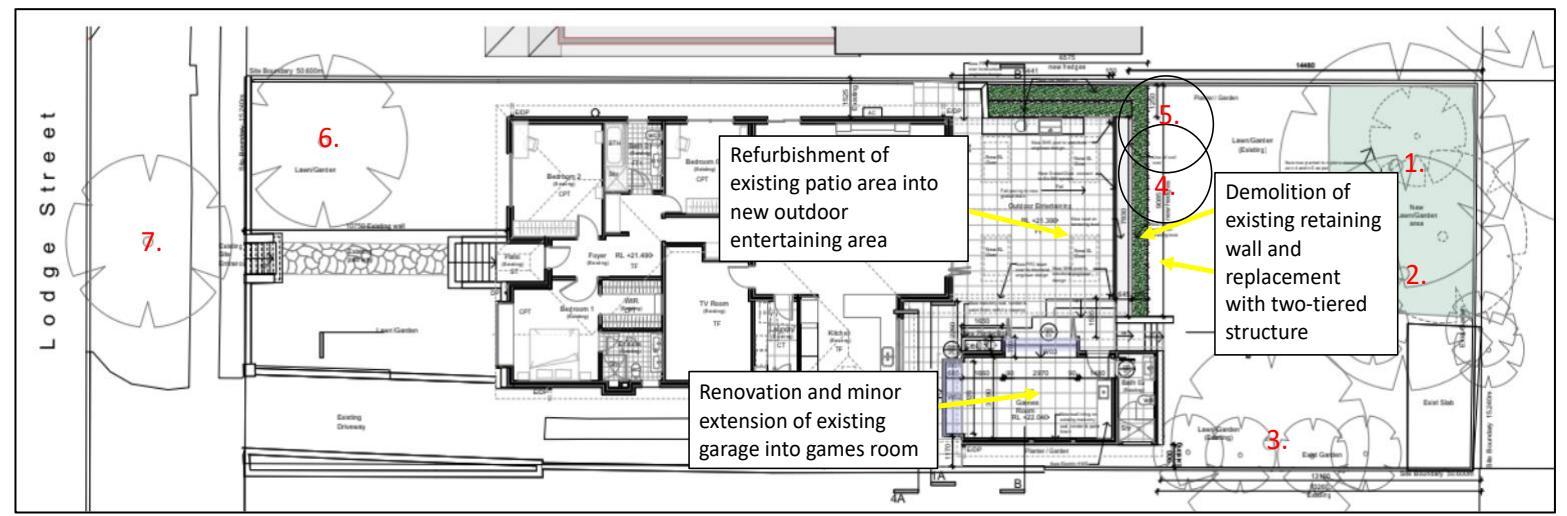
Figure 1. Position of Stage 2 planned development works in relation to Trees 1 - 7 at 35 Lodge Street, Balgowlah. Ground Floor drawn by *Playoust Churcher Architects* (2020) annotated by *Temporal Tree Management Pty Ltd* (2020).

Trees 1 - 5 may be impacted upon due to their close proximity to the second stage of this development. Trees 6 and 7 are less likely to be impacted upon due to their considerable distance from the proposed works and site access using point along the existing driveway. However, they may be indirectly impacted upon by material storage or accidental contamination.

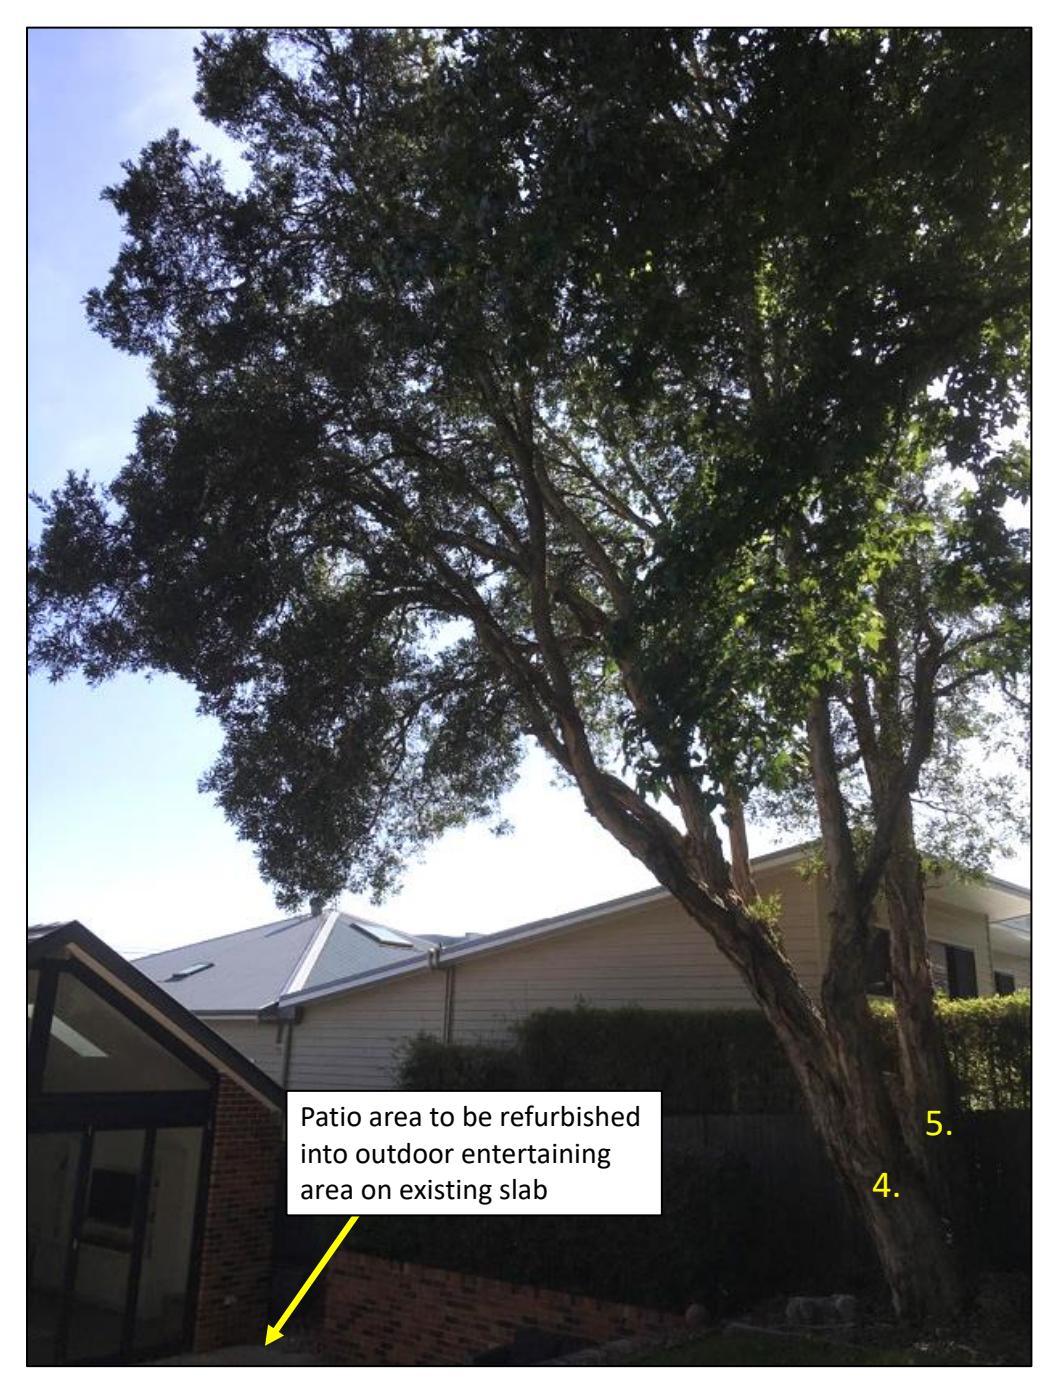
Figure 2. Refurbishment of existing patio area adjacent to Trees 4 and 5.

The proposed plans for Stage 2 of the development involve the refurbishment of the existing patio area into a new outdoor entertaining area and the renovation of the existing garage within its current building envelope into a detached games room (Figure 1). The existing concrete slab of the patio area will be utilised for this extension (Figure 2). However, the existing retaining wall must be demolished and rebuilt with a two-tiered structure to adequately comply with current building codes (Figure 3).

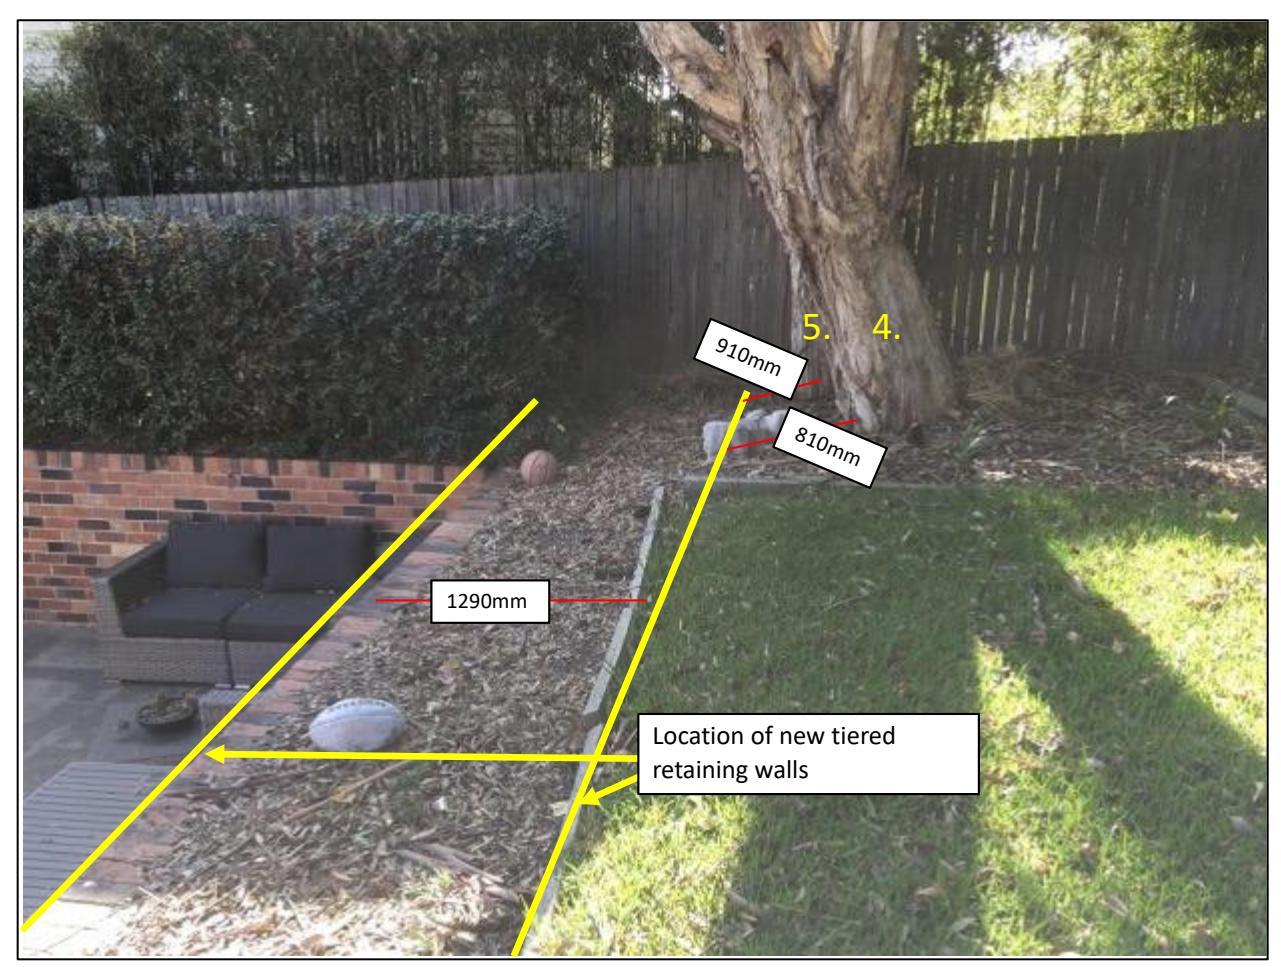
Figure 5. Close position of Trees 4 and 5 to proposed location of new tiered retaining wall.

To facilitate the demolition of the existing retaining wall, and its replacement with a twotiered structure, Trees 4 and 5 will require removal. At the closest point, the stem of Tree 4 is 2.1 metres from the existing retaining wall while the stem of Tree 5 is 2.2 metres from it. The new tiered wall structure will be spaced 1290 mm (2 x 645 mm tiers) from the existing wall, which will place the required works at the closest point 0.91 metres and 0.81 metres from the stems of Trees 4 and 5 respectively (Figure 5). This will position the works within the SRZs of Tree 4 (2.65 metres) and Tree 5 (2.49 metres) and require a major encroachment within their TPZs.

This encroachment may negatively impact not only the two trees' health, but also the structural integrity of their root plates (Matheny and Clark 1994, Day et al. 2008). A significant reduction in the ULE and increase in their Risk of Harm is a likely outcome from this major root disturbance. Both trees were determined to be of Z10 Low retention value in the preliminary assessment (Table 1, Appendix A). The reconstruction of the retaining wall is required to be suitably compliant with current building regulations. The retention of Trees 4 and 5 is therefore unsuitable as part of this development. Their removal is considered to be the most appropriate management strategy for this proposed development under Section 3.3.2.2 and Schedule 4 of the Manly DCP (2013).

Both trees must be suitably replaced as stipulated in Section 3.3.2.2 4 of the Manly DCP (2013). Two juvenile specimens of the same or similar indigenous species capable of reaching the same or greater mature size as Trees 4 and 5 should be planted within the property boundaries of the subject site in a suitable location during the landscape works. The undeveloped area close to the southern boundary has been identified as the most suitable location for the replacement plantings (Figure 8).

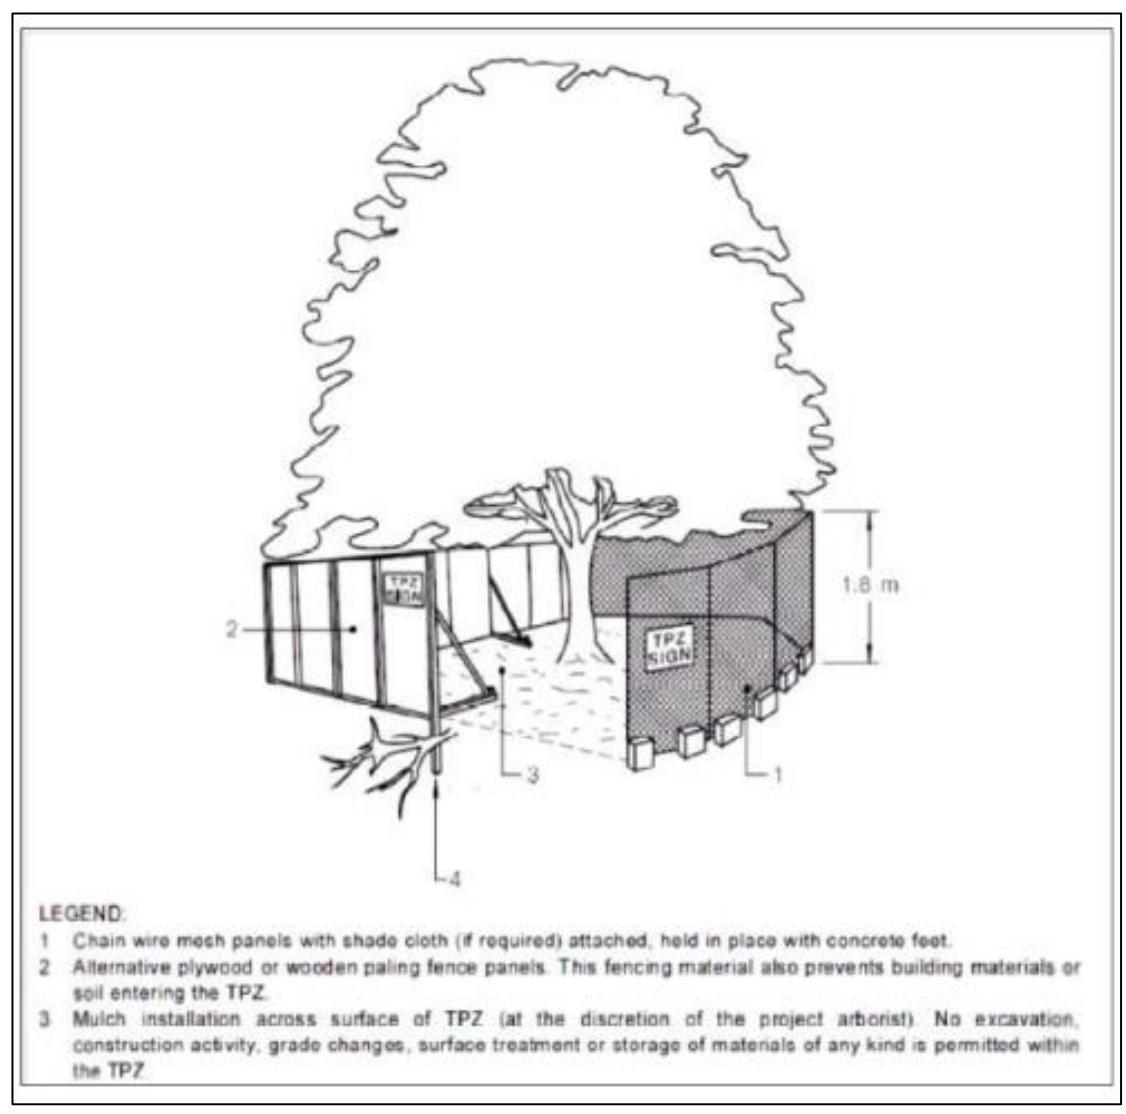
Figure 7. Steel fencing should be erected around the perimeter of TPZs in accordance with AS4970.

The area established by the radial measurement should be enclosed by 1.8 metre steel fencing that is securely fixed to the ground as stated in section 4.3 of the *Australian Standard for the Protection of Trees on Construction Sites* (AS4970 2009) (Figure 7). Signage stating the purpose of these exclusion zones should be fixed to the fencing so that it is visible from all points within the site.

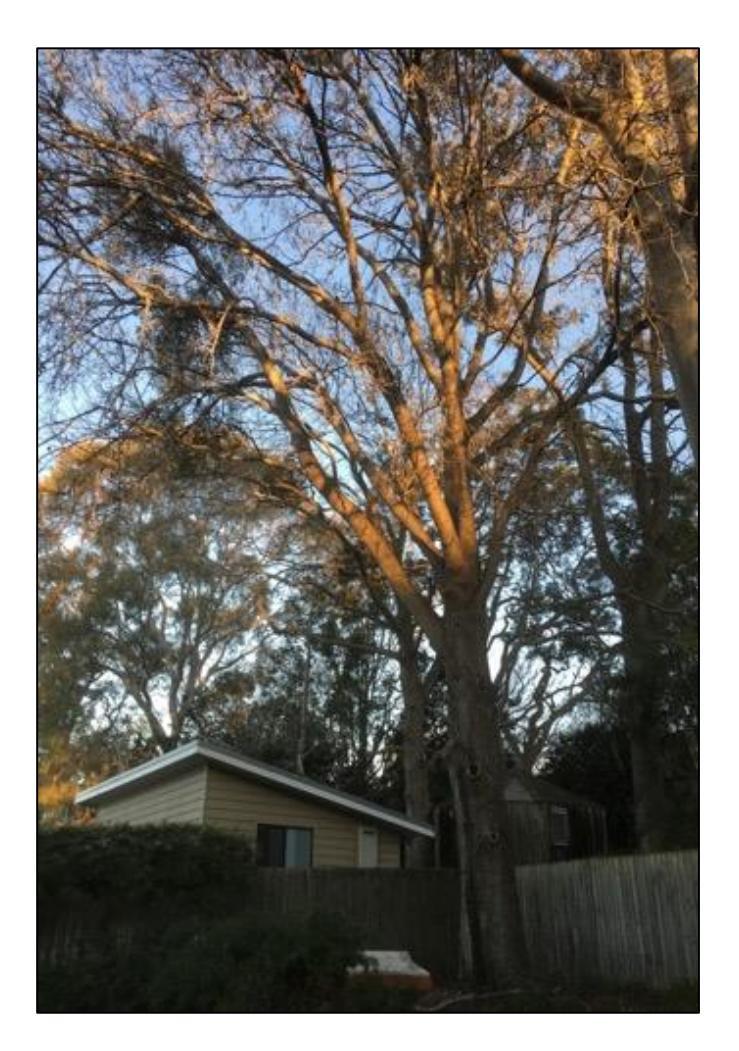
Tree N₀: 1. Botanical Name: *Liquidambar styraciflua* Common Name: American Sweetgum Age: Mature Origin: Exotic DBH: 740 mm DGL: 920 mm Height: 15 metres Width: 14 metres x 11 metres Health: Fair Structure: Poor ULE: Medium Retention Value: Z3 TPZ: N/A SRZ: N/A

Comments: This specimen is positioned close to the south-eastern corner of the subject site. Its canopy form has been suppressed by its much larger neighbour. Due to its species' exemption from the Northern Beaches Council TPO this tree was determined to be of Low retention value.

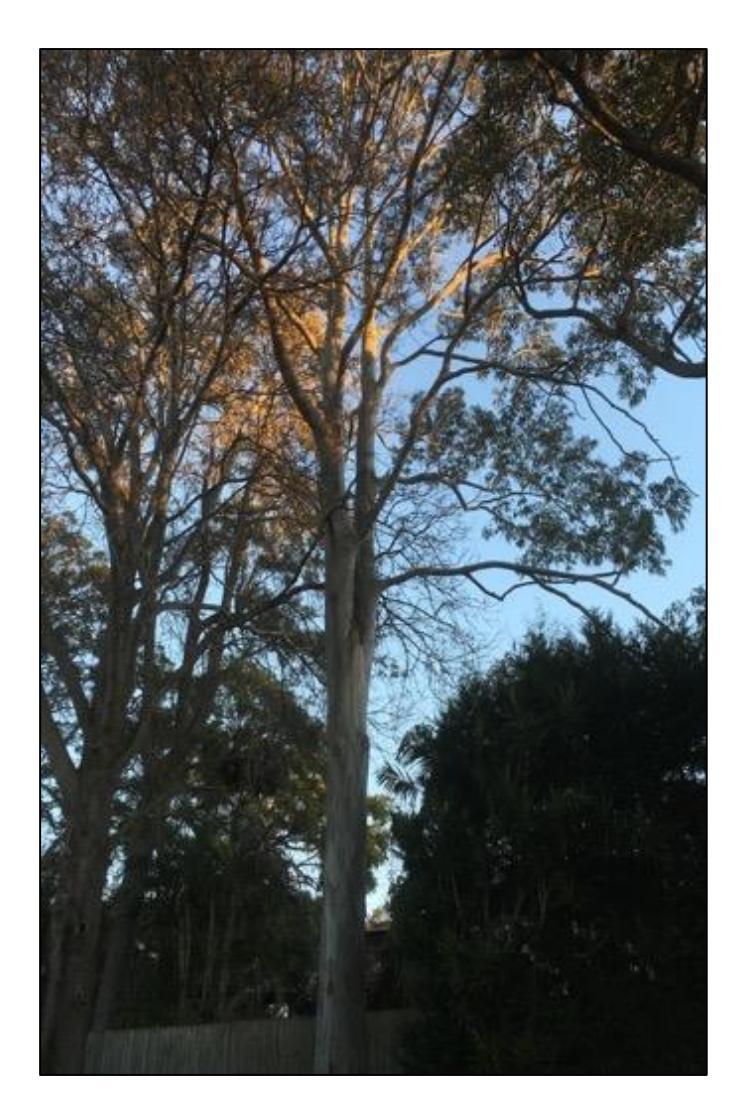
Tree N₀: 2. Botanical Name: *Eucalyptus saligna* Common Name: Sydney Blue Gum Age: Mature Origin: Indigenous DBH: 760 mm DGL: 930 mm Height: 26 metres Width: 20 metres x 16 metres Health: Fair Structure: Fair ULE: Long Retention Value: A1 TPZ: 9.12 metres SRZ: 3.21 metres

Comments: This large Sydney Blue Gum specimen is positioned close to the southern boundary of the subject site. Its large size, fair condition, long ULE estimate, and species importance render it of High retention value within this landscape.

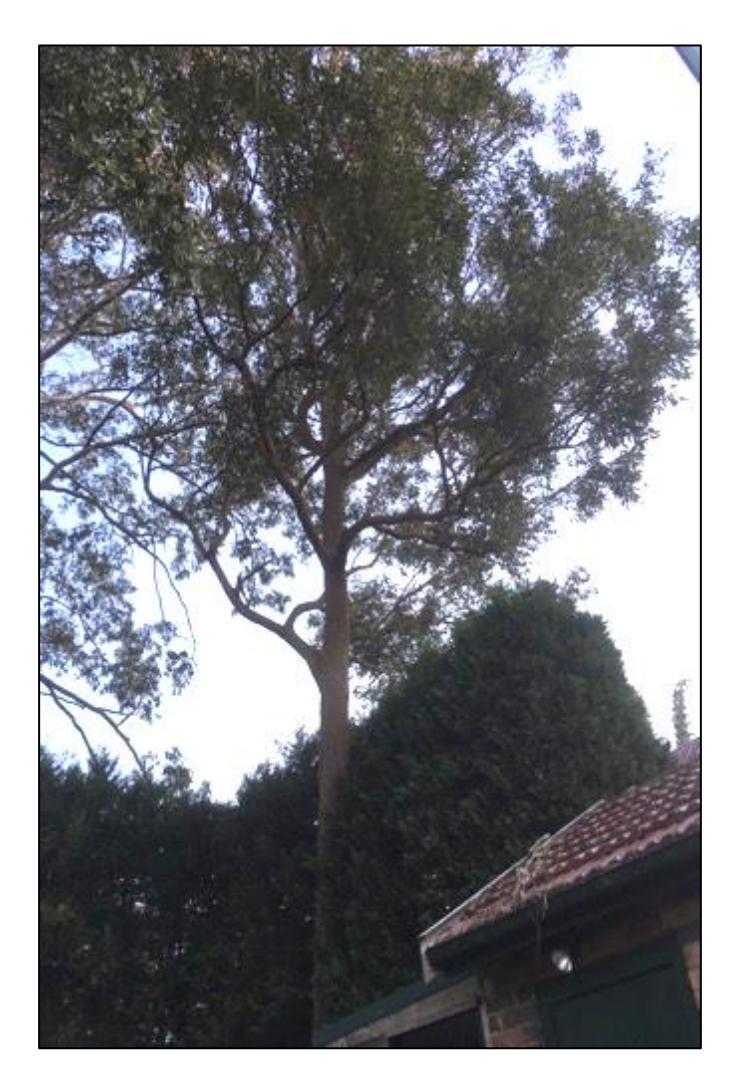
Tree No: 3. Botanical Name: *Eucalyptus robusta* Common Name: Swamp Mahogany Age: Mature Origin: Indigenous DBH: 710 mm DGL: 920 mm Height: 18 metres Width: 15 metres x 16 metres Health: Fair Structure: Fair ULE: Long Retention Value: A1 TPZ: 8.52 metres SRZ: 3.2 metres

Comments: This large Swamp Mahogany specimen is positioned adjacent to the western boundary of the subject site. Its large size, fair condition, long ULE estimate, and species importance render it of High retention value within this landscape.

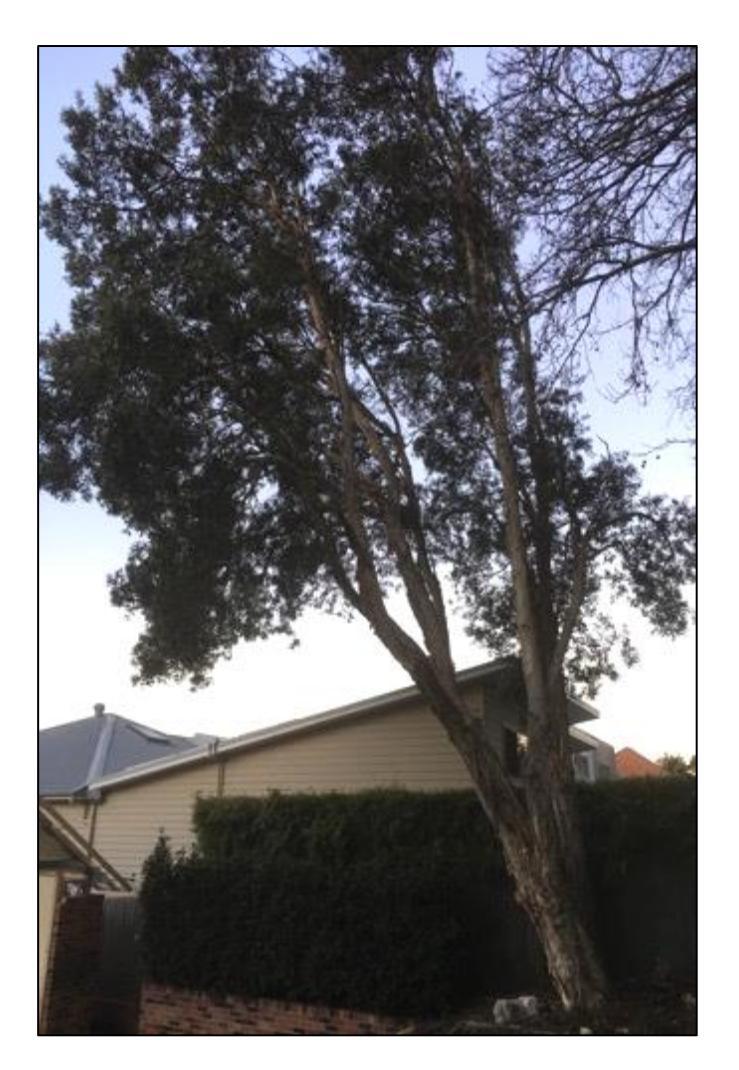
Tree No: 4. Botanical Name: *Melaleuca quinquenervia* Common Name: Broad-leaved Paperbark Age: Mature Origin: Indigenous DBH: 420 mm DGL: 590 mm Height: 14 metres Width: 12 metres x 11 metres Health: Fair Structure: Poor ULE: Medium-short Retention Value: Z10 TPZ: N/A SRZ: N/A

Comments: This Broad-leaved Paperback is positioned adjacent to the existing retaining wall at the southern end of the patio area close to the eastern boundary of the subject site. Its stem becomes codominant from an included union at 1 metre. This feature underpinned its poor structural rating, Medium-short ULE estimate and Low retention value rating.

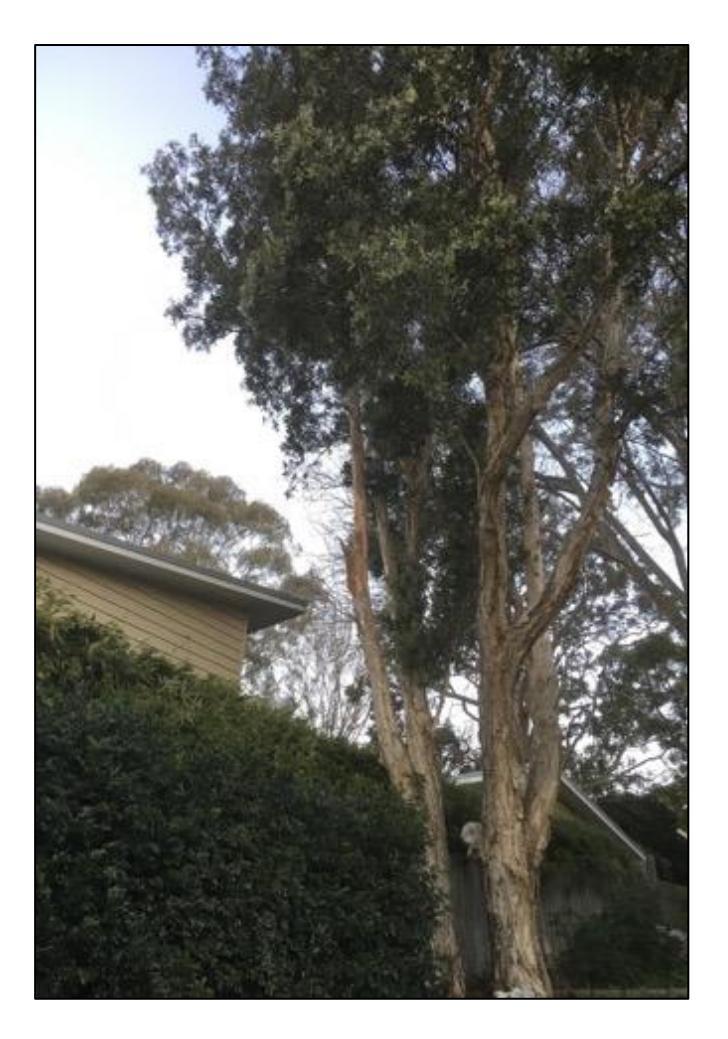
Tree No: 5. Botanical Name: *Melaleuca quinquenervia* Common Name: Broad-leaved Paperbark Age: Mature Origin: Indigenous DBH: 400 mm DGL: 510 mm Height: 14 metres Width: 8 metres x 8 metres Health: Fair Structure: Poor ULE: Medium-short Retention Value: Z10 TPZ: N/A SRZ: N/A

Comments: This Broad-leaved Paperback is positioned adjacent to the existing retaining wall at the southern end of the patio area close to the eastern boundary of the subject site. Its canopy form has been suppressed by its larger neighbour. This feature underpinned its poor structural rating, Medium-short ULE estimate and Low retention value rating.

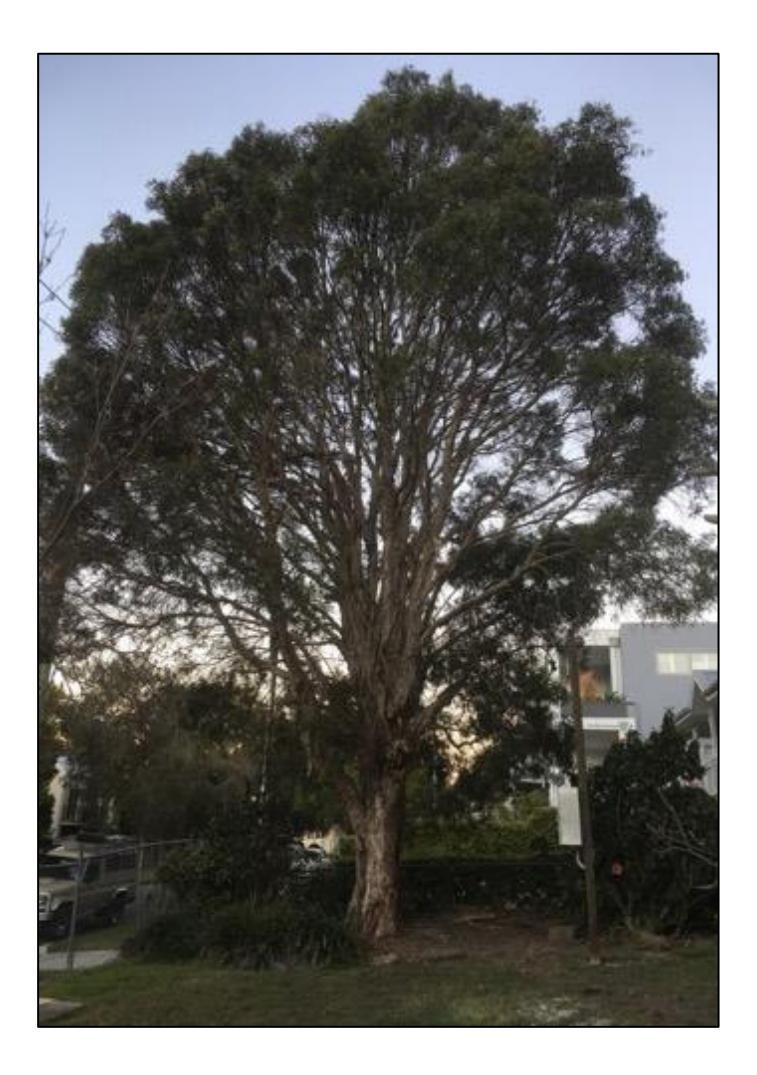
Tree No: 6. Botanical Name: *Melaleuca quinquenervia* Common Name: Broad-leaved Paperbark Age: Mature Origin: Indigenous DBH: 380 mm DGL: 480 mm Height: 11 metres Width: 9 metres x 9 metres Health: Poor Structure: Poor ULE: Medium-short Retention Value: Z10 TPZ: N/A SRZ: N/A

Comments: This Broad-leaved Paperback is positioned on the northern side of the dwelling close to the eastern boundary of the subject site. It has multiple stems originating from codominant unions. Its canopy was also observed to be thin and with Sooty Mould throughout. Its poor condition underpinned this tree's Medium-short ULE estimate and Low retention value rating.

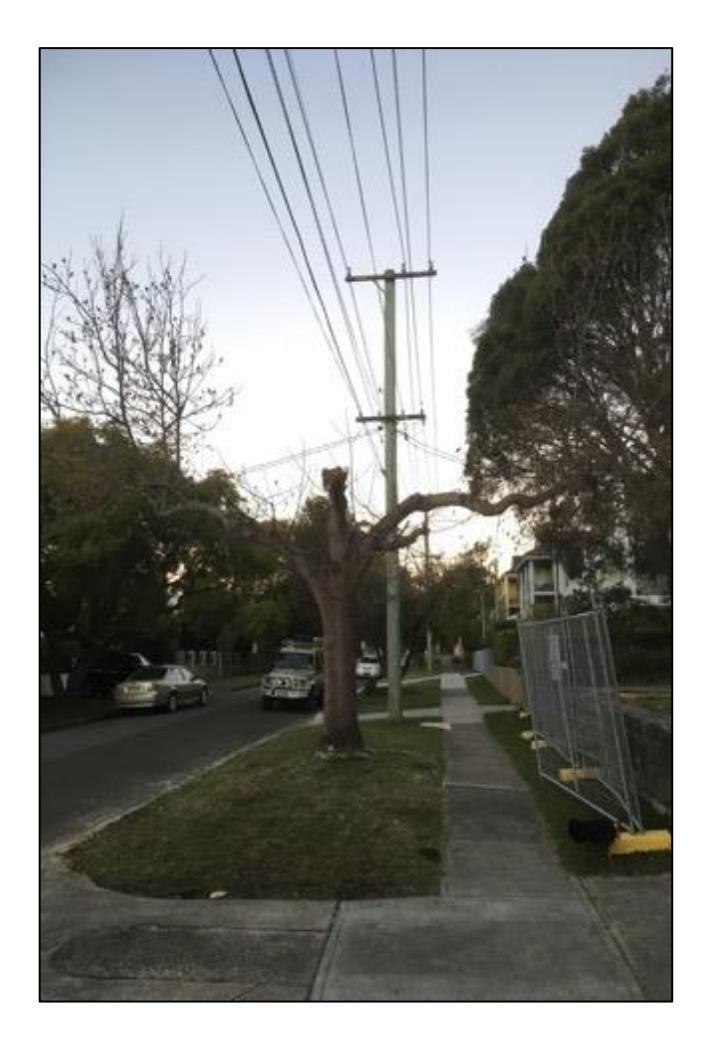
Tree N₀: 7. Botanical Name: *Liriodendron tupilifera* Common Name: Tulip Tree Age: Mature Origin: Exotic DBH: 420 mm DGL: 560 mm Height: 6 metres Width: 7 metres x 10 metres Health: Fair Structure: Poor ULE: Medium-short Retention Value: A4 TPZ: 5.04 metres SRZ: 2.49 metres Comments: This Tulin Tree specimen

Comments: This Tulip Tree specimen is positioned outside of the northern property boundary within the Council street verge. Its canopy has been heavily pruned for powerline clearance. Despite its poor structure this tree's public ownership renders it of High retention value within this landscape.

Despite its High retention status, no protection measures are recommended for Tree 7. This council tree will be adequately protected from the construction activity associated with the proposed development by its considerable distance from the work zone and its position outside of the property boundaries of the subject site.
