Arboricultural Impact Assessment and Tree Protection Plan

Site: 117 Rickard Road, North Narrabeen

Reference: AIA117Rick/042023

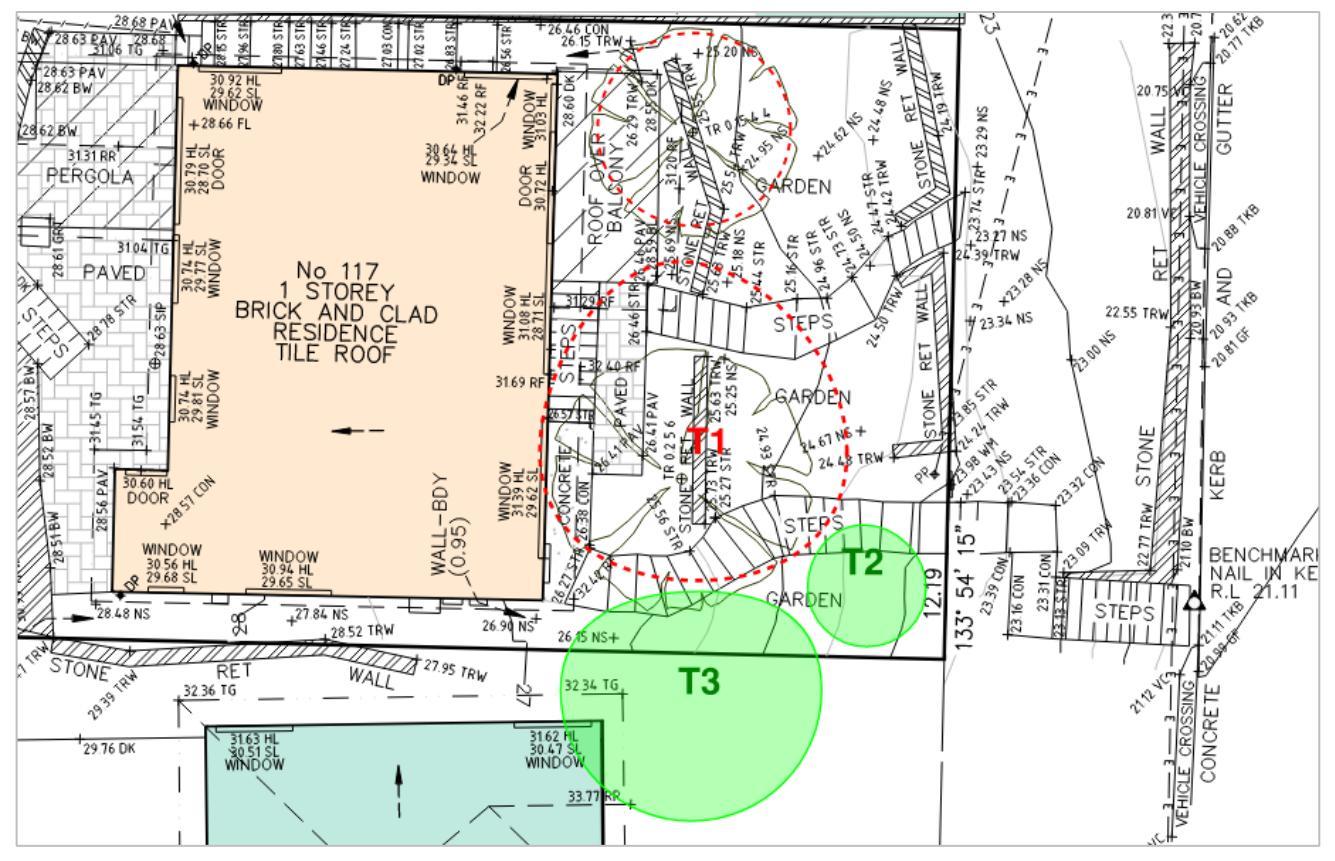
Figure 2 – Location of Tree 1 from survey plan – trees 2 and 3 were not included on the survey and are estimated only. The trees in green are nominated for retention. The trees in red are nominated for removal – any tree that is not numbered is not a prescribed tree due to dimensions (also for removal).

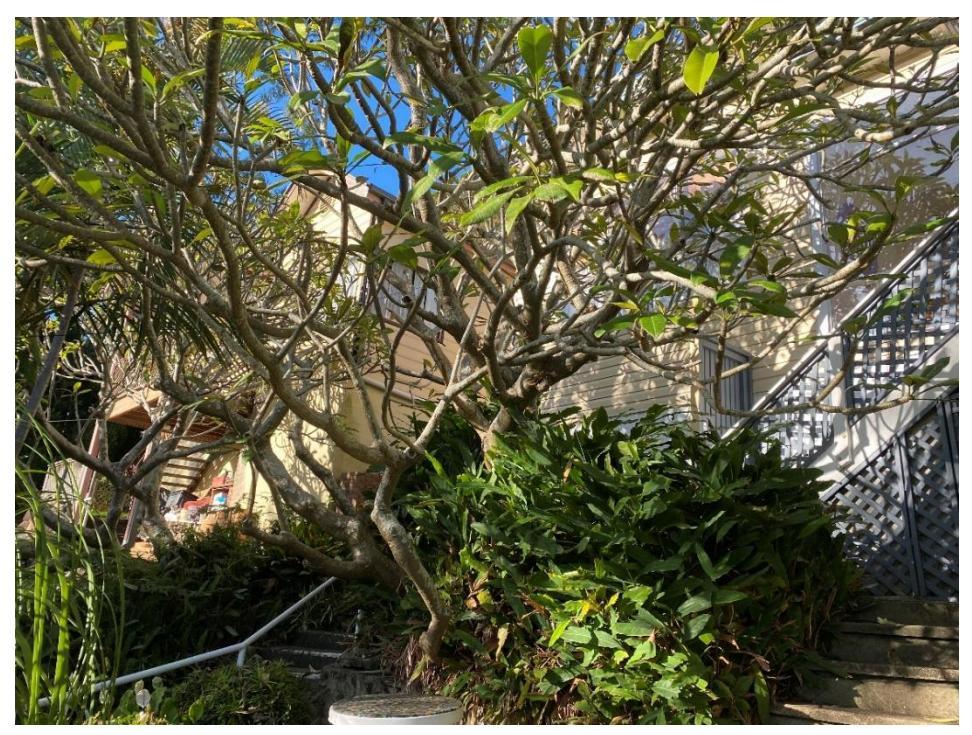
Image 2 - Tree 1

Should the application be supported Tree 1 will require removal as it is located within the building footprint. This tree has been allocated a moderate retention value.

It is noted that the site supports a significant percentage of canopy cover excluding Tree 1 and that the lost canopy can be replaced in the front setback within 5 -10 years using a locally occurring species.

- Trees 2 and 3 are protected during demolition and construction.
- If approved by the Northern Beaches Council, Tree 1 be removed.
- All excavation within 3.5 m (beyond this would be impacting less than 10% of the estimated TPZ area and therefore considered minor) of Tree 3 (*Plumaria acutifolia* Frangipani) and within 2.5 m of the outer edge of the clump that forms Tree 2 (*Dypsis lutescens* Golden Cane Palm) must be undertaken as directed by, and under the supervision of, the Project Arborist. Should roots be encountered that are not approved for removal the design must be modified to accommodate the retention of such roots. Appropriately located piers or pads and or cantilevered structures will be suitable.

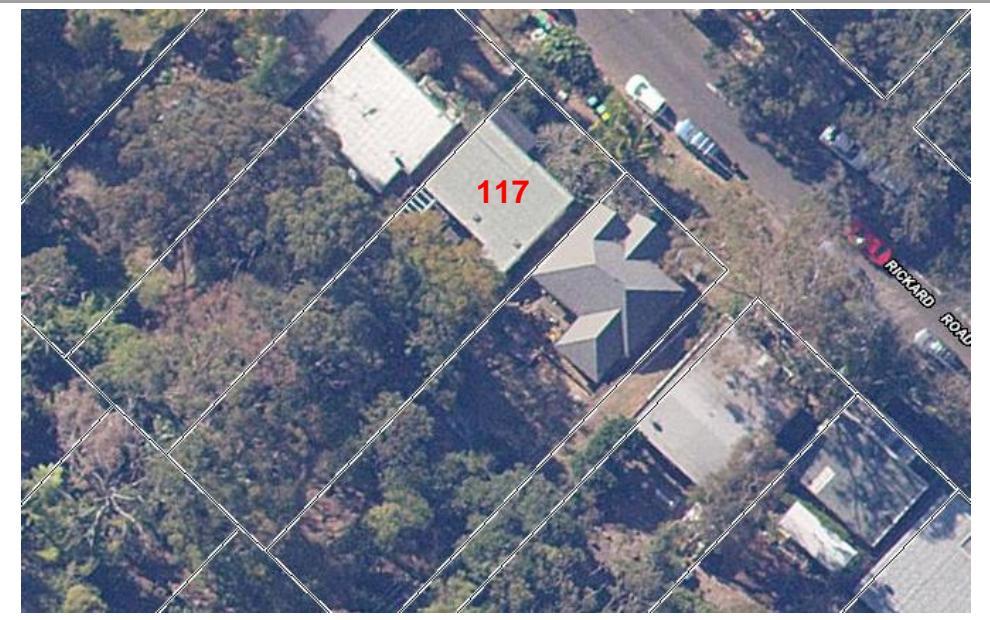
Image 3 – Showing the substantial canopy cover the site supports to the rear of the dwelling.

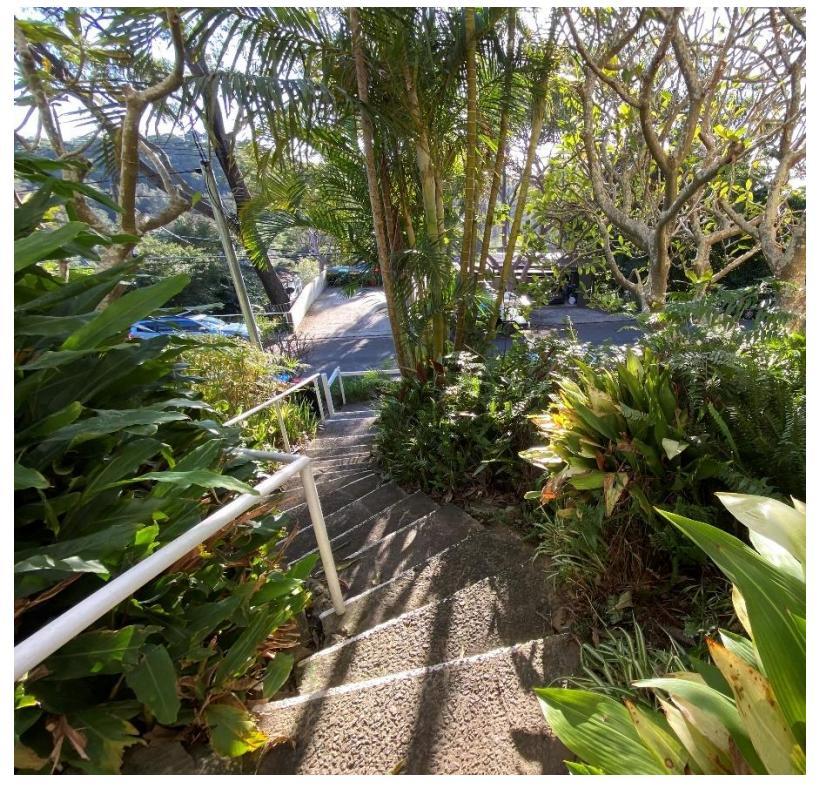
Image 4 – Tree 2

Tree 2 can be viably retained in conjunction with the proposed development. The existing concrete stairs within the nominated TPZ are to be retained.

The excavation required for a pier at point A as indicated in Image 6 is approx. 2.3 metres from the outer edge of the clump of palms and at point B is approx. 3.5 m.

The proposed works will have little, if any, impact on Tree 2.

Tree protection fencing should be erected as indicated in Appendix 2 and clause 8.2. Works must be undertaken as recommended in section 8.

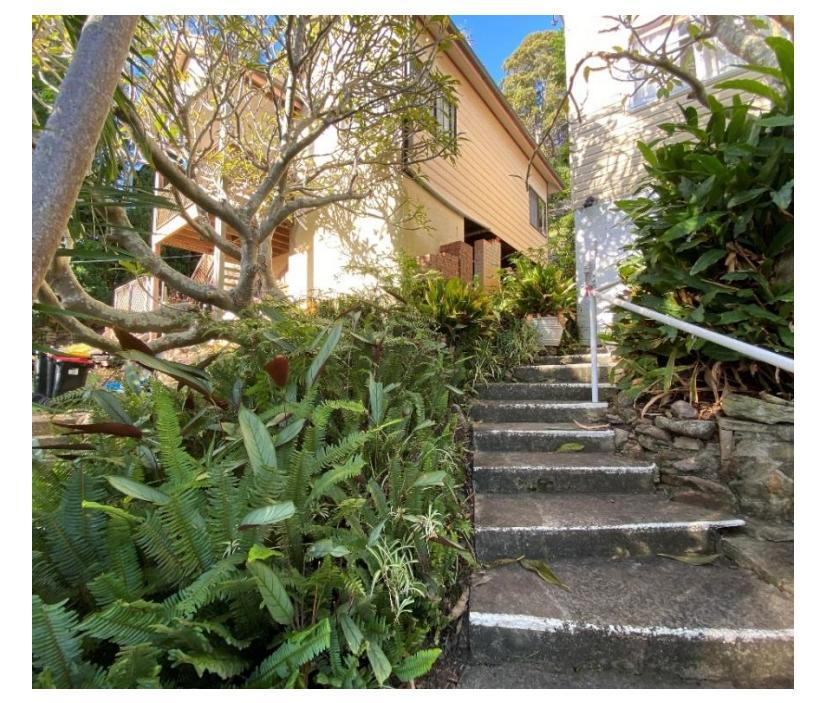
Image 5 – Tree 3

Tree 3 can be viably retained in conjunction with the proposed development. Some of the existing concrete stairs within the estimated SRZ are to be retained and it is considered highly unlikely that there will be roots from this tree where any excavation may be required for piers (marked A and B) to support the landing/steps as shown in Image 6. Should roots that cannot be severed be encountered, the location of supporting piers/pads can be adjusted accordingly or an alternative solution such as a cantilever can be used.

The proposed works will have little, if any, impact on Tree 3 provided any excavation within the TPZ is limited to small, isolated areas and/or for isolated piers/pads if tree roots are encountered during excavation.

Tree protection fencing should be erected as indicated in Appendix 2 and clause 8.2. Works must be undertaken as recommended in section 8.

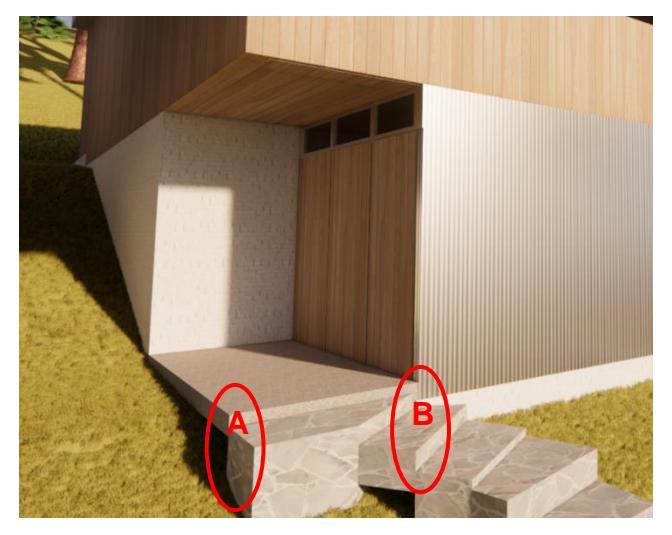
Image 6 – Excavation can be limited to isolated piers/pads to avoid roots from Tree 3 if encountered.

Excavation for the footings of the approved structure within the TPZ of Tree 2 and 3 must be undertaken under the supervision of the Project Arborist. The excavation must be undertaken carefully using tree sensitive techniques such as handheld implements, air pressure (Airspade/Airknife ®) or water pressure avoiding damage to tree roots that are not approved for removal.

Piling, piers, pads and footings to be designed and located accordingly.

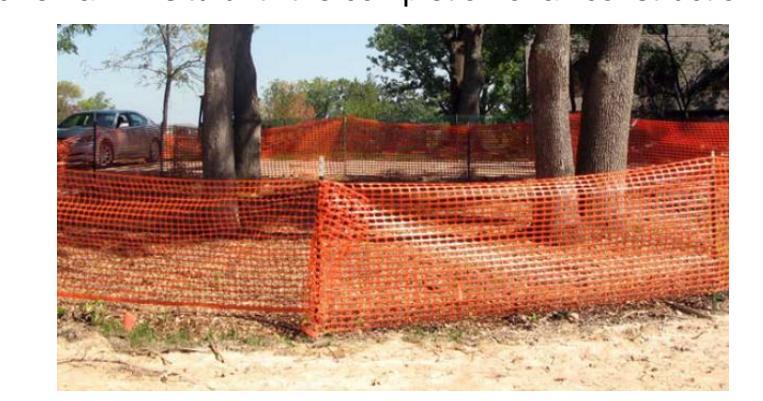
Image 7 - Example of fencing materials

The tree protection fencing shall be erected prior to any works (other than tree removal and pruning) commencing on the site. The fencing shall be installed in the location as shown by the blue lines on the plan in Appendix 2. Given the slope of the site the fencing can be constructed from star pickets and Parawebbing - refer to Image 7 below as an example. Alternately 1.8-metre-high steel frame panels with chain mesh infill fencing can be used. The fencing should remain in situ until the completion of all construction.

All tree protection fencing shall be prominently sign posted indicating that the area is not to be accessed. The sign shall include contact details for the builder/project manager and project arborist and can also include information about activities that are not allowed within the Tree Protection Area.
