Arboricultural Impact Assessment

197 McCarrs Creek Road, Church Point

Version 1

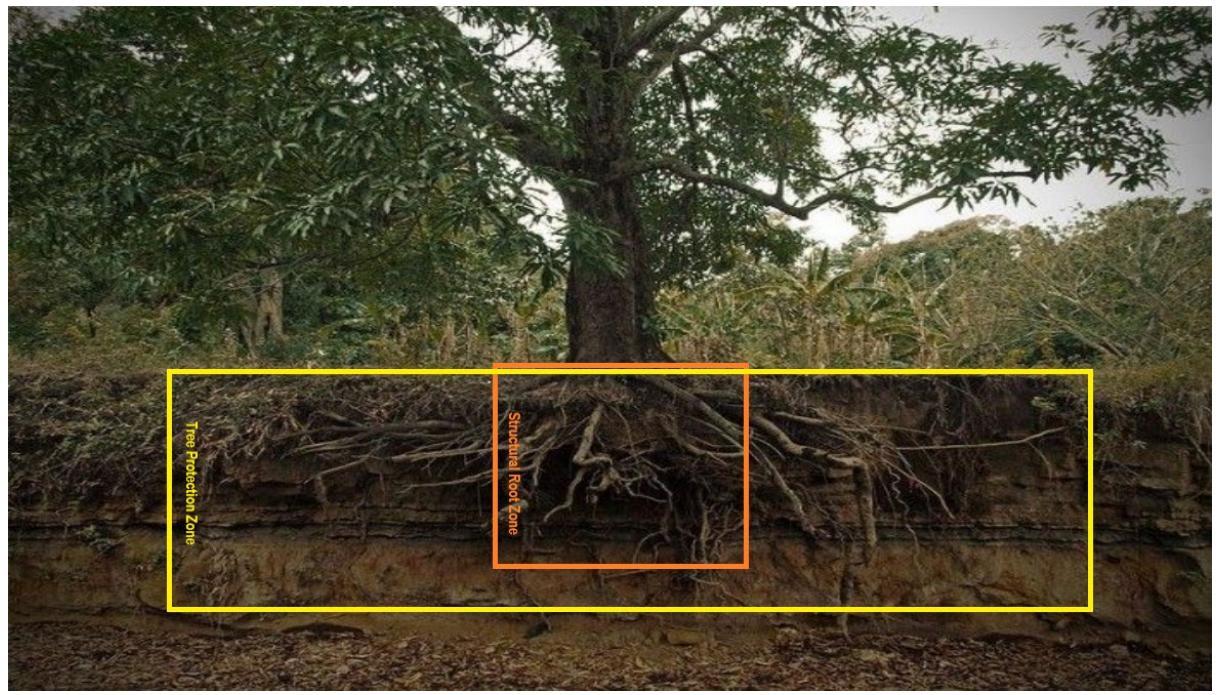
Figure 1: TPZ and SRZ cross section

The Structural Root Zone (SRZ) represents the minimum area required to maintain tree stability without consideration to the ongoing health of the tree. Severing roots within the SRZ that are >50mm is not recommended as it may lead to the decline or structural failure of the tree/s

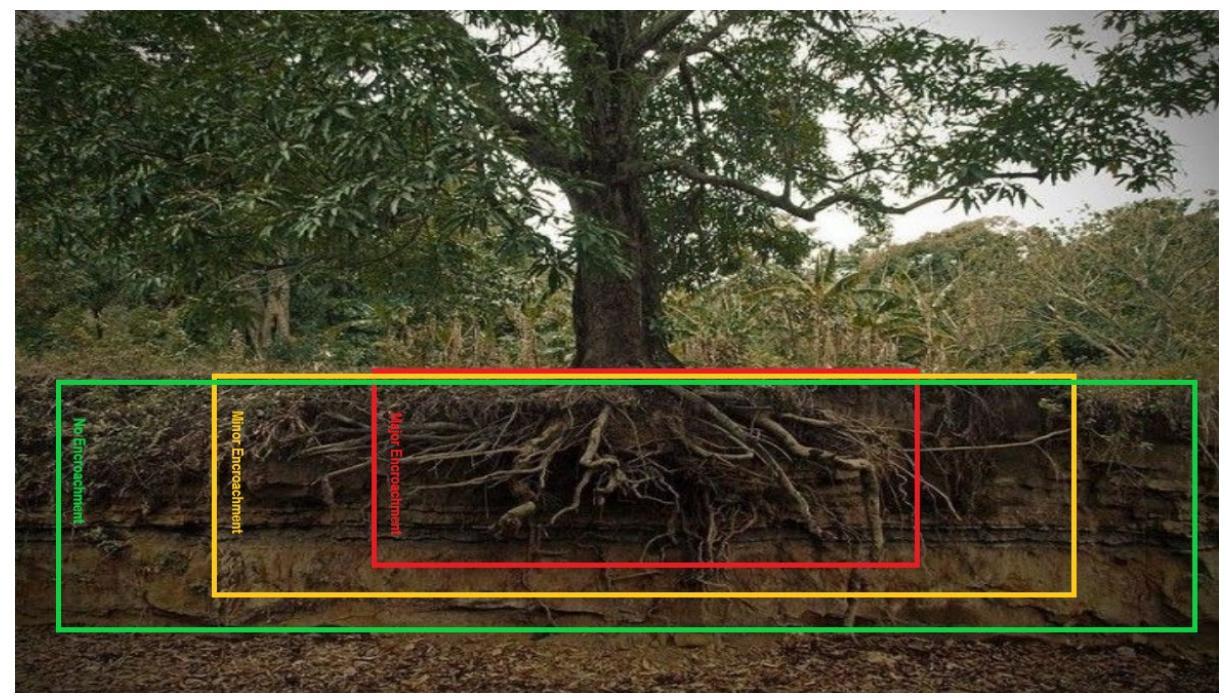
Figure 2: Encroachment zones

- No Encroachment: No likely foreseeable encroachment within the TPZ,
- Minor Encroachment (<10%): If the proposed encroachment within the TPZ is less than 10% and there is no encroachment into the SRZ then detailed root investigations should not be required. The area that has been encroached upon should be compensated for elsewhere and be contiguous with the TPZ,
- Major Encroachment (>10%): The project arborist must be able to demonstrate that the subject tree/s remain viable if the encroachment is greater than 10%. The area that has been encroached upon should be compensated for elsewhere and be contiguous with the TPZ,

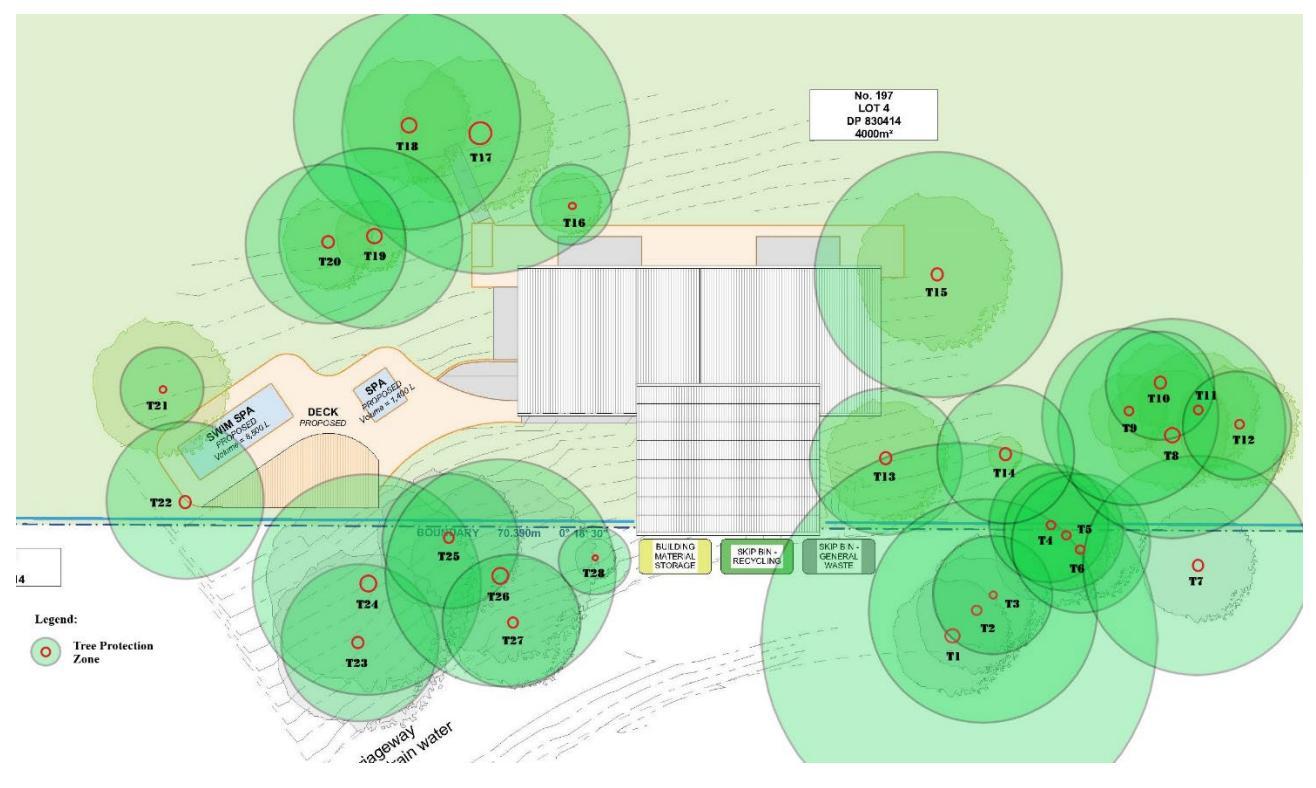
Figure 3: TPZ Plan

Tree locations associated with the numbers above can be found in *Figure 3*. These trees will be the focus of this report.

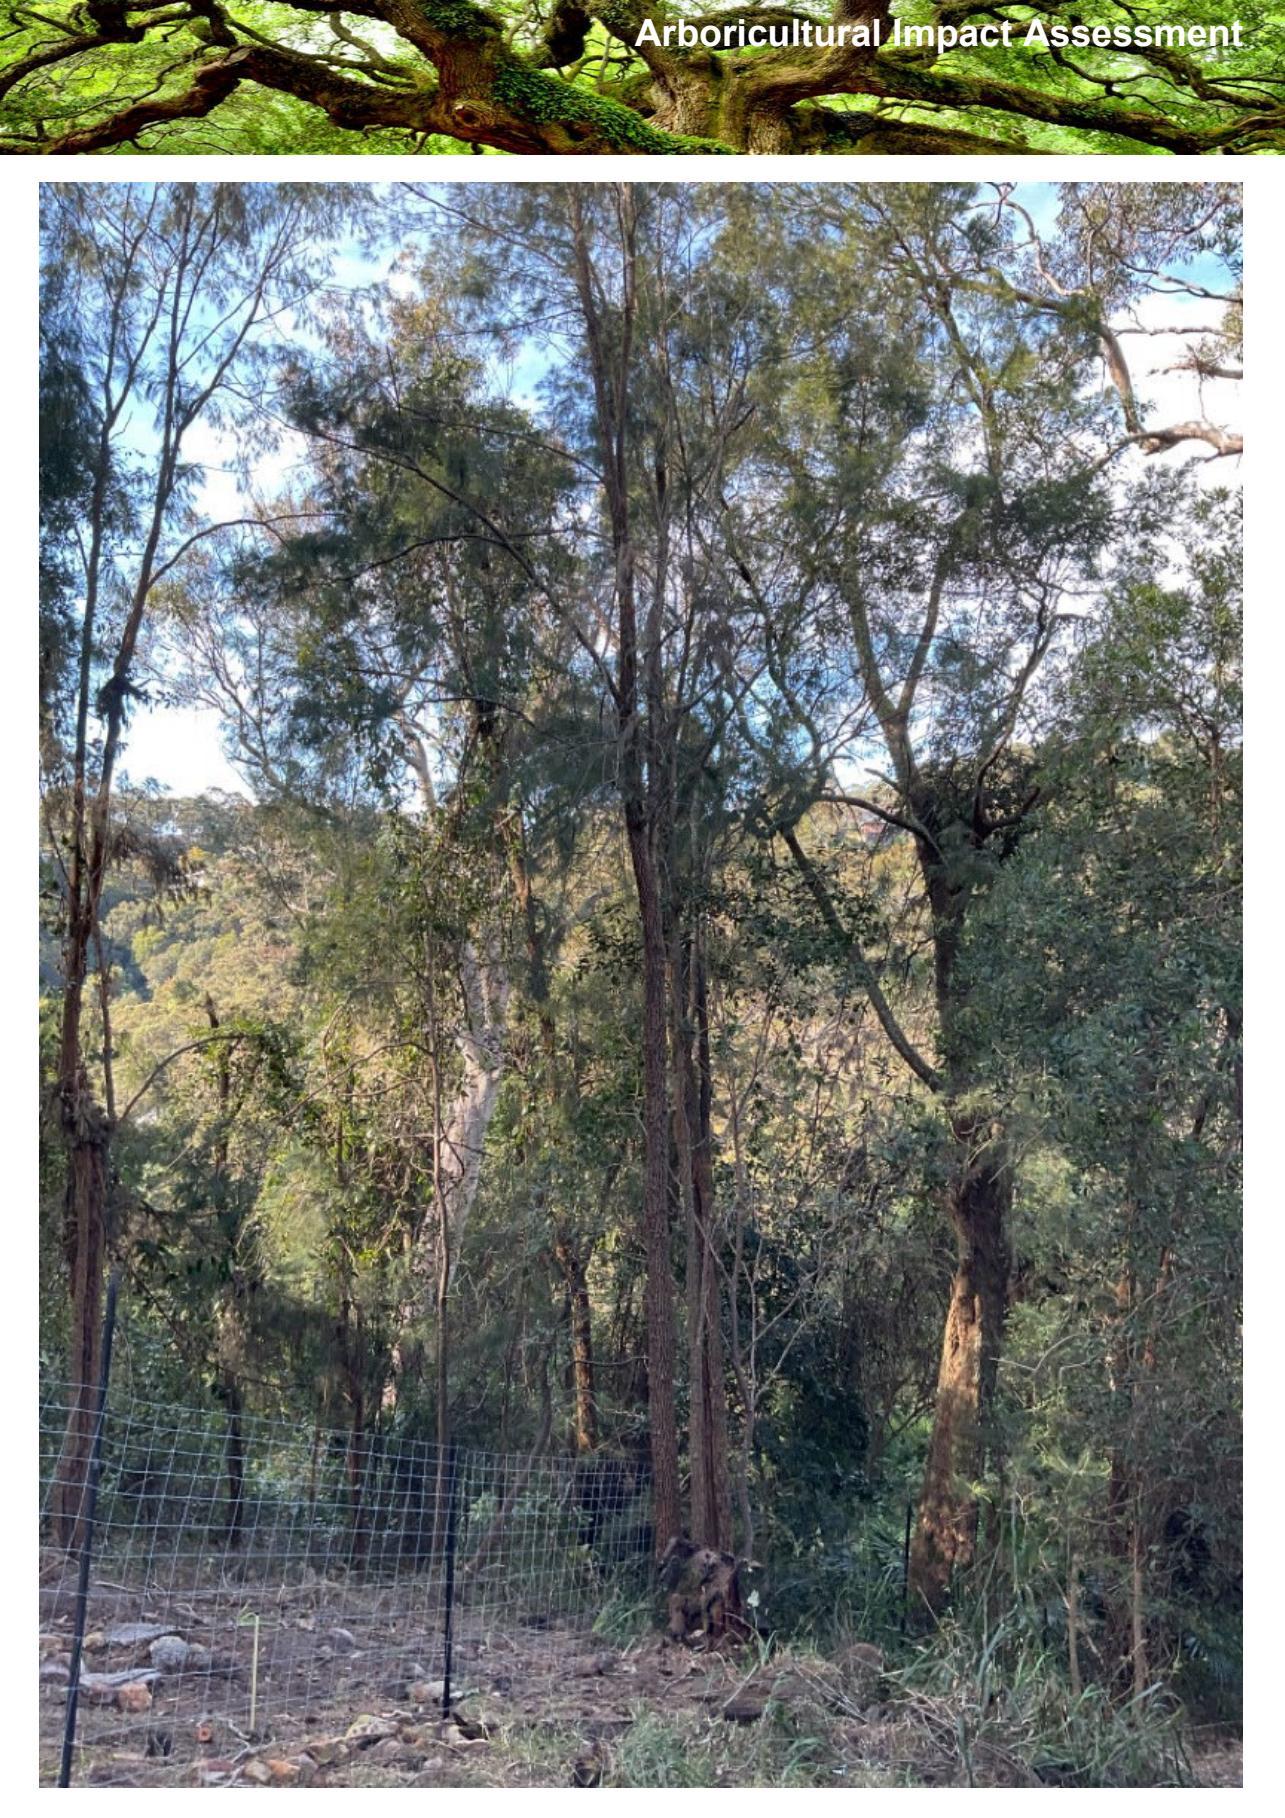
Figure 6: Tree 21

- Tree 15 will have a minor encroachment of 8%% of the TPZ due to the proposed deck along the southern side of the building.
- Tree 21 will have minor encroachment of 4% to the TPZ due to the proposed deck.
- Tree 24 will have major encroachment of 7% to the TPZ due to the proposed deck.

- Tree 11 is dead and is unworthy of retention.
- Tree 22 is within the proposed building footprint and cannot be retained if the proposed development is to proceed.
- Tree 21 has poor structure and a low retention rating. It is unworthy of retention.

- Tree 11 is dead and is unworthy of retention.
- Tree 22 is within the proposed building footprint and cannot be retained if the proposed development is to proceed.
- Tree 21 has poor structure and a low retention rating. It is unworthy of retention.
