J3518. 24<sup>th</sup> June, 2021. Page 1.

## **PRELIMINARY ASSESSMENT:** Acid Sulfate For Proposed Works at **3 Lido Avenue, North Narrabeen**

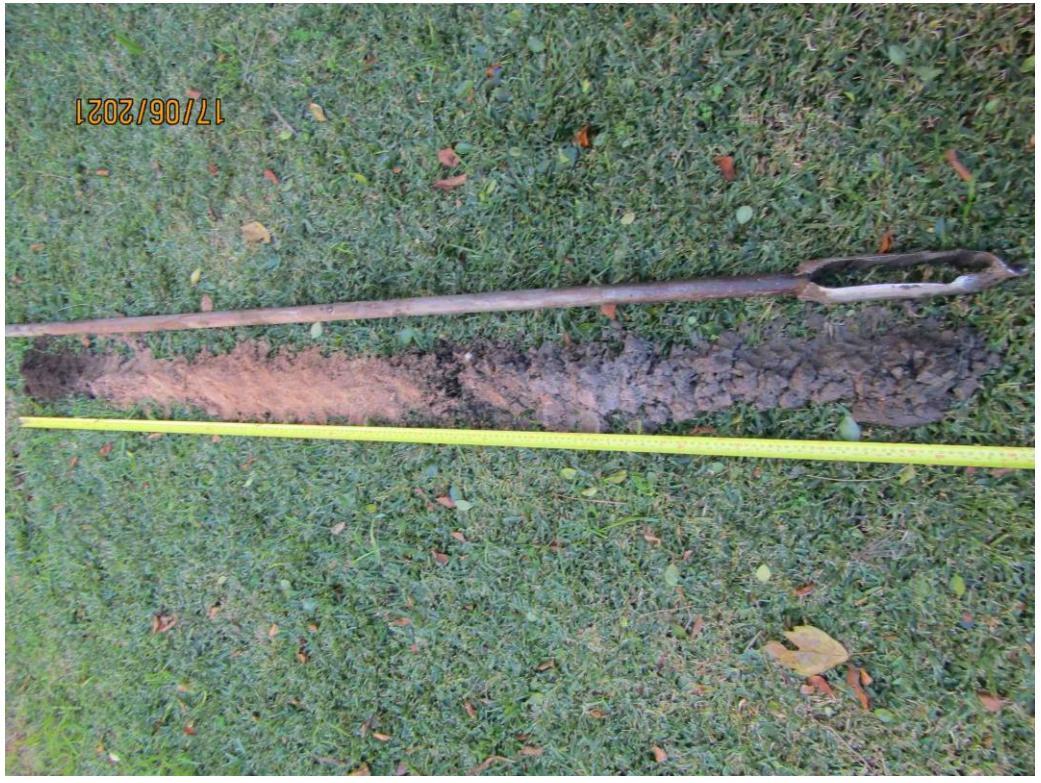
Photo 1: AH1 – Downhole is from left to right.

Depth (m)	Material Encountered
0.0 to 0.3	<b>TOPSOIL</b> , sandy soil, dark brown, moist, fine to medium grained with fine trace organic matter
0.3 to 1.1	SAND, with shell fragments, light brown/yellow, moist, fine to medium
1.1 to 1.2	grained. SANDY PEAT, with shell fragments, black, damp.
1.2 to 1.9	<b>SAND</b> , with shell fragments, grey, wet to very wet, fine to medium grained.

End of Hole @ 1.9m. Watertable encountered at ~1.4m.

TEST: AH1	FIELD pH & PEROXIDE RESULTS				
Sample depth (m)	pH⊧	30% Peroxide reaction	рН <sub>ғох</sub>	pH <sub>F</sub> - pH <sub>FOX</sub>	SS=Shell J=Jarosite R=Roots
0.2	7.6	L	7.2	0.4	-
0.5	8.0	М	7.7	0.3	SS
0.9	8.3	М	8.0	0.3	SS
1.2	8.0	L	7.8	0.2	SS
1.9	7.5	L	7.5	0.0	SS

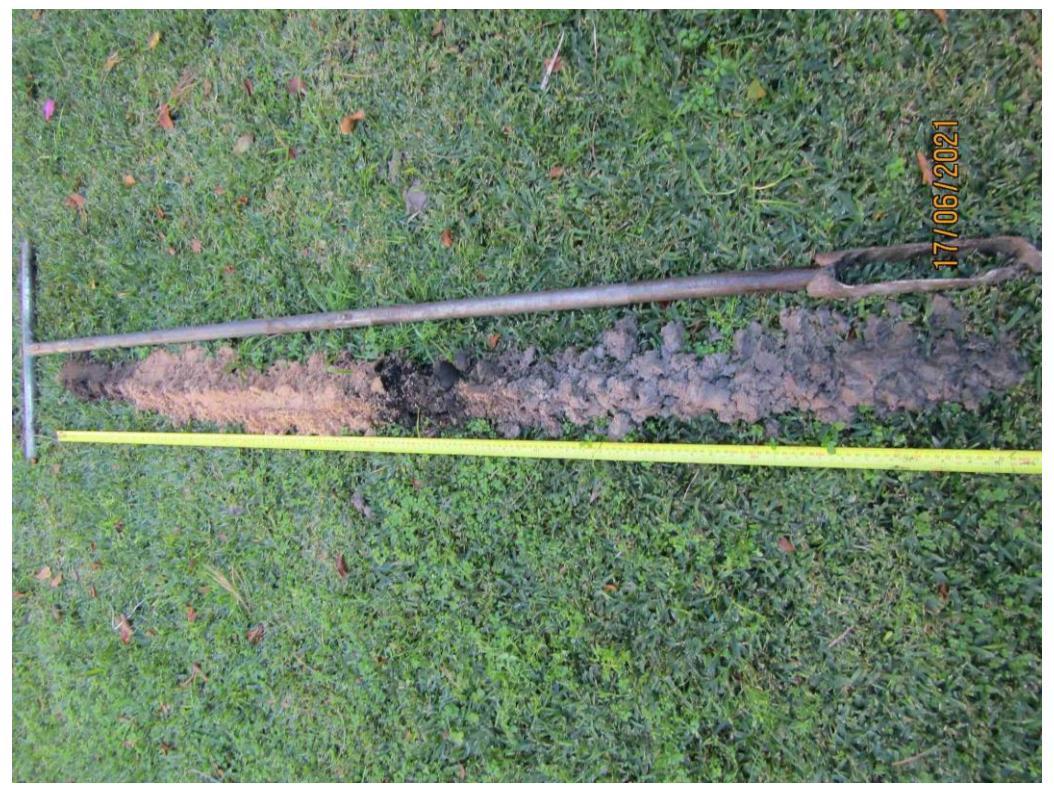
Photo 2: AH2 – Downhole is from left to right.

- 0.0 to 0.3 **TOPSOIL**, sandy soil, dark brown, moist, fine to medium grained with fine trace organic matter.
- 0.3 to 0.9 **SAND**, with shell fragments, light brown/yellow, moist, fine to medium grained.
- 0.9 to 1.1 **SANDY PEAT**, with shell fragments, black, damp.
- 1.1 to 1.8 **SAND**, with shell fragments, grey, wet to very wet, fine to medium grained.

End of Hole @ 1.8m. Watertable encountered at ~1.4m.

TEST: AH2	FIELD pH & PEROXIDE RESULTS				
Sample depth (m)	pH⊧	30% Peroxide reaction	рН <sub>ғох</sub>	pH <sub>F</sub> - pH <sub>FOX</sub>	SS=Shell J=Jarosite R=Roots
0.2	7.7	L	7.6	0.1	-
0.5	8.1	М	8.0	0.1	SS
0.8	8.2	L	8.1	0.1	SS
1.1	7.6	L	7.4	0.2	SS
1.8	7.4	L	7.4	0.0	SS

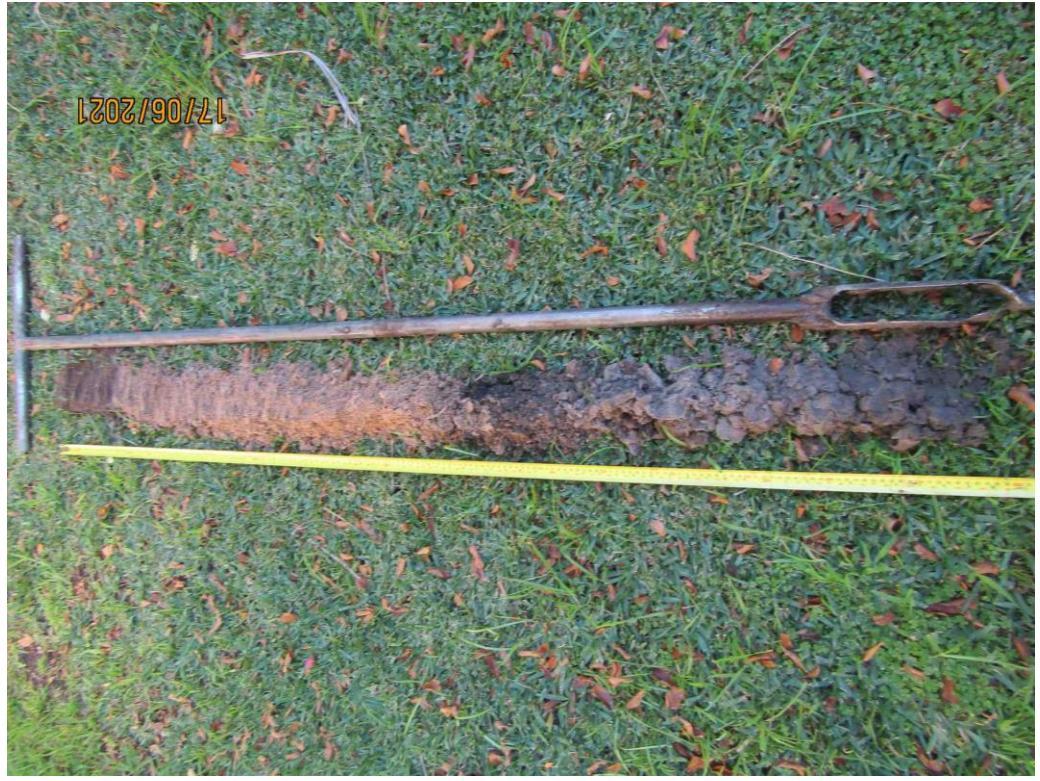
Photo 3: AH3 – Downhole is from left to right.

Depth (m)	Material Encountered
0.0 to 0.2	<b>TOPSOIL</b> , sandy soil, dark brown, moist, fine to medium grained with fine trace organic matter.
0.2 to 1.0	<b>SAND</b> , with shell fragments, light brown/yellow, moist, fine to medium grained.
1.0 to 1.2	SANDY PEAT, with shell fragments, black, damp.
1.2 to 1.8	SAND, with shell fragments, grey, wet to very wet, fine to medium grained.

End of Hole @ 1.8m. Watertable encountered at ~1.4m.

TEST: AH3	FIELD pH & PEROXIDE RESULTS				
Sample depth (m)	pH⊧	30% Peroxide reaction	рН <sub>ғох</sub>	pH <sub>F</sub> pH <sub>FOX</sub>	SS=Shell J=Jarosite R=Roots
0.2	7.5	L	7.4	0.1	-
0.5	7.9	L	7.8	0.1	SS
0.8	8.3	М	8.1	0.2	SS
1.2	7.6	L	7.5	0.1	SS
1.8	7.4	L	7.4	0.0	SS

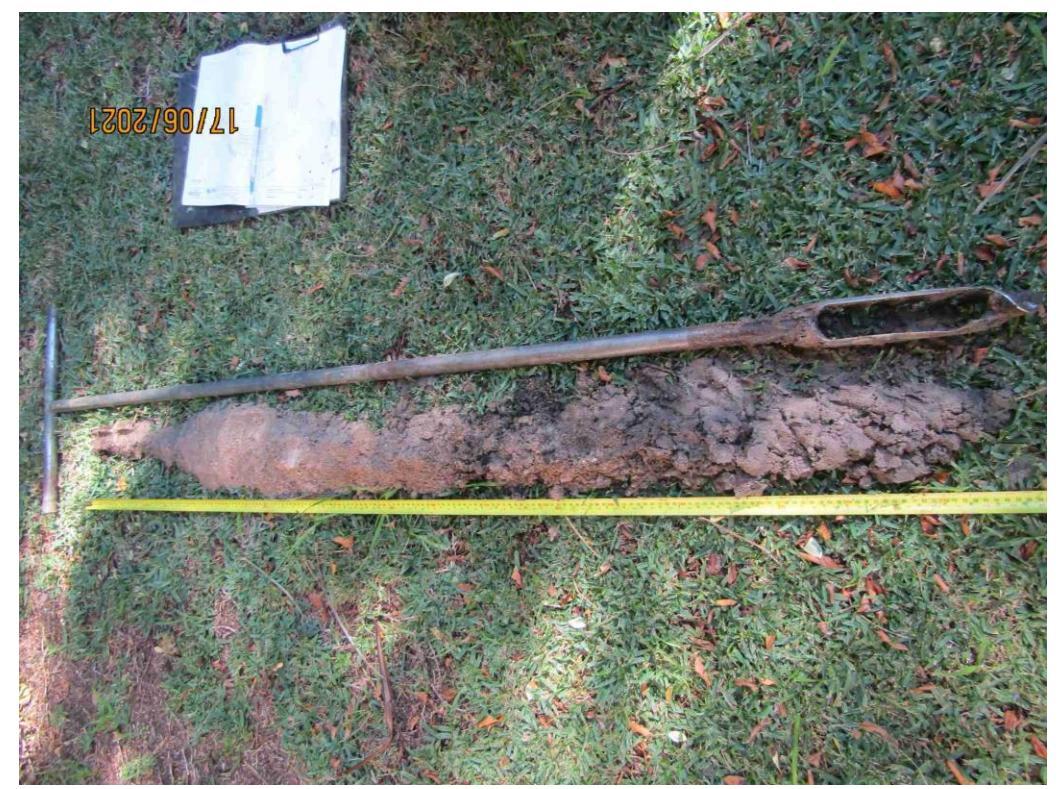
Photo 4: AH4 – Downhole is from left to right.

Depth (m)	Material Encountered
0.0 to 0.1	<b>TOPSOIL</b> , sandy soil, dark brown, moist, fine to medium grained with fine trace organic matter.
0.1 to 0.4	SILTY SAND, with shell fragments, brown/grey, moist, fine to medium grained.
0.4 to 1.0	SAND, with shell fragments, light brown/yellow, moist fine to medium grained.
1.0 to 1.2	SANDY PEAT, with shell fragments, black, damp.
1.2 to 1.8	SAND, with shell fragments, grey, wet to very wet, fine to medium grained.

**TEST: AH4** FIELD pH & PEROXIDE RESULTS Sample depth 30% Peroxide pH<sub>F</sub> SS=Shell **pH**<sub>FOX</sub> pH<sub>F</sub> - pH<sub>FOX</sub> (m) reaction J=Jarosite R=Roots 0.1 7.4 Μ 7.4 0.0 -7.7 7.7 0.0 SS 0.4 L SS 0.8 8.1 Μ 8.0 0.1 1.2 7.6 L 7.5 0.1 SS 1.8 7.4 L 7.4 0.0 SS

End of Hole @ 1.8m. Watertable encountered at ~1.4m.
