Arboricultural Impact Assessment

Alterations & Additions at

981 Barrenjoey Road, Palm Beach

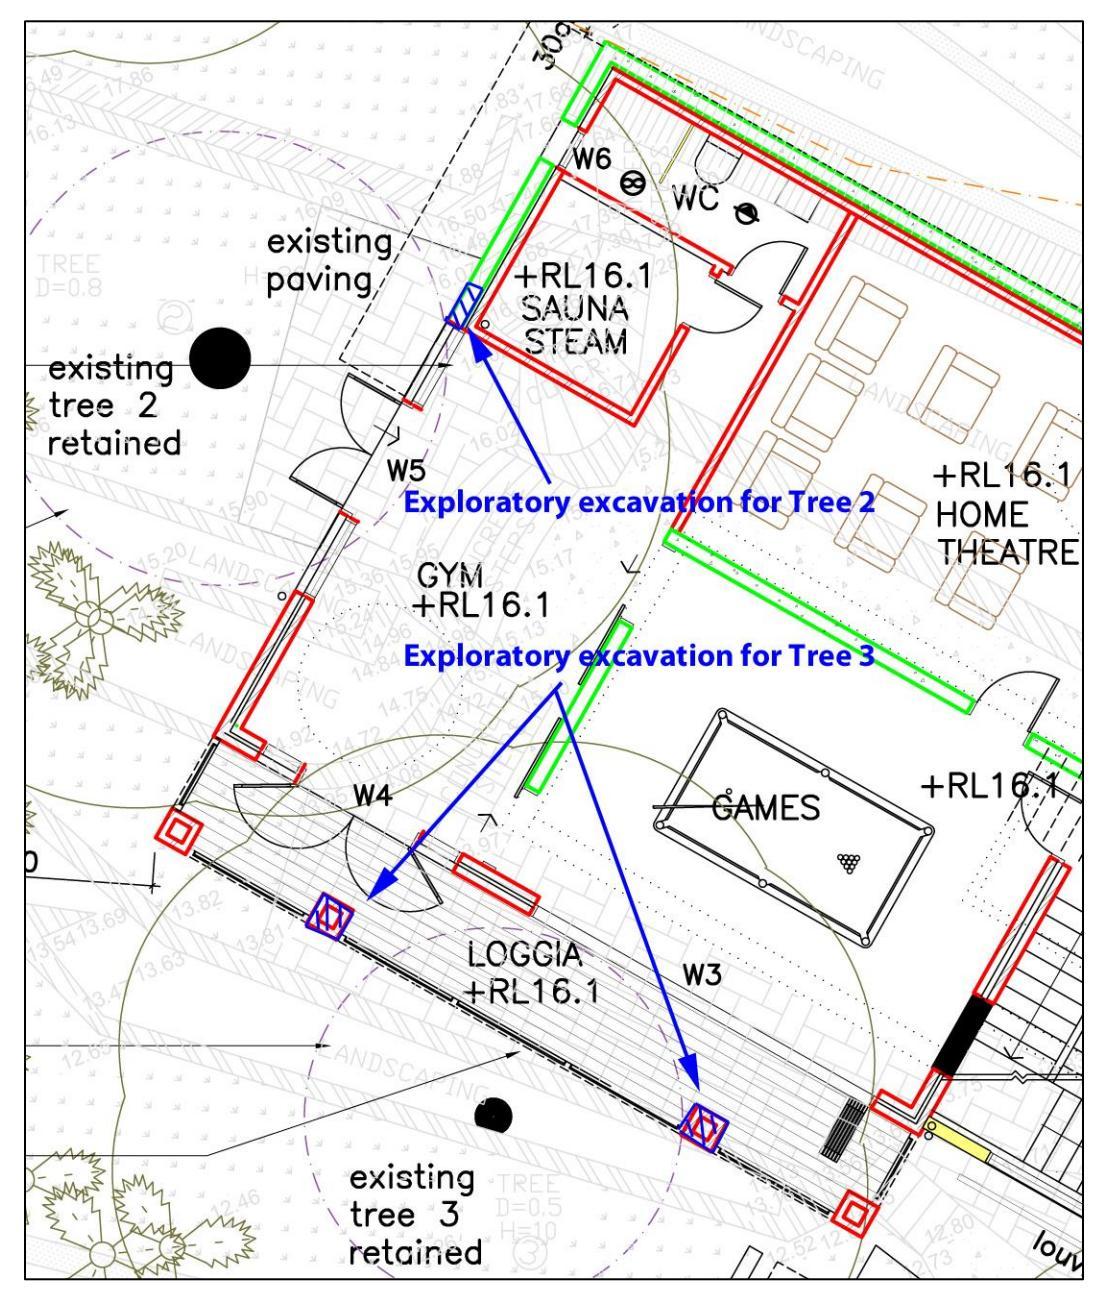
Figure A: Excerpt from the Ground Floor Plan showing locations where exploratory excavation was undertaken.

Exploratory excavation was undertaken in the areas where building footings are proposed close to the perimeters of the Structural Root Zones of Trees 2 and 3 (Figure A below). The purpose of this was to determine the extent of root damage likely to occur during excavation.

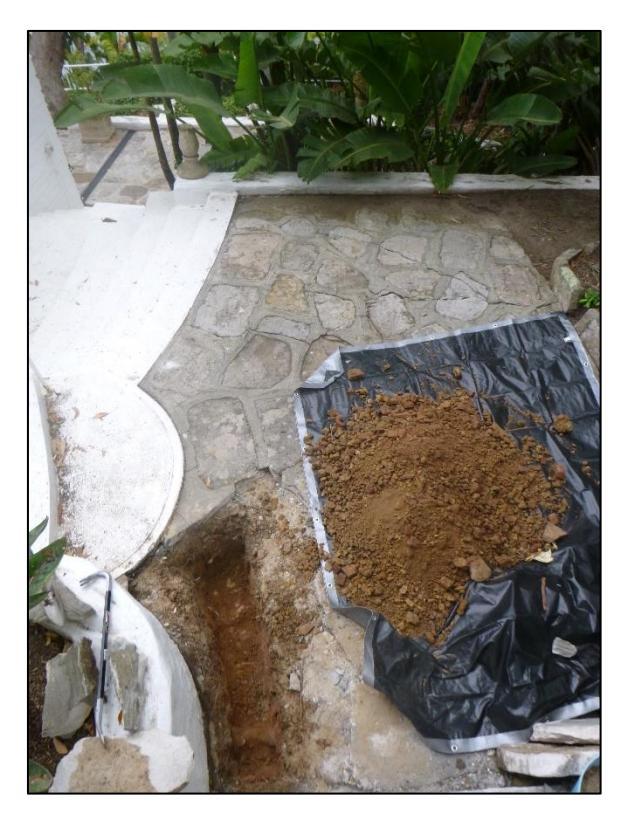
Photo A: Location of exploratory excavation near Tree 2.

Exploratory excavation was undertaken near Tree 2 in the location outlined in Figure A and Photo A, Section 4.3. This was undertaken to a depth of 500mm which was sufficient to expose the underlying claystone and shale bedrock. One (1) x 80mm diameter root was exposed at a depth of 400mm in the location of the proposed sauna/steam room footing. This root was located outside of the Structural Root Zone at a distance of 4.0m from the centre of trunk. This root is not considered to critical for inground structural support. Pruning of this root is unlikely to compromise the stability of Tree 2.

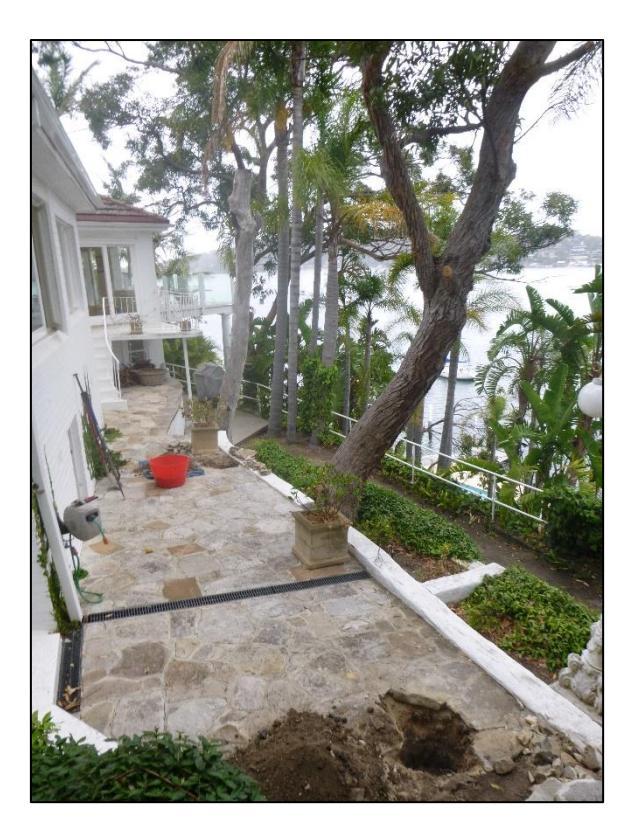
Photo B: Location of exploratory excavation near Tree 3.

Exploratory excavation was undertaken near Tree 3 in the locations outlined in Figure A and Photo B, Section 4.3. This was undertaken to a depth of 600mm which was sufficient to expose the underlying sandstone bedrock. No tree roots were found in the locations of exploratory excavation.

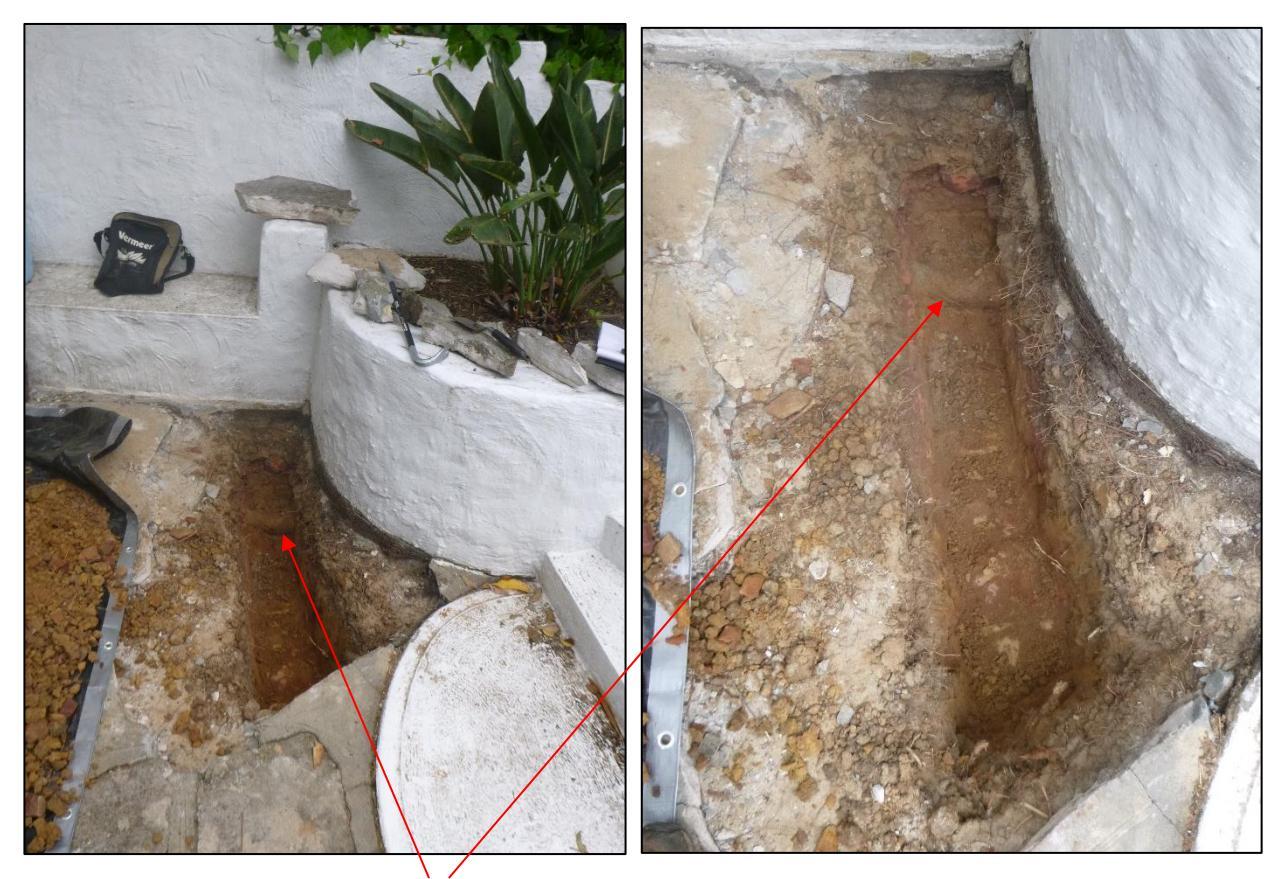
Photos B and C: 80mm diameter root located in the location of proposed footings, 4.0m from Tree 2.

Excavation for building footings (Trees 2 and 3): All excavation within the TPZ's of Trees 2 and 3 must be undertaken using hand tools within the top 600mm of soil or to the depth of bedrock. All tree roots encountered must be cleanly cut using a hand saw or secateurs. The purpose of this is to avoid additional unnecessary root damage such (tearing/splintering) that typically occurs when roots are pruned using an excavator and to minimise the surface area of pruning wounds.

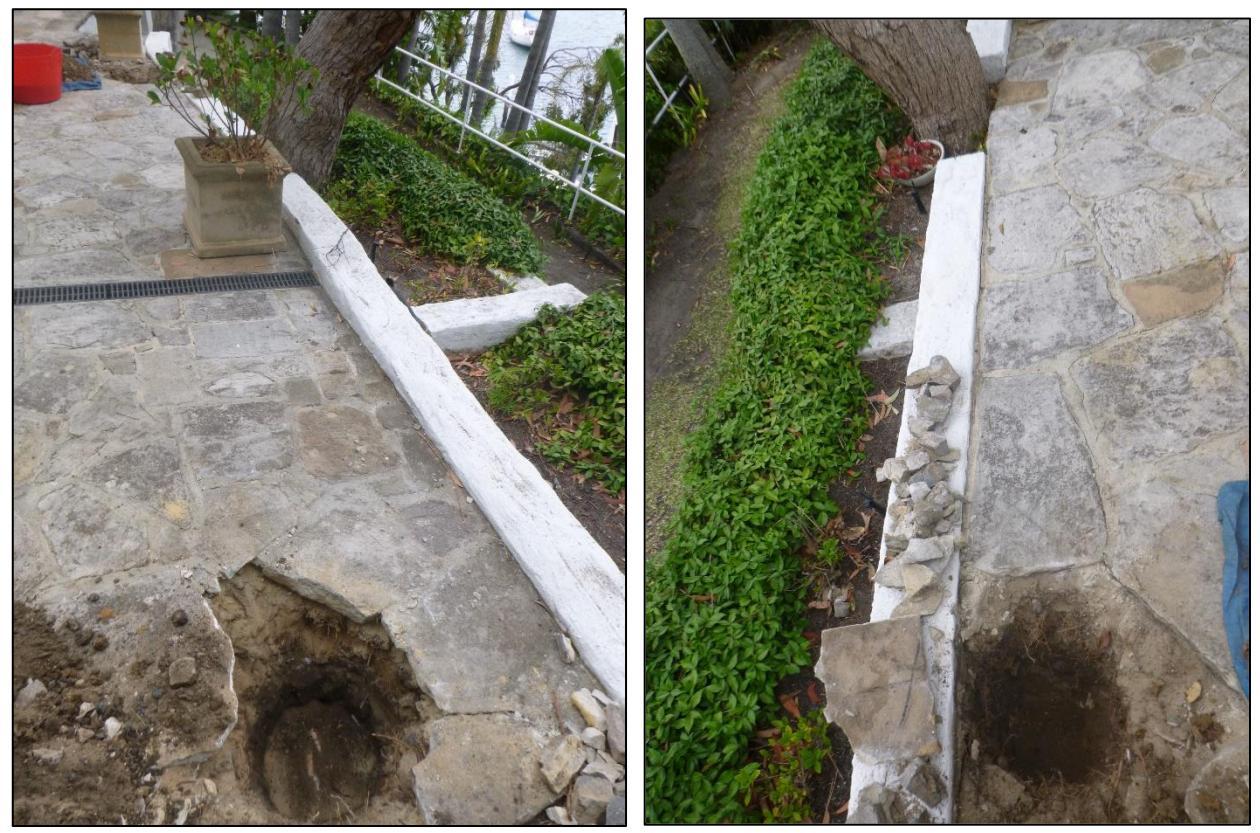
Photos D and E: Exploratory pits excavated within the location of column footings at the perimeter of the Structural Root Zone of Tree 3.

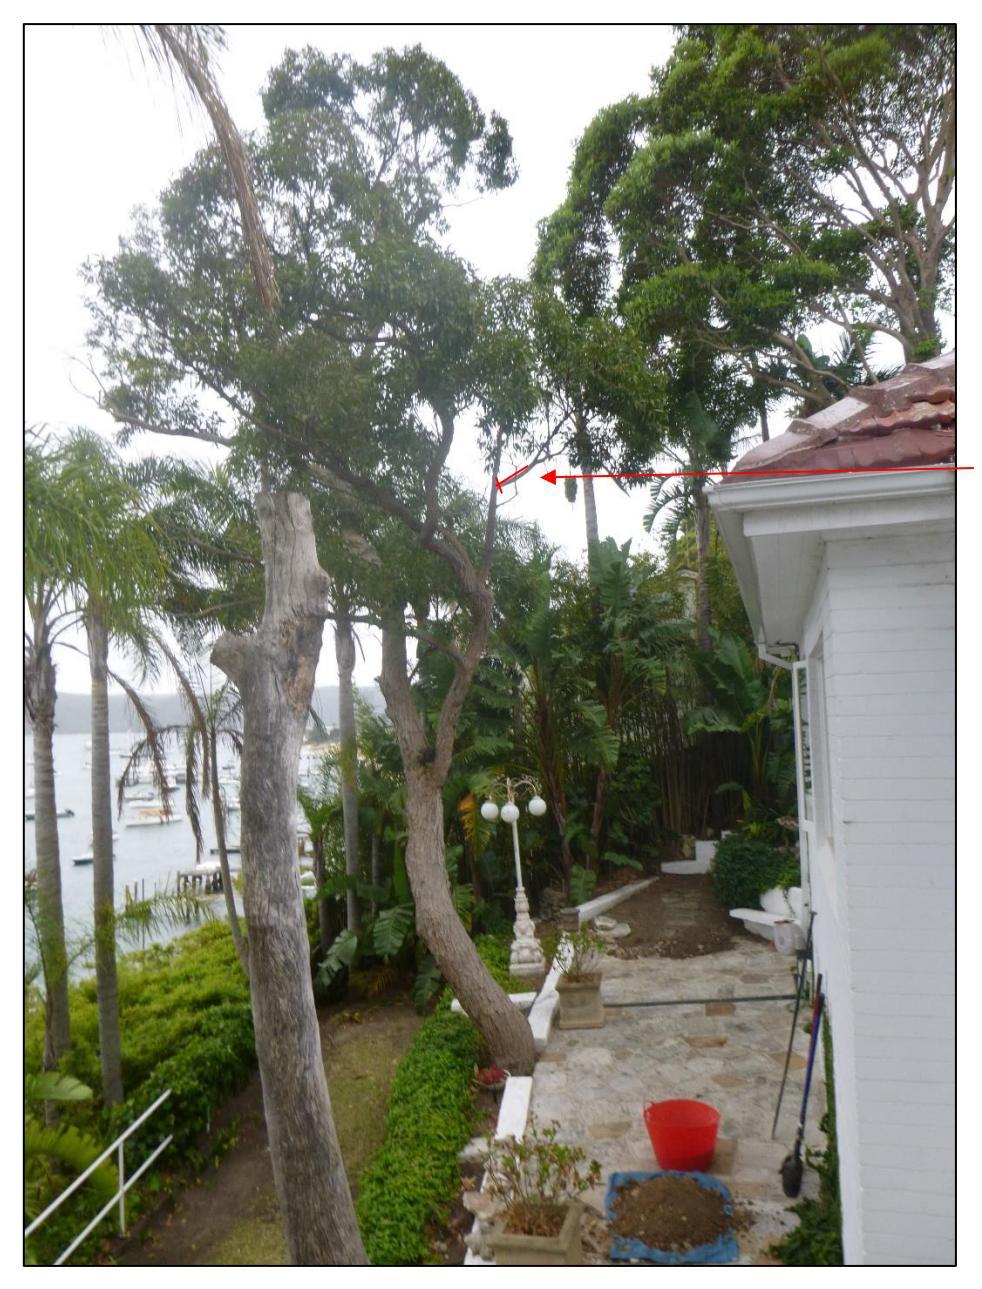
Photo F: 3rd order branch to be removed.

Canopy Pruning (Tree 3): A single 60mm diameter 3rd order branch is to be removed to allow construction (Photo F). Canopy pruning should be undertaken by an AQF Level 2 (minimum) Arborist in accordance with AS4373-2007-*Pruning of Amenity Trees,* Section 7.2.4 (Selective Pruning). No more than 5% of the canopy volume should be removed.

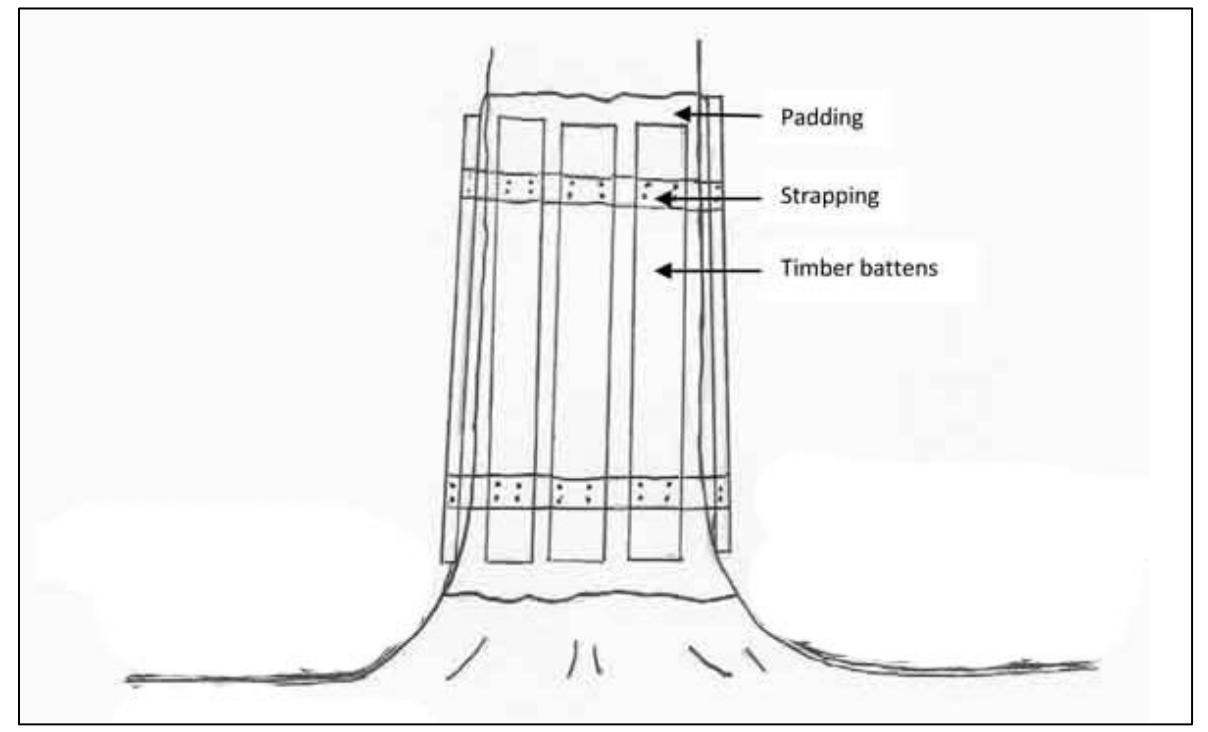
Trunk battening is aimed at preventing accidental bark wounds as often occurs on construction sites where heavy machinery is used.

Figure B: Specification of appropriate trunk protection.

<u>Trunk Protection</u>: (Trees 2, 3, 4, 5, 20, 22): Trunk protection is recommended for these trees as an alternative to fencing due to the sloping/terraced ground levels.

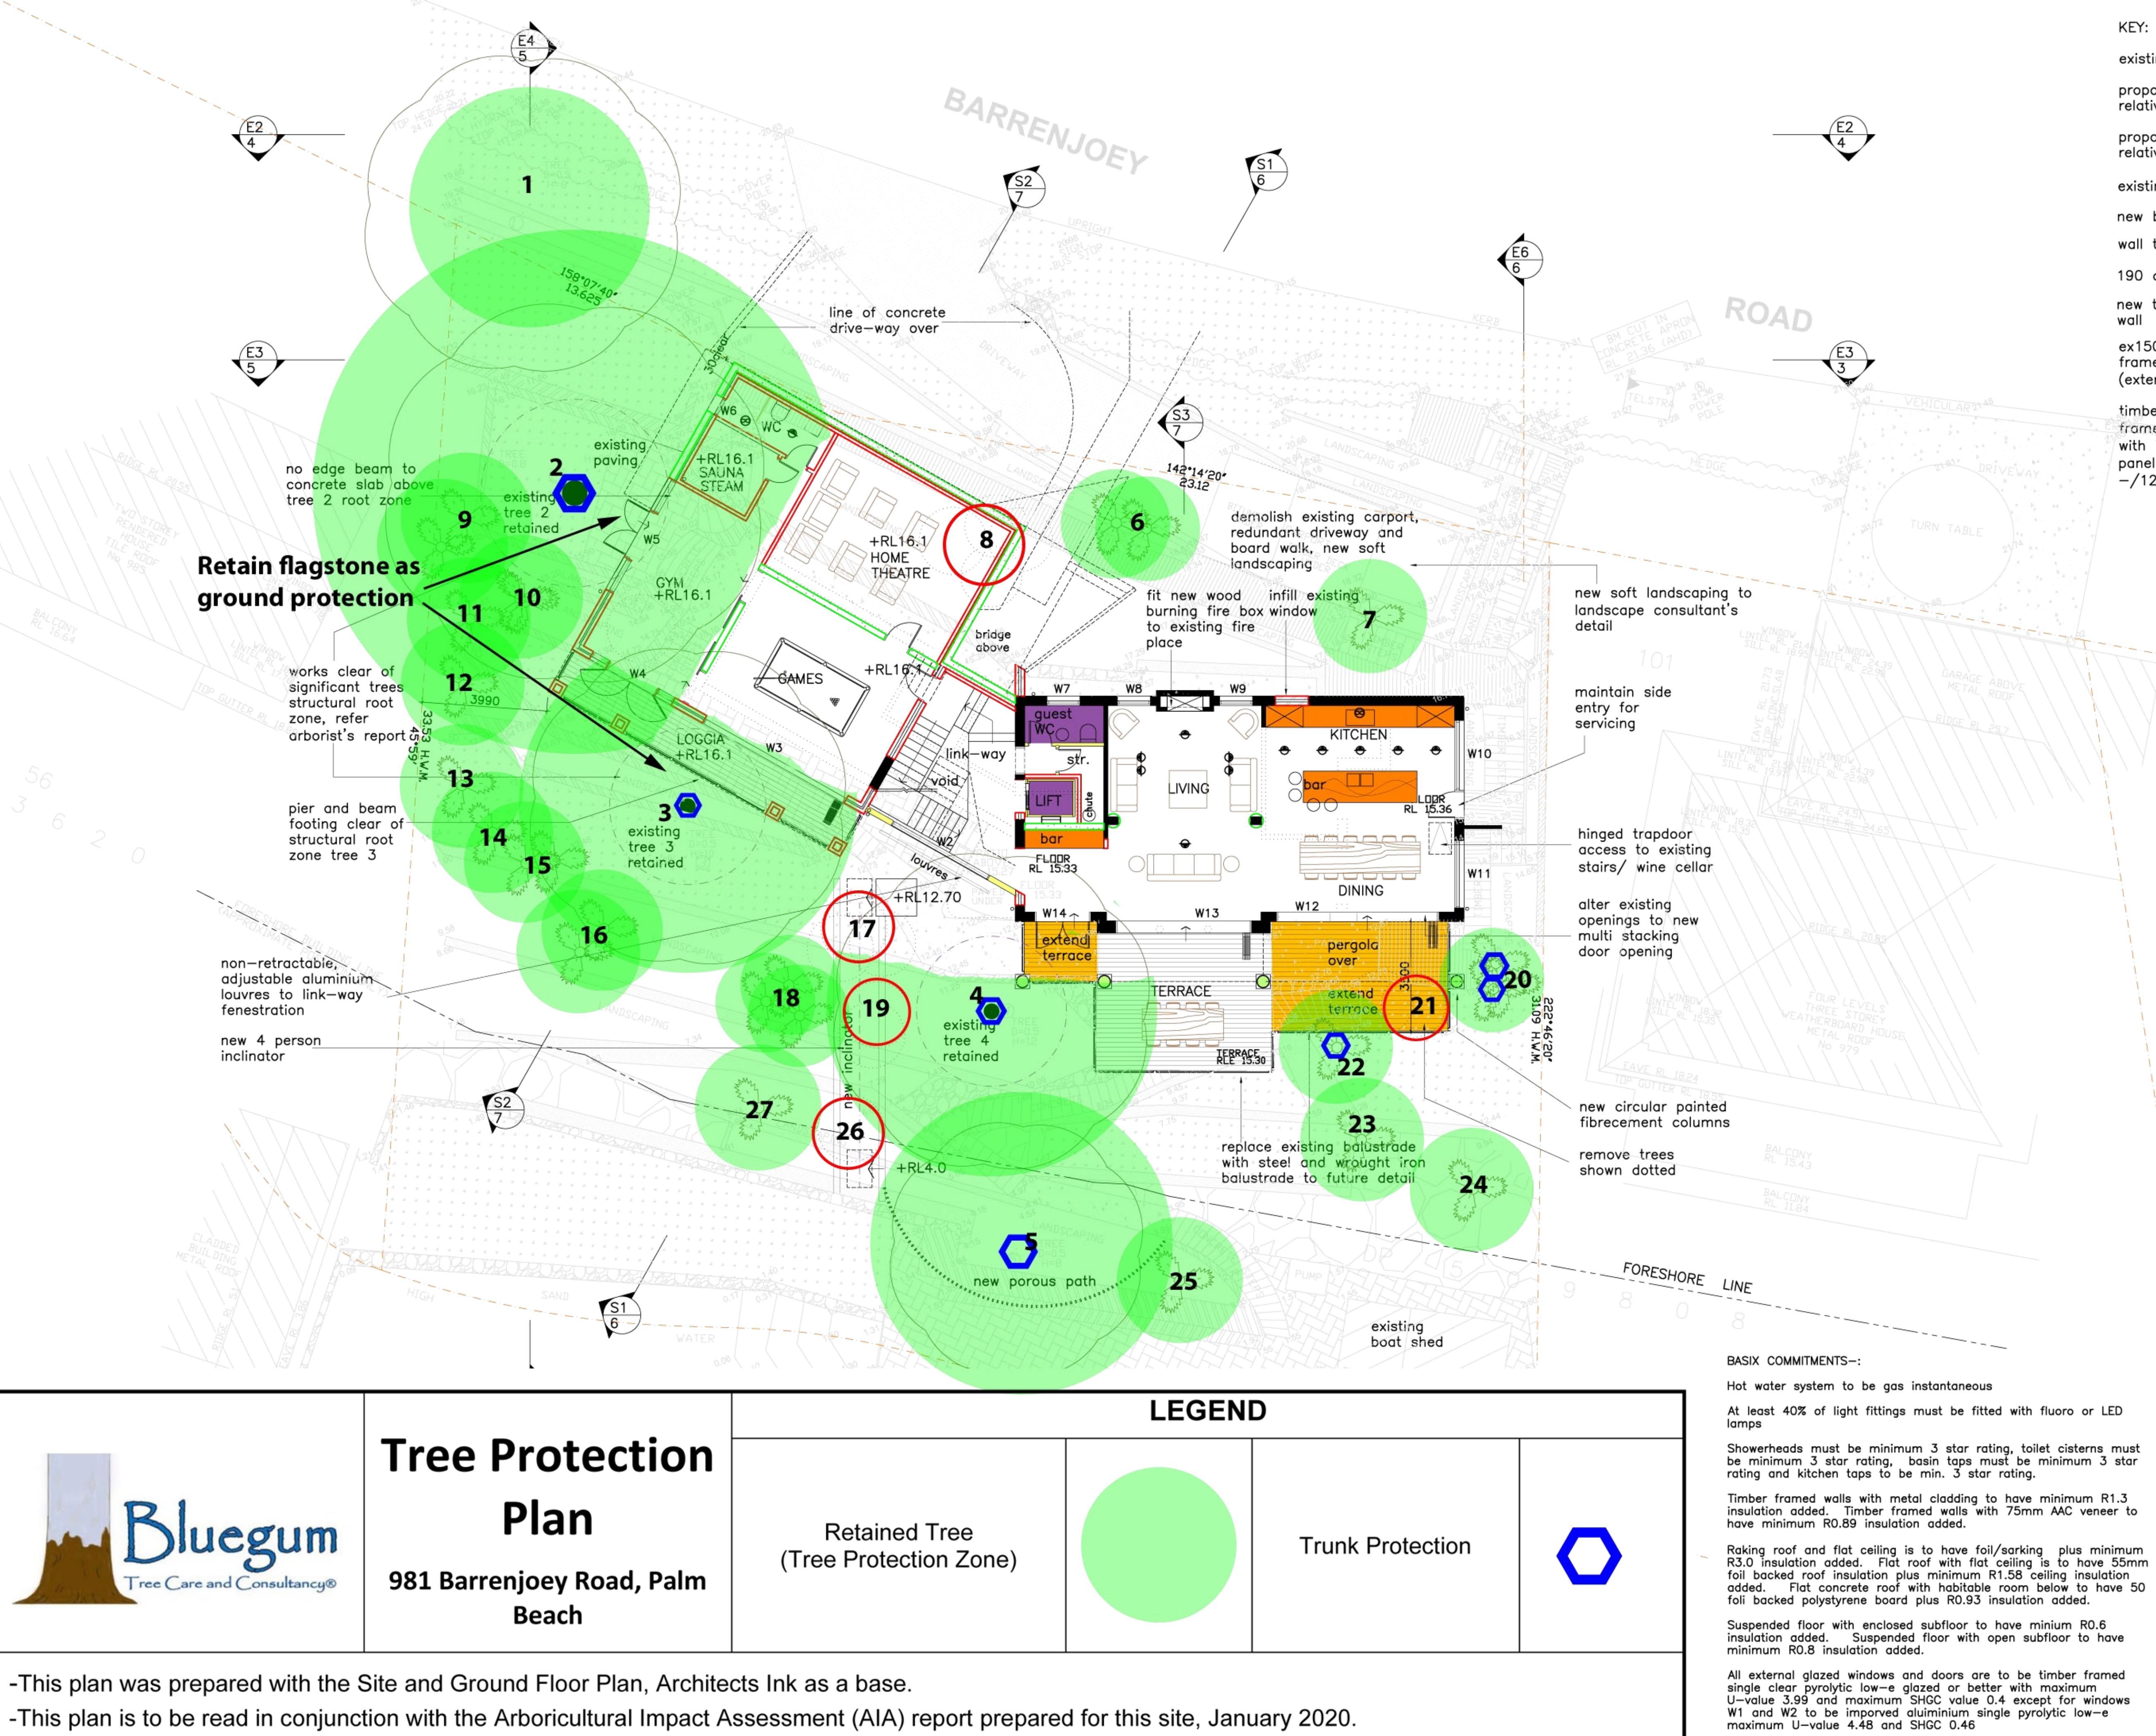
-Tree protection detail is indicative only. The extent and type of tree protection should be determined with co-ordination between the Site Foreman and Project Arborist to allow adequate site access during construction.
