REPORT TO WES MAAS

ON GEOTECHNICAL ASSESSMENT

FOR PROPOSED ALTERATIONS AND ADDITIONS

AT 44 BOWER STREET, MANLY, NSW

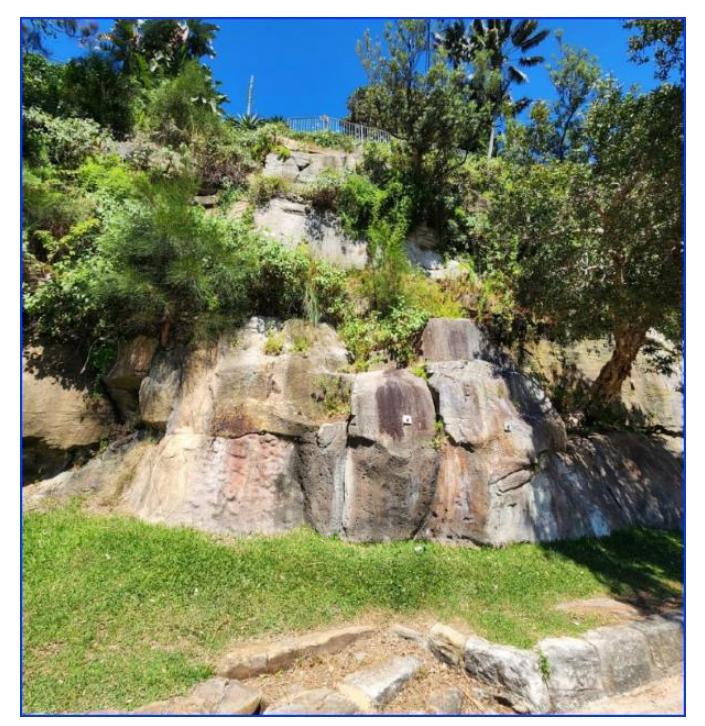
The site spans the stepping sandstone cliff lines from the seafront walkway (near Shelly Beach) to the start of gentle mid-slopes of the promontory which forms Sydney's North Head National Park.

No 44 Bower Street is a rectangular property 15m wide by 45m long with three distinct cliff lines over its northern (lower) half while the southern (upper) half is occupied by a large house with relatively flat surrounds. Surface reduced levels range from 27.7m at the southern street frontage to about RL6m at the northern property boundary, although the lower cliffs extend down to a narrow lawn beside the coastal walkway at about RL2m.

Photo 1- (looking south) View from coastal (Manly to Shelly Beach) walkway

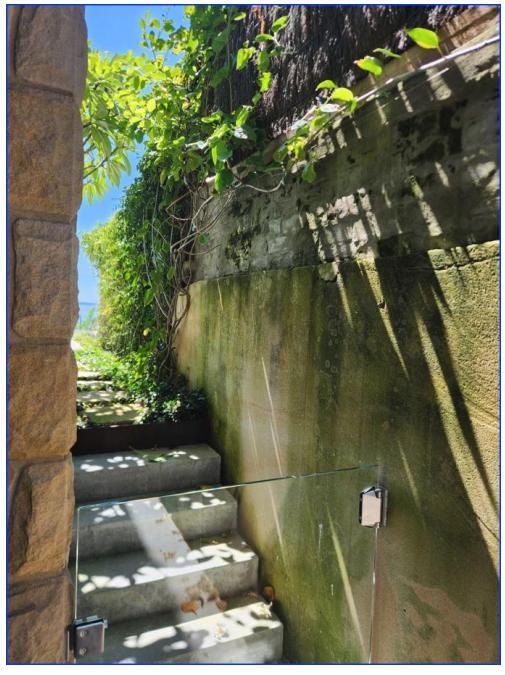
The basement has been cut into the hillside with a saw-cut finished sandstone rock face on the eastern boundary, as shown in Photos 2 and 3. Above the rock face is a cement rendered brick wall (only a few courses high) and then a brush fence.

Photo 2 - looking north-eastwards

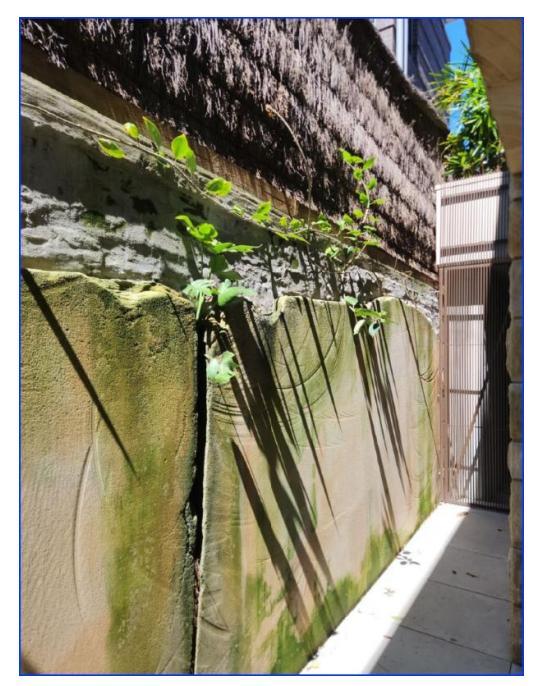
Photo 3 - looking south-eastwards

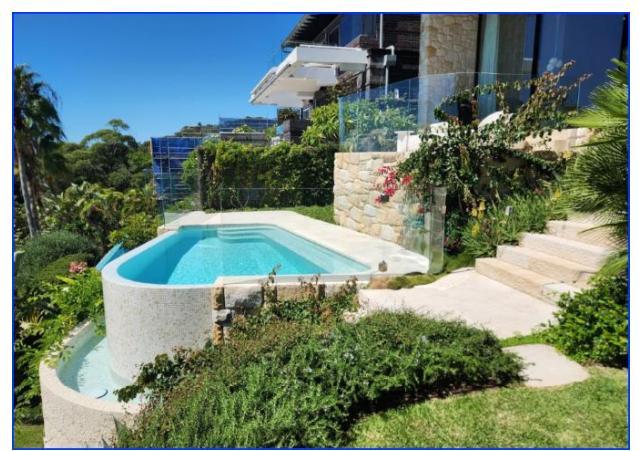
On the northern side of the house, the hillside steps down to a lawn on the western side and pool on the eastern side. The lawn is set back about 1m to 2m from the crest of the first cliff line (Cliff Line 1) that runs across the site. The cliff is about 3m high and comprises a series of large rounded outcrops with vertical jointing that strikes north-south. The pool was built into the cliff line as shown in Photos 4 and 5 below. A weathered bedding parting on the western side of Cliff 1 was underpinned during construction but is now almost entirely hidden by vegetation.

Photo 4- (looking east) existing conditions

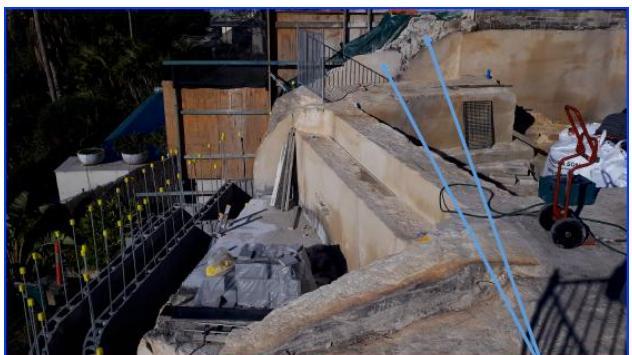
Photo 5- (extract from JKG Site Report 4, July 2021)

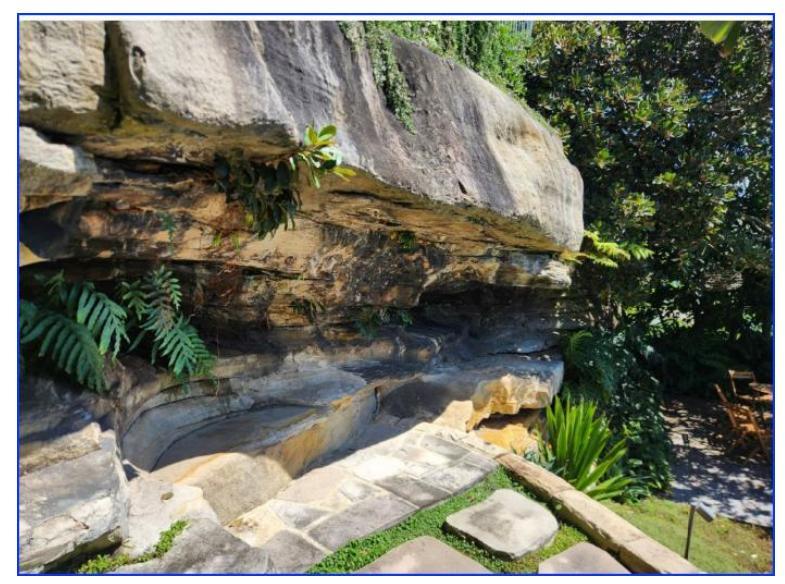
At the toe of the pool structure is a natural terrace in the hillside which has been landscaped with a lawn to the edge of a rounded crest of a cliff ('Cliff Line 2'). The cliff is a about 4m to 5m high. As shown on Figure 2, and Photos 6 and 7, the cliff has an extensive but irregularly shaped overhang with a natural central column. Either side of the column of sandstone bedrock the overhang extends about 2m and 2.3m respectively. At the western side of Cliff 2, there is a lower overhanging unit of sandstone of only about 0.5m from base to ceiling, but extending back to a maximum of 1.3m from the cliff face. At the face there is a fig tree trunk. At the foot of the cliff is a deck accessible via steps that lead up through the eastern side of the cliff.

Photo 6- looking east- showing main overhanging outcrop

At the western end of Cliff Line 2, there is a lower overhang which extends for a length of about 6m and is up to about 1.3m back from the rock face. We recommend an underpin be constructed, behind the fig tree trunk. The underpin could comprise masonry or formed mass concrete, founded on sandstone bedrock scraped clear of any loose material. The underpin should be constructed to about 50mm shy of the underside of the rock and then once initial set has taken place, the void packed with non-shrink grout.

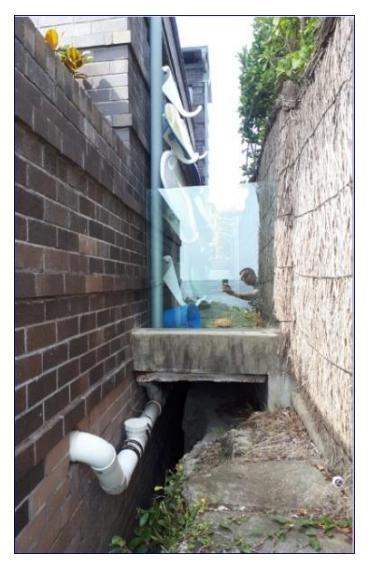
Photo 7

The house to the east of the site, No 42, is of brick construction and set back about 1m from the common boundary. It has a swimming pool between Cliff Lines 1 and 2. Between the southern end of the houses, existing surface levels are similar across the boundary which is marked by a combination of stone masonry walls, fencing, low height rendered walls and vegetation. The house at No 42 has a partial basement level cut into the hillside with an approximately 3.3m deep vertical cutting though sandstone bedrock located parallel to, and set back 0.8m from, the common boundary. The northern end of the ground floor level side path is suspended over a narrow passage between the basement wall and the rock face. The path has adown turn supported on the top of the rock on the common boundary.

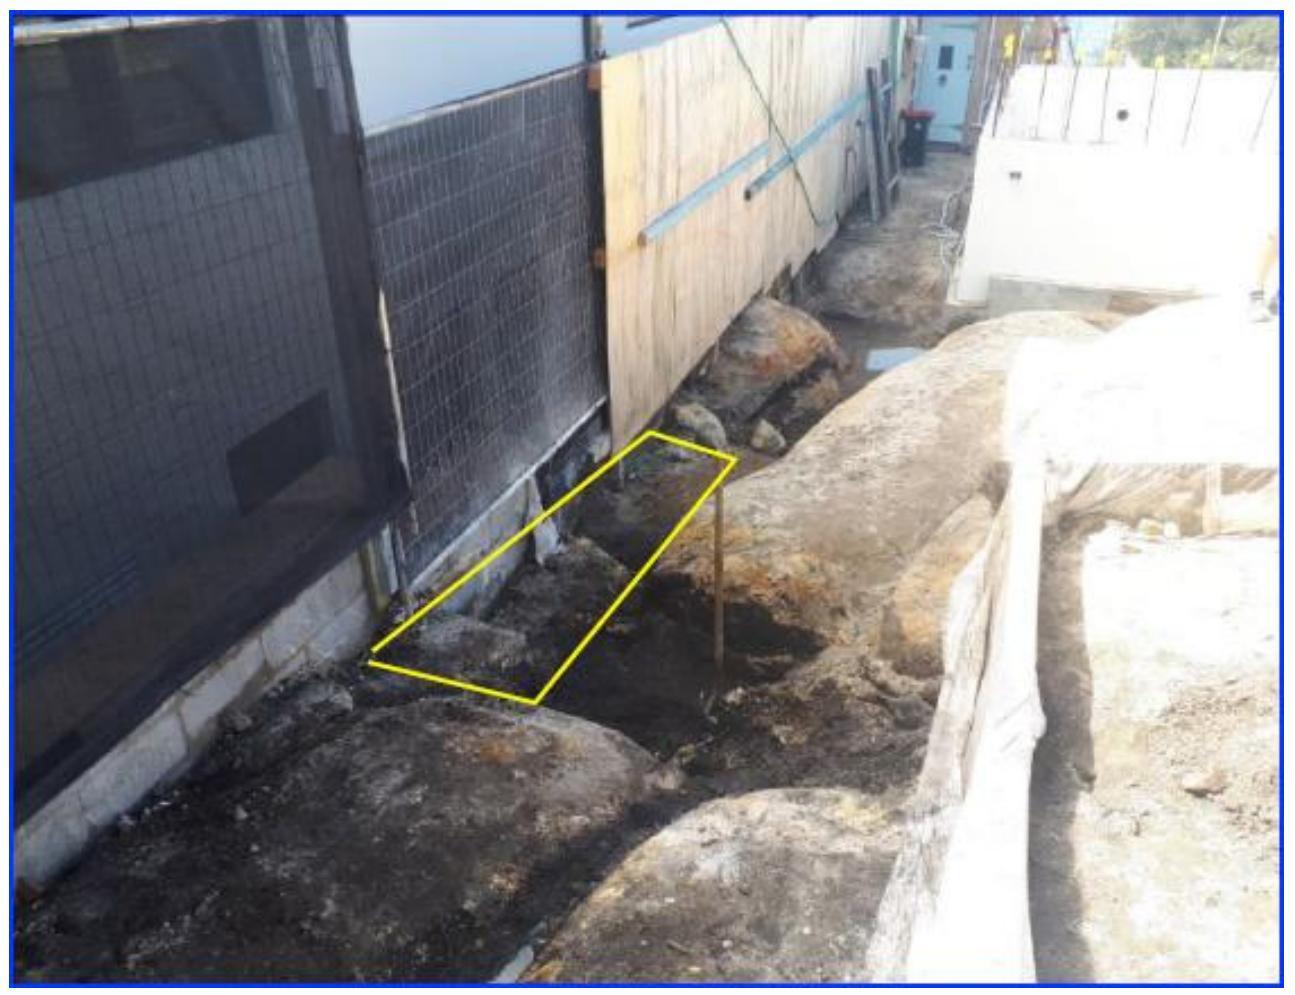
The subsurface profile comprises a nominal depth of topsoil fill over sandstone bedrock. The sandstone bedrock was previously assessed during construction to be of at least medium strength with vertical jointing of the rock mass primarily oriented NNE to SSW. Photo 8 shows the exposed conditions following stripping of soil and Photo 9 shows conditions following detailed excavation. The bedrock had sub-horizontal beddings generally spaced greater than 2m.

Photo 8- (looking north) from November 2020, showing top of rock conditions on western side of site

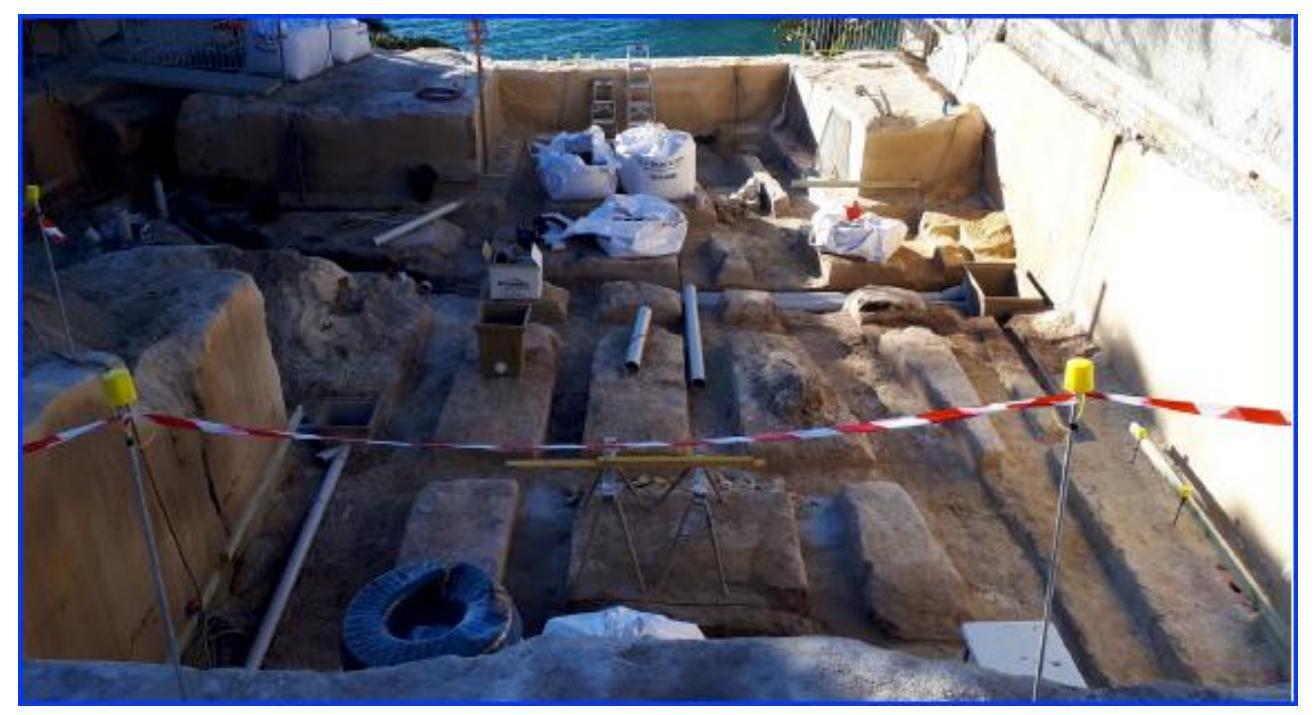
Photo 9- (looking north), from July 2021, showing conditions on central and eastern side of site

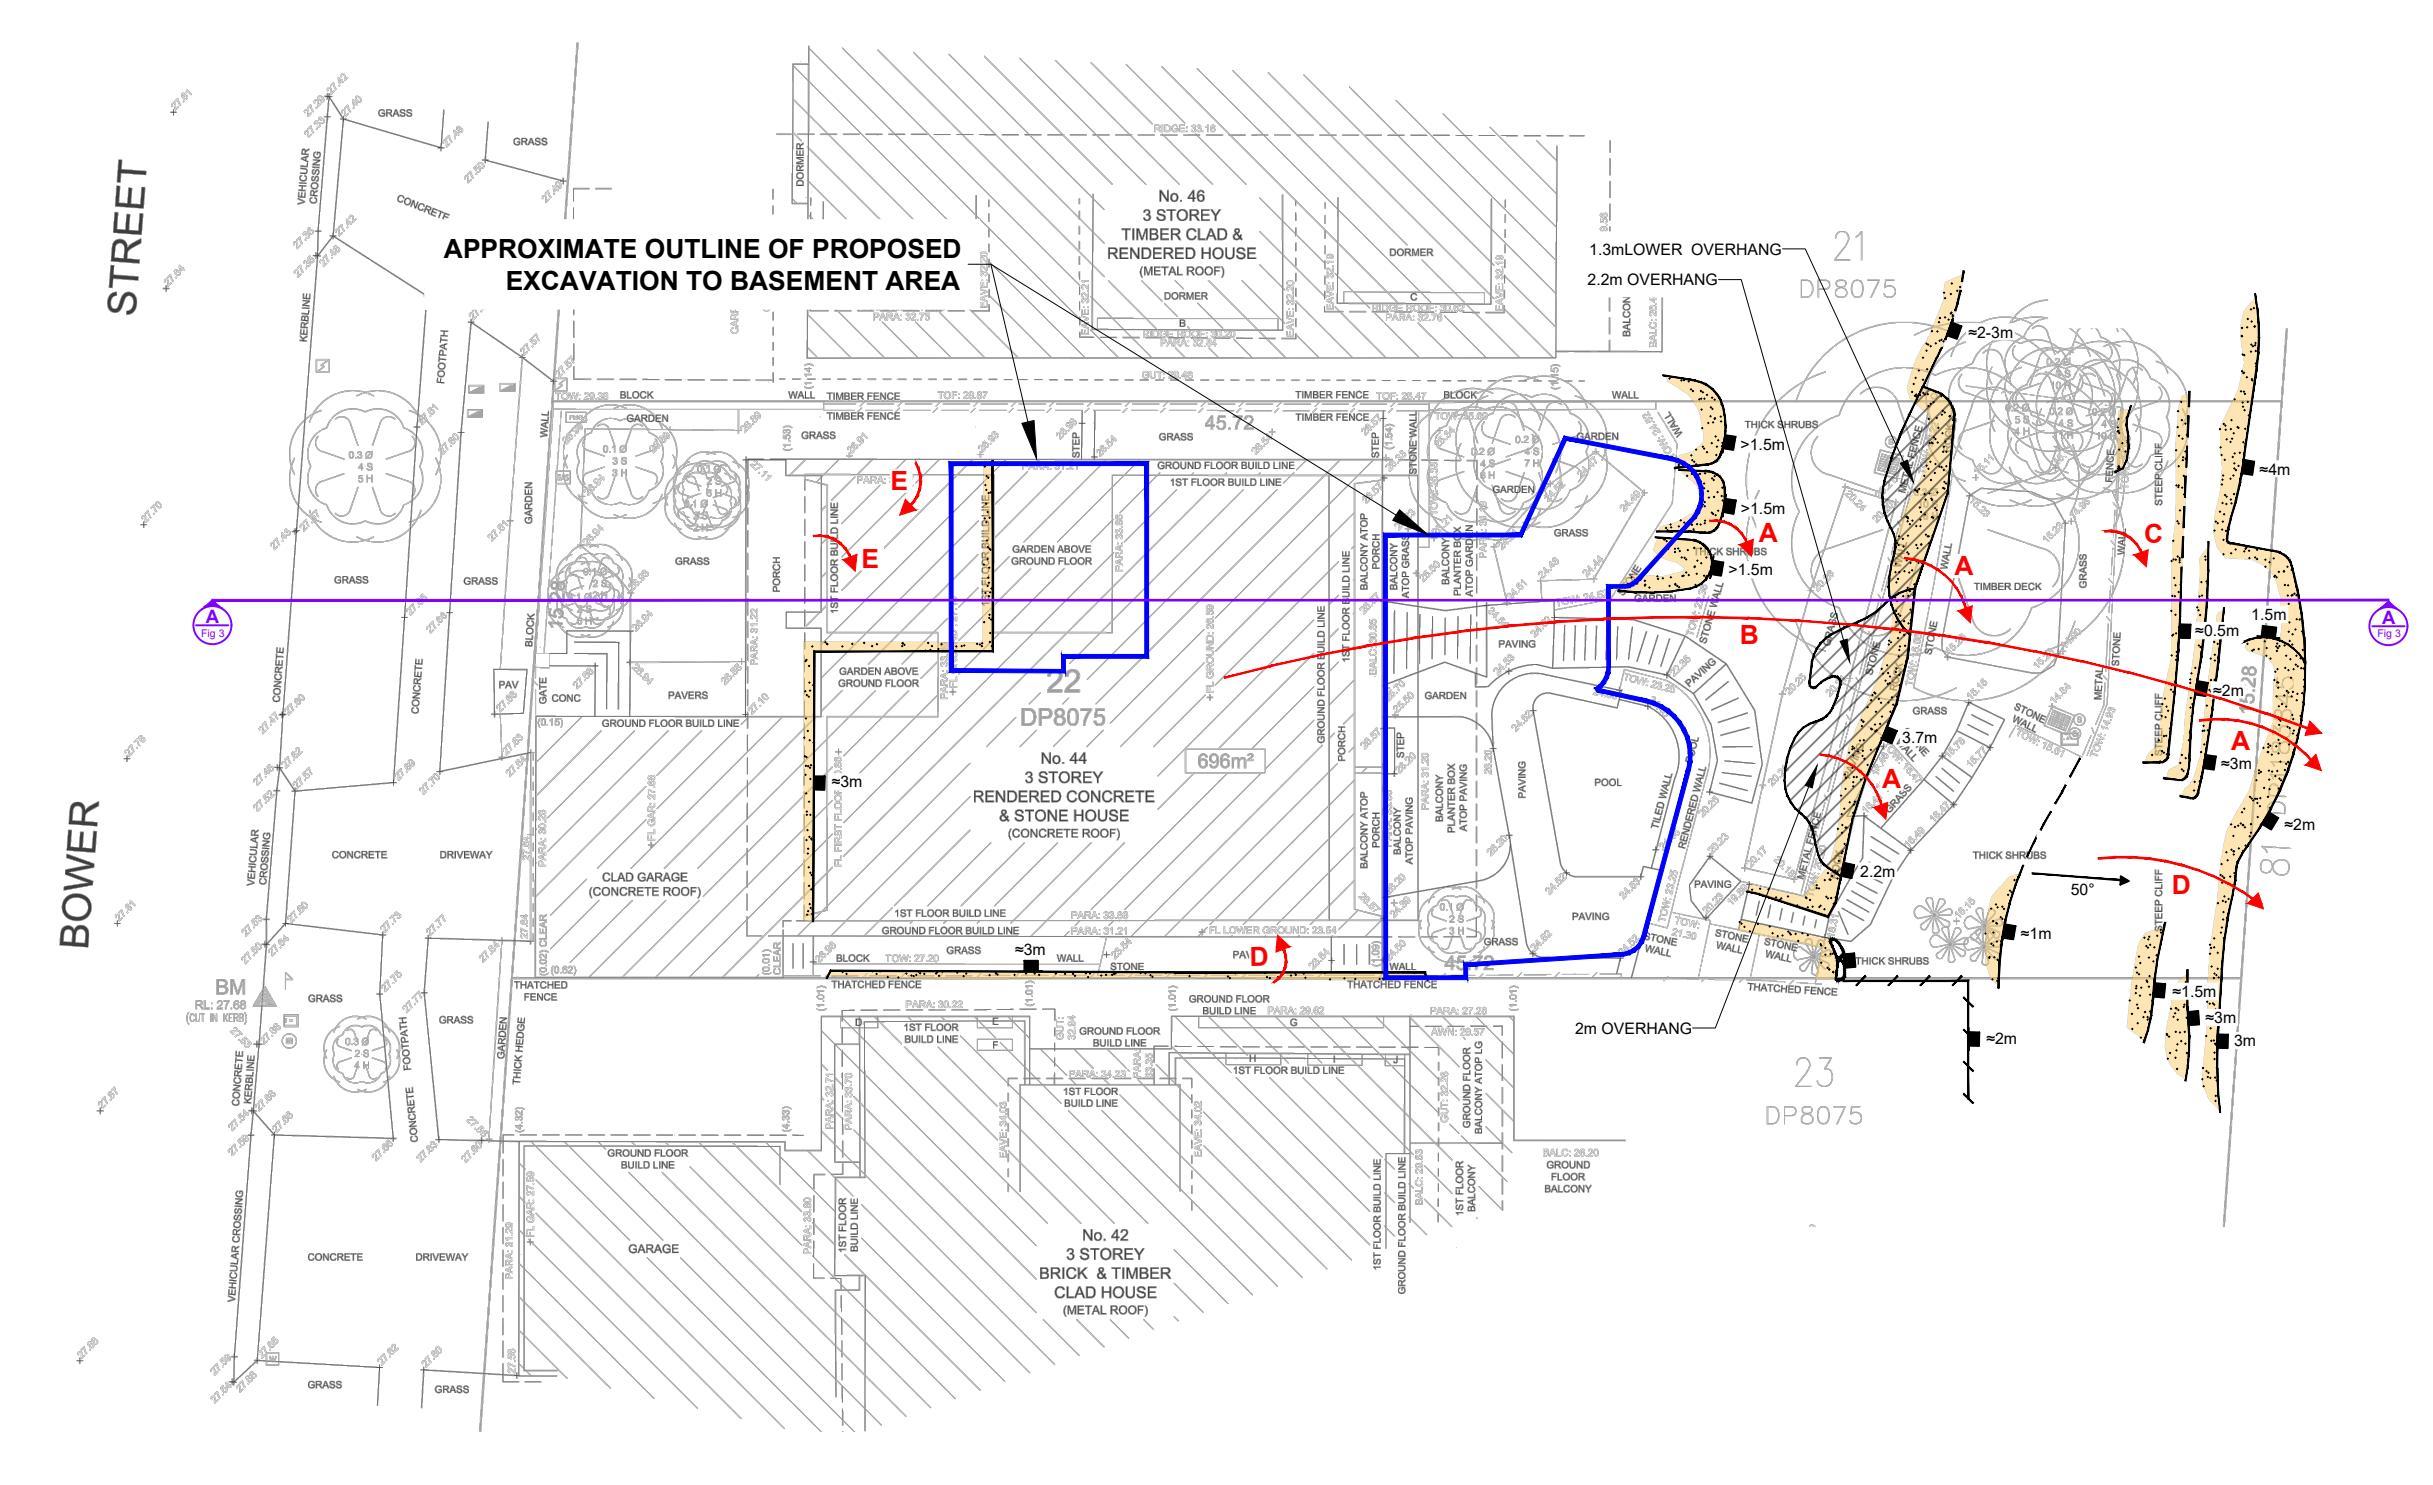
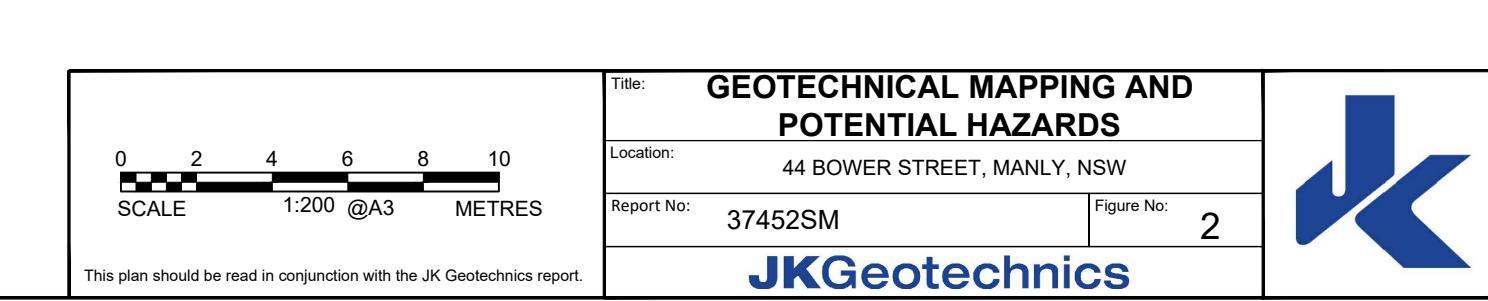
The principal geotechnical features, which were measured using taped measurements and hand-held clinometer, are presented on Figure 2 using the existing survey by Peak Surveying Service Pty Ltd (Job. 24-2354, dated 3 December 2024) as a base plan. Should any of the features be critical to the proposed development, we recommend they be located more accurately using instrument survey techniques. Figure 3

A GEOTECHNICAL HAZARD

NOTE: REFER TO FIGURE 4 FOR GEOTECHNICAL MAPPING SYMBOLS.

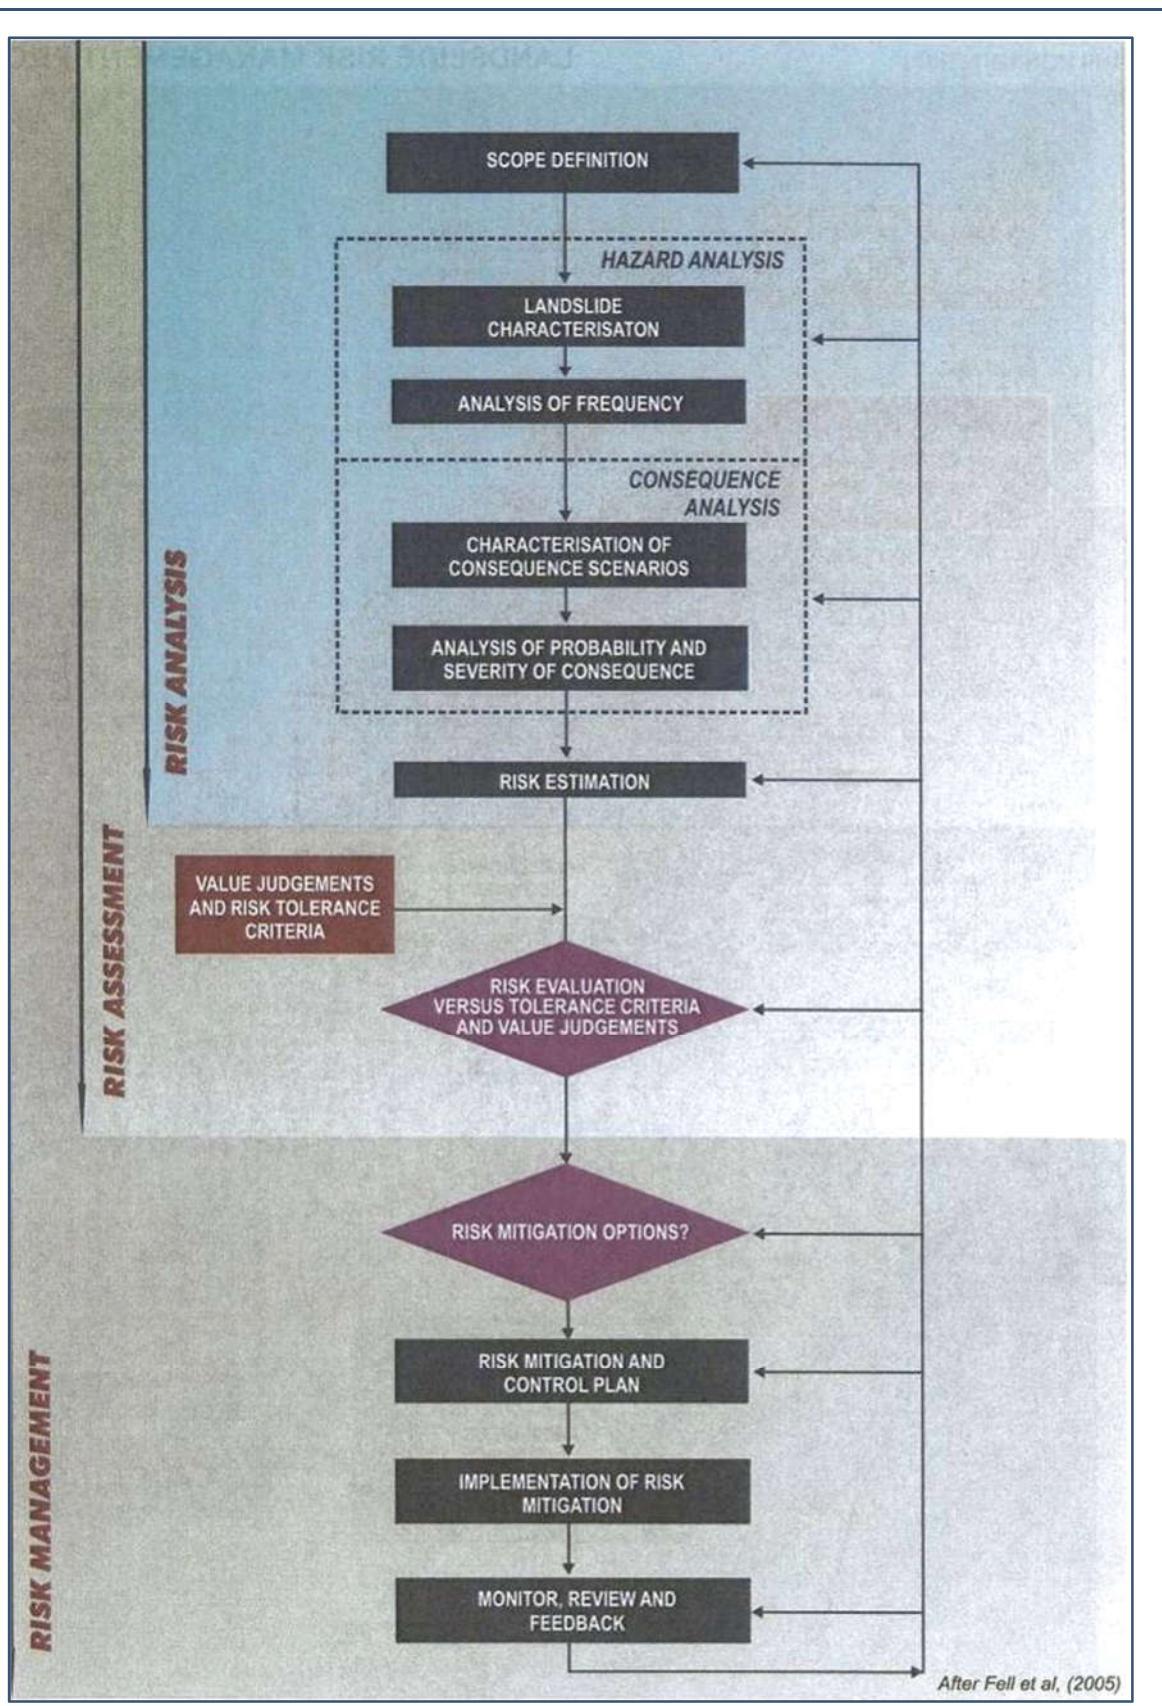
FIGURE A1: Flowchart for Landslide Risk Management.

This figure is an extract from GUIDELINE FOR LANDSLIDE SUSCEPTIBILITY, HAZARD AND RISK ZONING FOR LAND USE PLANNING, as presented in Australian Geomechanics Vol 42, No 1, March 2007, which discusses the matter more fully.
