Arboricultural Impact Assessment

Proposed New Residence at

40 Pine Street, Manly

Date: November 2021
Client: James Bell
Author: Alexis Anderson
Qualifications: -Diploma Horticulture (Arboriculture) –AQF Level 5. -Bachelor of Applied Science (CM)
Membership: -Arboriculture Australia-Member No.2268 -International Society of Arboriculture –Professional Member
A.B.N: 989 613 015 96
Contact: 0431 286 080 info@bluegumarborist.com.au

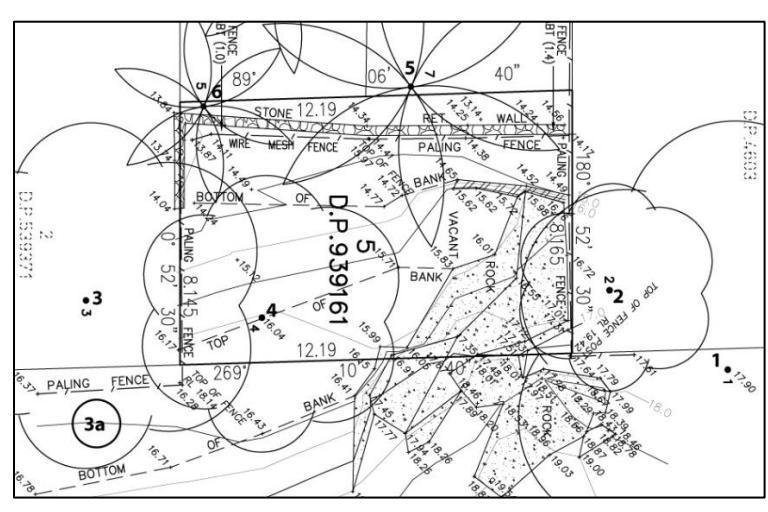
Figure A: Excerpt from the Survey Plan showing tree locations and numbering.

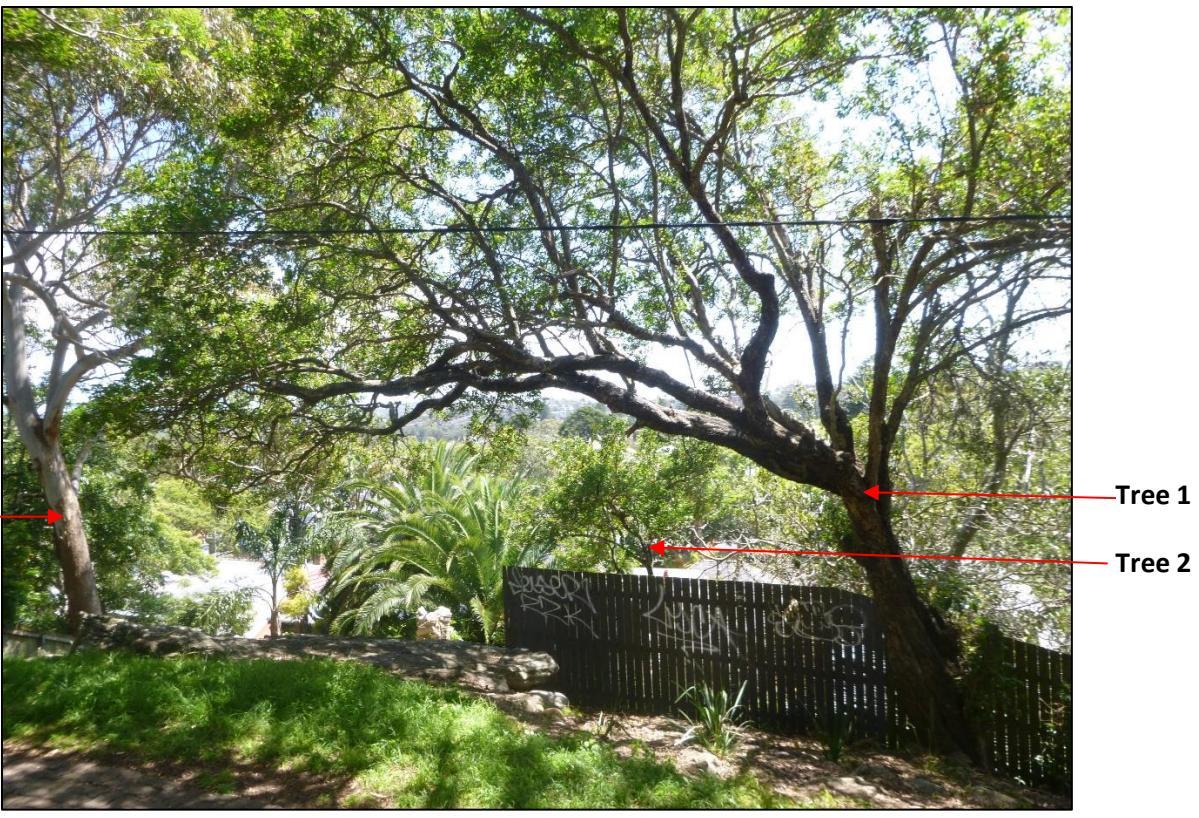
Tree 4

Photo A: Trees 1,2 and 4 viewed facing north-west.

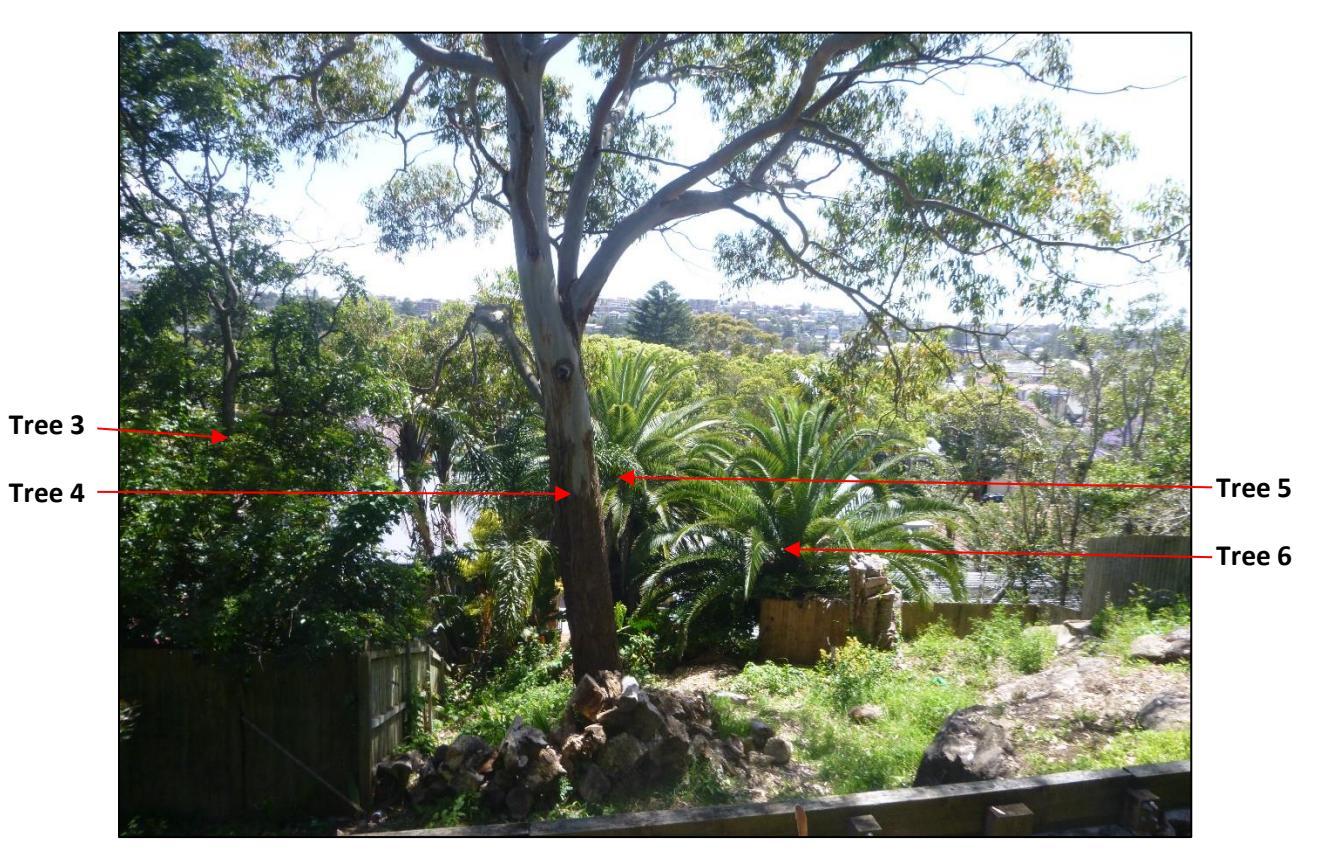
Photo B: Trees 3-6 viewed facing north.

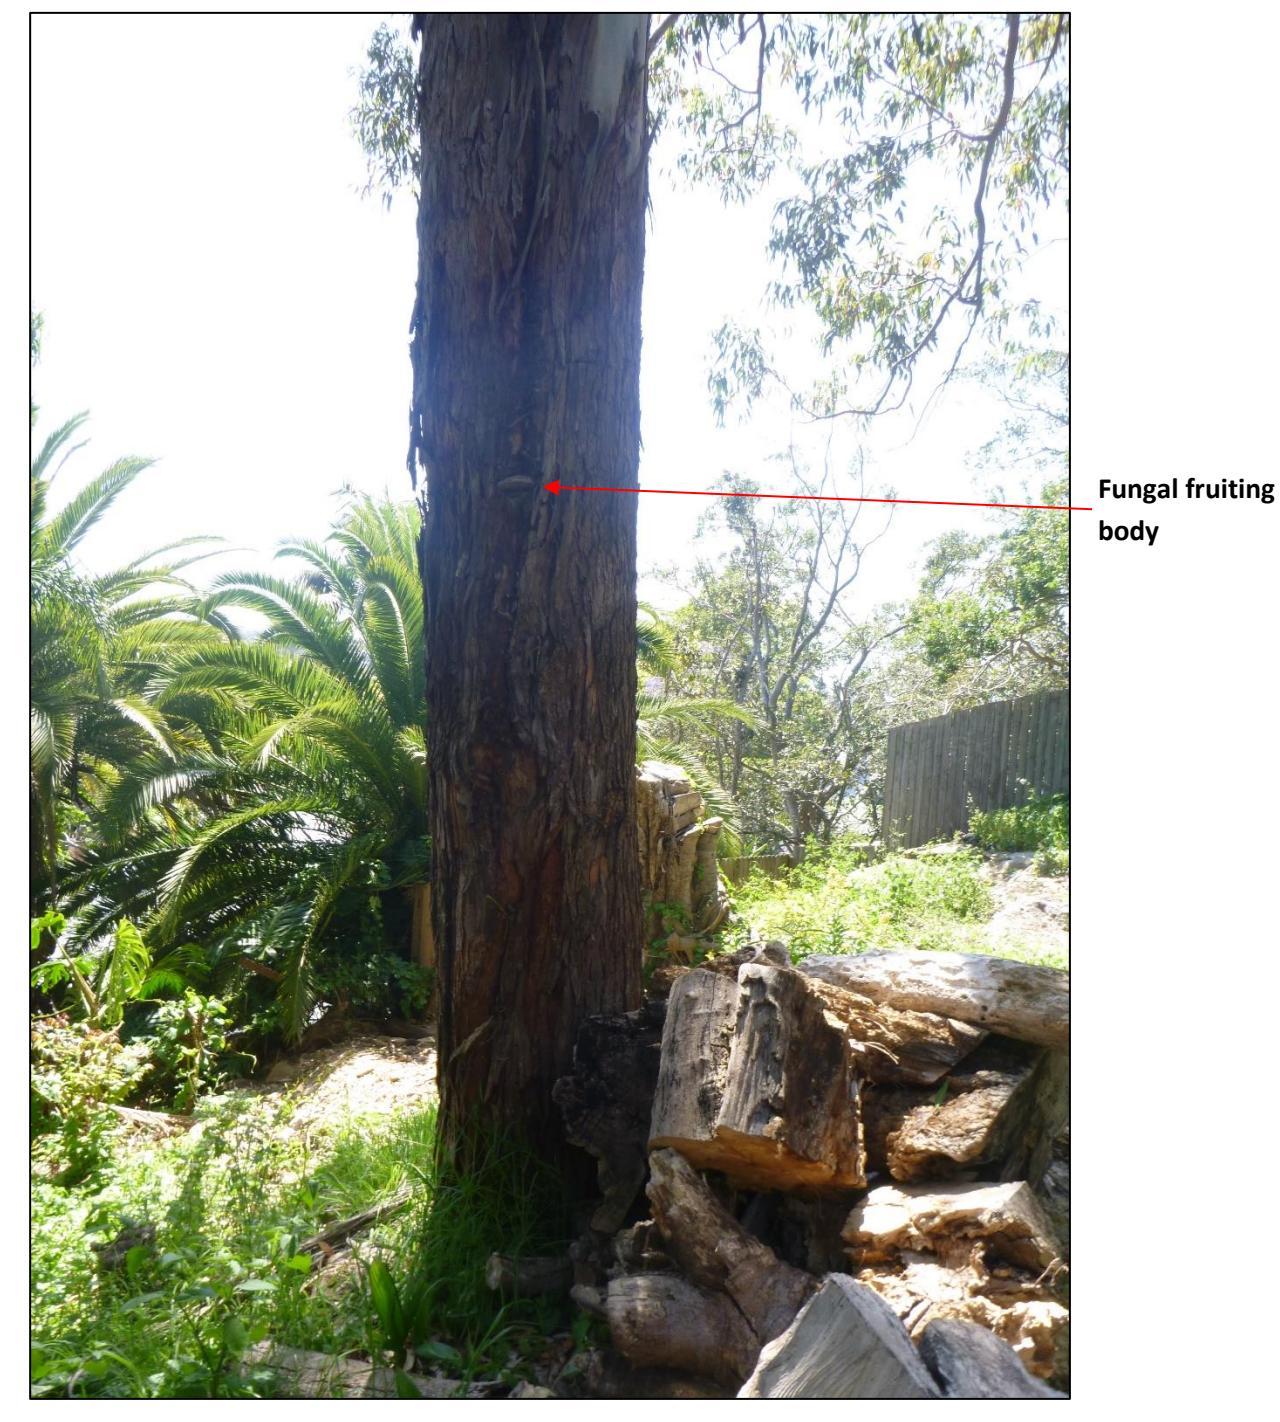
Photo C: Trunk of Tree 4 with the fungal fruiting body visible on the western side.

The visible spread of trunk wounding associated with the decay extends from the base to 3.0m height. Trunk drilling was undertaken at a height of 2.5m height to correspond with the location of the fungal fruiting body.

Drilling Height	2.5m	Drill 3
Trunk Diamater @ drill height	55cm	
Average trunk radius (minus bark)	27cm	
Drill 1 (from west)	Decay - 0-16cm	Aprovimate area
	Sound wood -16-28cm	of decay
Drill 2 (from south)	Sound wood - 0-28cm	
Drill 3 (from north)	Sound wood -0-28cm	2800
Average thickness of sound wood	23cm	16cm 10-200
(undecayed) surrounding the		Drill 1 0-10-
decay pocket		0-28
t/R ratio (average % of trunk	23/27= 85%	ŝ .
radius remaining as sound wood)		
		Drill 2
Discussion	This finding suggests that	at trunk failure is improbable within the next 5 years.
	Given the good health a	nd vitality of the tree it is likely that the spread of decay
	will be successfully inhib	pited by the tree's natural strategies of decay
	compartmentalisation.

Tree Risk Assessment (refer to Attachment B for methodology)					
Potential Targets	Proposed new house (constant occupancy). The house is likely to be strong enough to				
	protect its residents from branch failure.				
Likelihood of Failure	Failure of the trunk resulting from the decay between between 0-3m height -Improbable				
(within the next 5 years)	Live branch failure (Storm damage or summer branch drop)-Possible.				
Likelihood of Impact	Low (Whole tree falling on new house). The trunk has a lean away from the house.				
	Medium (Branch falling on new house). Approx. 30% of canopy will overhang the house.				
Likelihood of Failure +	Unlikely (Whole tree impacting house following trunk failure)				
Impact	Unlikely (Live branch failure impacting house)				
Consequences of Failure +	Severe (house damage from trunk failure)				
Impact	Significant (house damage from live branch failure).				
Risk Rating	Low -Live branch failure impacting the house

Low - Whole tree impacting house following trunk failure				
Recommended Action	Remove the dead branch on the southern side of the canopy.				
	Engage an AQF Level 5 Arborist to re-assess the tree in 5 years.

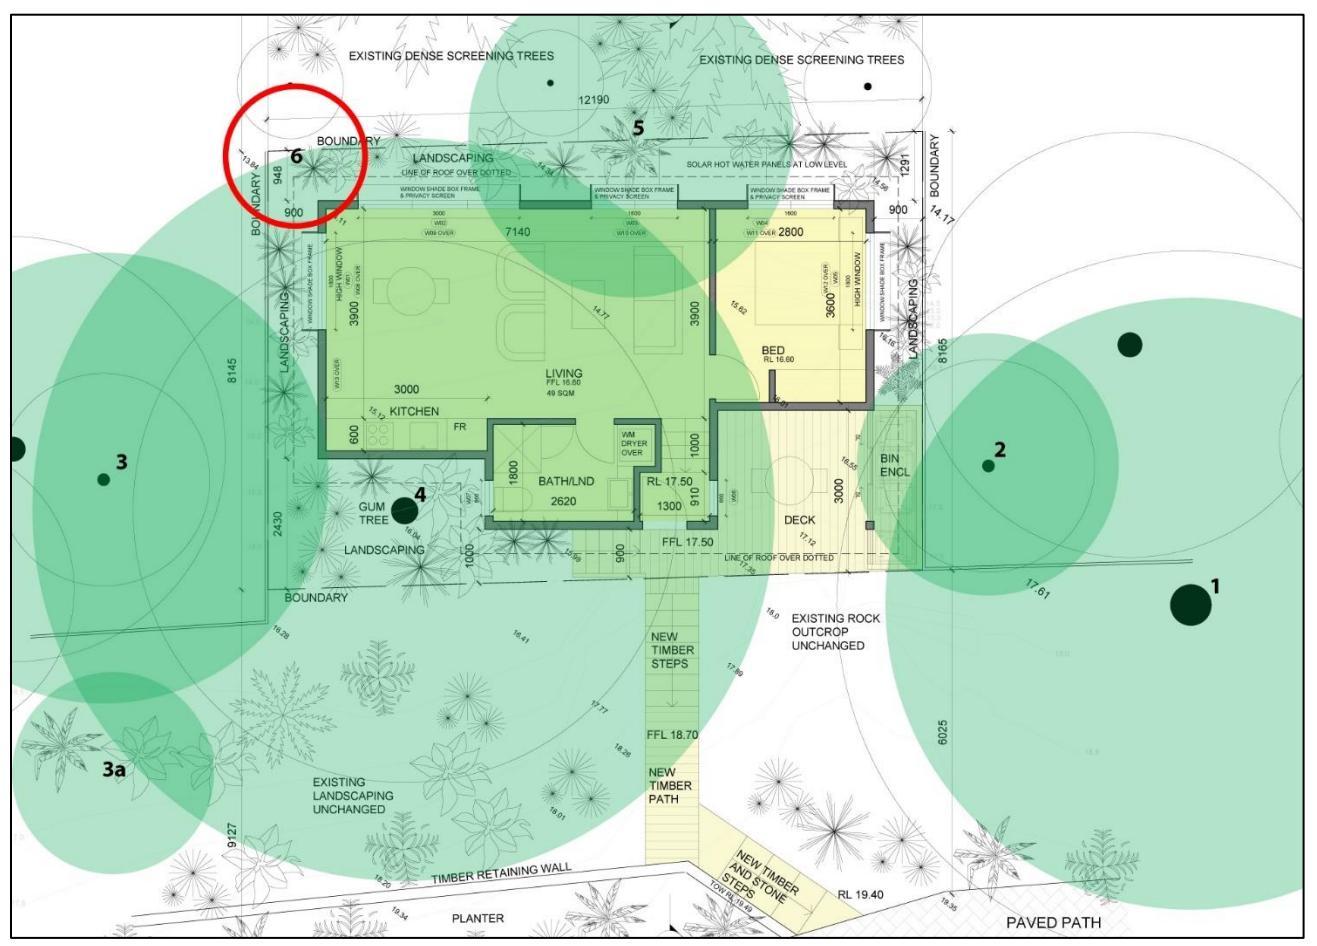
Figure B: Excerpt from the Floor Plan showing the TPZ's (green circles) of the retained trees.

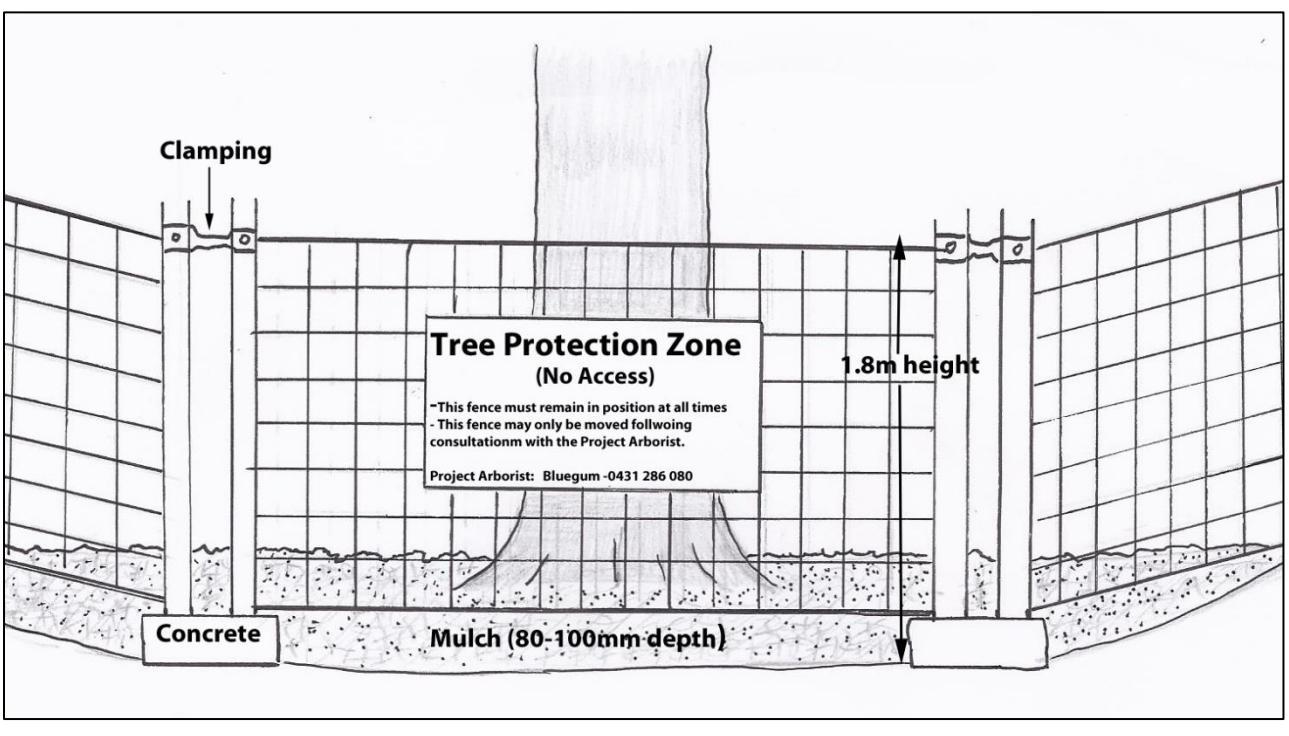
Figure C: Example of adequate tree protection fencing.

Tree Protection Fencing: Tree Protection Fencing should be installed prior to any machinery or materials being bought on site and remain in position throughout the entire project. Tree Protection Fencing should be erected in the position outlined in Figure E (following page). Tree Protection Fencing should consist standard temporary steel mesh fencing was not recommended for this site.

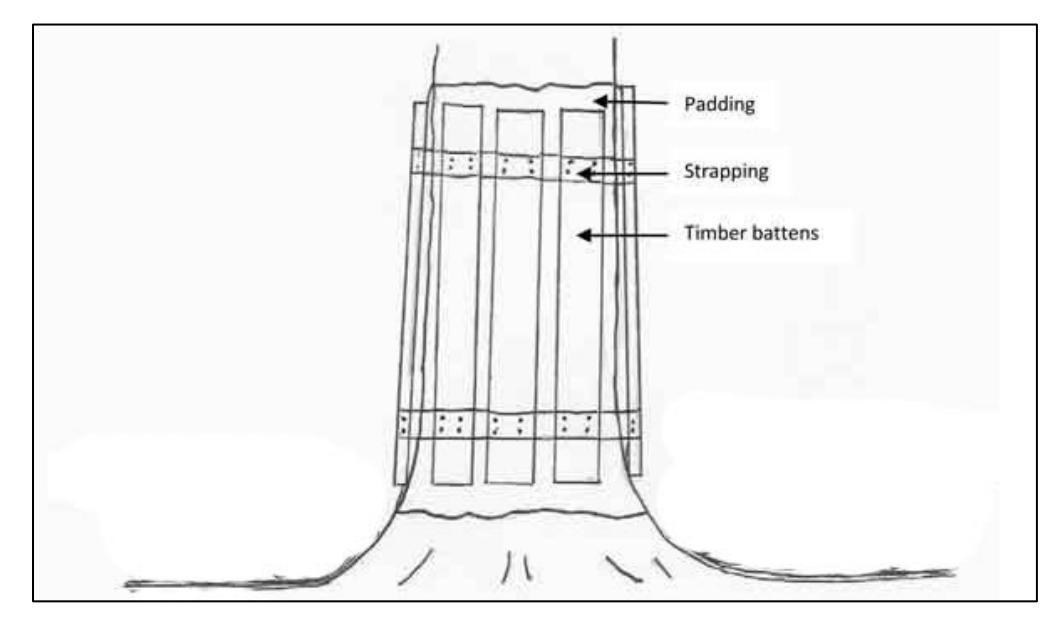
Figure D: Example of adequate trunk protection for Tree 4.

Trunk Protection (Tree 4): Trunk Protection is recommended for Tree 4 to prevent accidental injury to the bark and cambium during the construction process. Trunk protection should be installed to the roof height of the proposed building. Refer to Figure D for detail of adequate trunk protection.

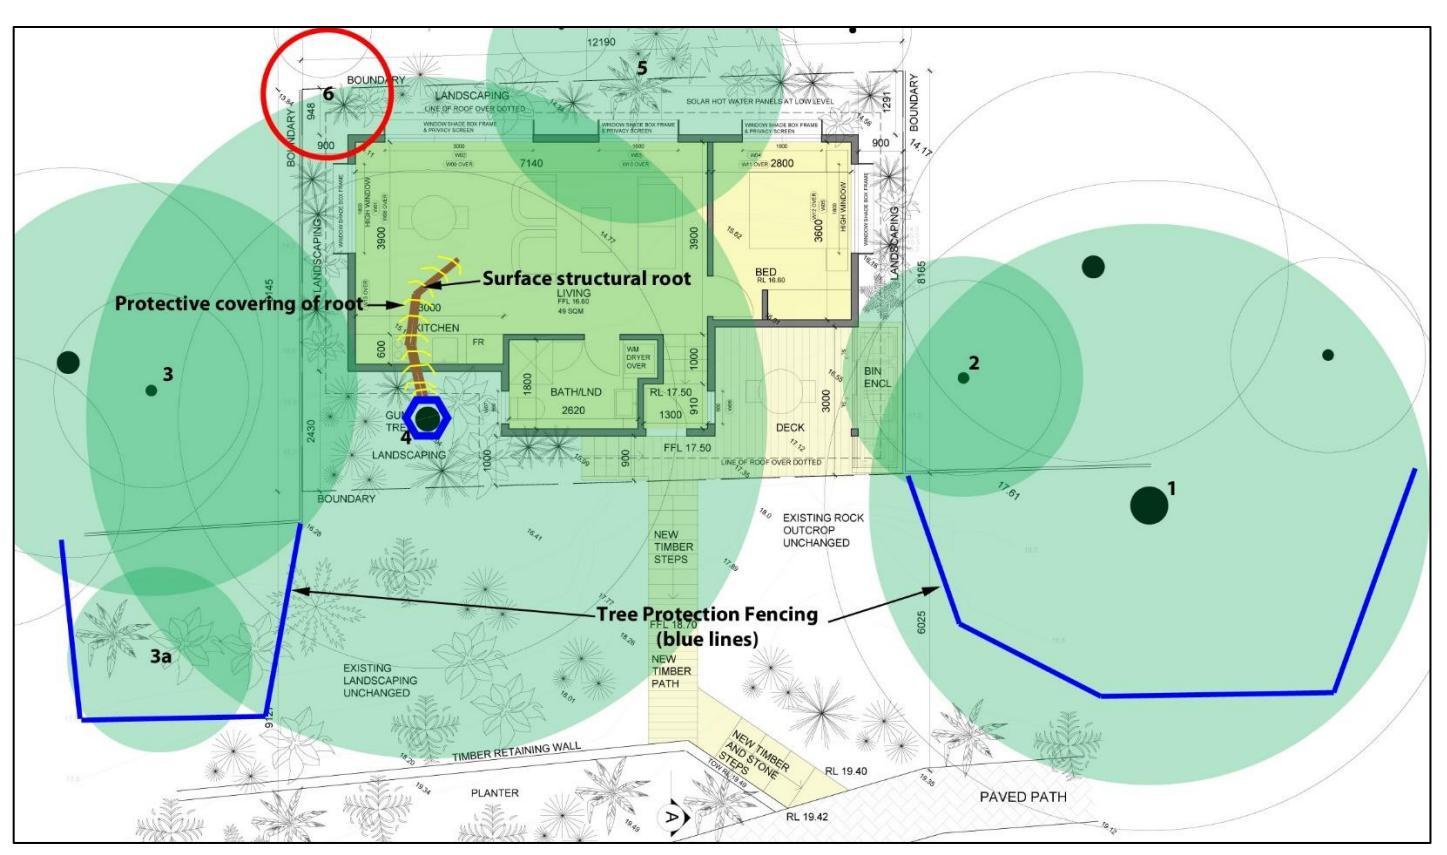
Figure E: Areas where tree protection fencing and root protection is recommended.

Root Protection (Tree 4): Root protection is recommended for the large surface structural root on the northern side of Tree 4 in the area outlined in Figure E. The purpose of this is to protect the root from accidental injury during construction. The type of root protection shall be determined by the Project Arborist in consultation with the Site Foreman. Root protection may be removed when building framing is complete.
