## **REPORT ON GEOTECHNICAL SITE INVESTIGATION**

### **CONSTRUCTION OF NEW EXTERNAL STAIRCASE AND BIN STORAGE AREA**

**249 BARRENJOEY ROAD, NEWPORT, NSW**

**Project No.: 2025-139**

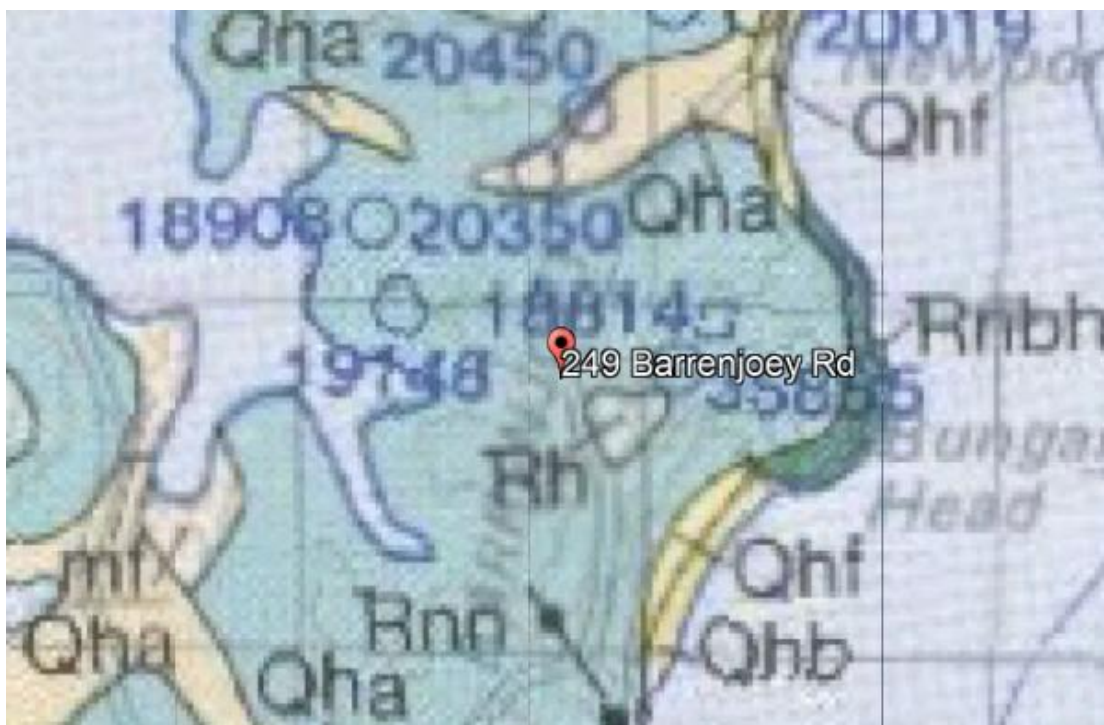
An extract from the Sydney 1:100,000 Geological Series sheet 9130 provided below (Extract 1) indicates the geology underlying the site and surrounding area.

*Extract 1: Sydney (9130 Geological Series Map): 1:100,000 – Geology underlying the site*

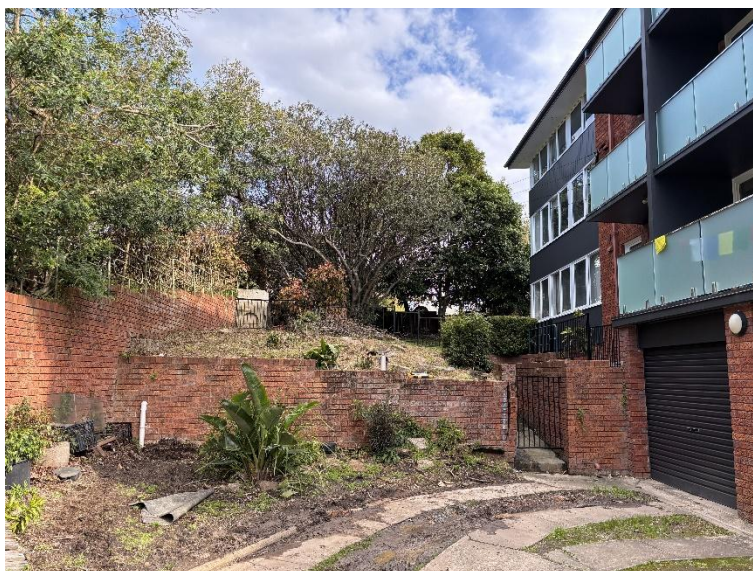
closed off. East of the ramp is an elevated grassed area retained by a brick masonry retaining wall approximately 1.40 m high. This retaining wall exhibits notable rotation and a vertical crack of approximately 85 mm in width (Photograph 5). The retaining wall south of the concrete strips shows minor cracking but no evidence of significant structural distress or excessive settlement. East of the grassed area, a boundary retaining wall supporting the Barrenjoey Road reserve extends to a maximum height of approximately 2.50 m and displays signs of ladder cracking and rotation; it also appears to have been previously bolted and underpinned (Photograph 4). Located to the rear (south) of the grassed area is a stormwater tank and several mature trees.

*Photograph 2: View of existing elevated grassy area, facing southwest*

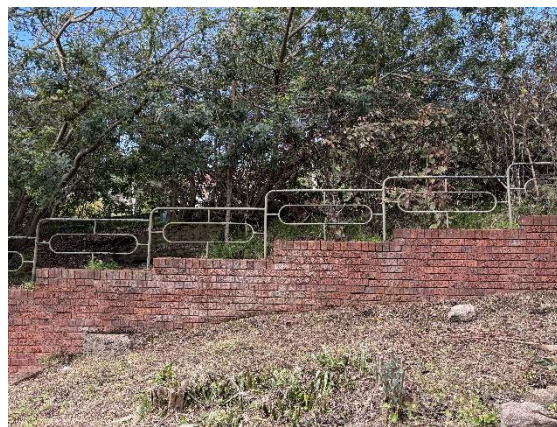
*Photograph 4: View of the ladder cracks on the boundary wall, facing east*

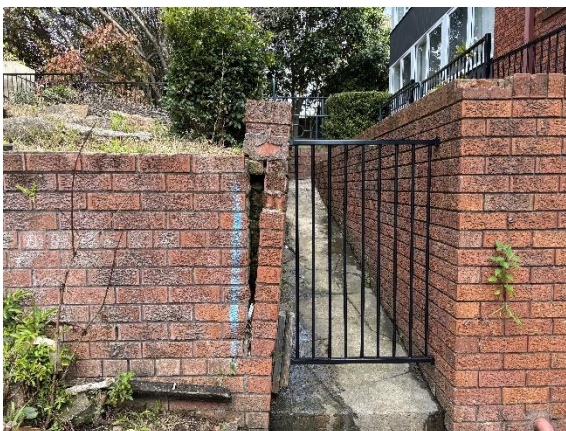
*Photograph 5: View of the retaining wall showing signs of rotation and significant cracking, facing south*

Along the eastern boundary, the local stormwater pit line is situated approximately 1.8 m from the proposed excavation and lies within the anticipated zone of influence. The underpinned boundary retaining wall is also located within this zone, along with a fibre optics junction positioned to the east of the boundary. These elements should be carefully considered during excavation planning to avoid damage and ensure stability and are hazards that define a requirement for pre-excavation support. It is recommended that appropriate protective measures be implemented, including physical barriers, vibration control, and monitoring of ground movements. Any excavation works in proximity to the retaining wall or fibre optics infrastructure should be carried out under close supervision, with immediate corrective action taken if signs of distress are observed.

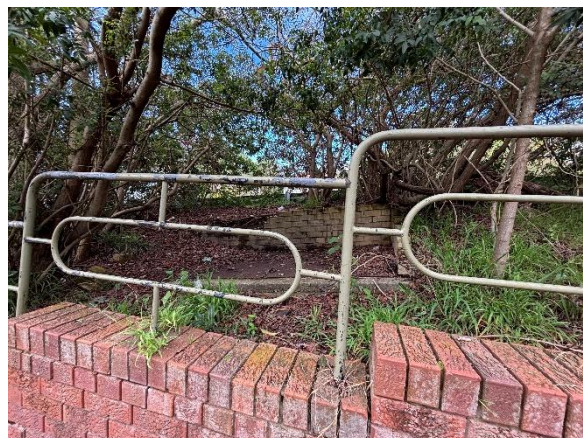
*Photograph 6: View of the fibre optics junction along the east boundary, facing east*

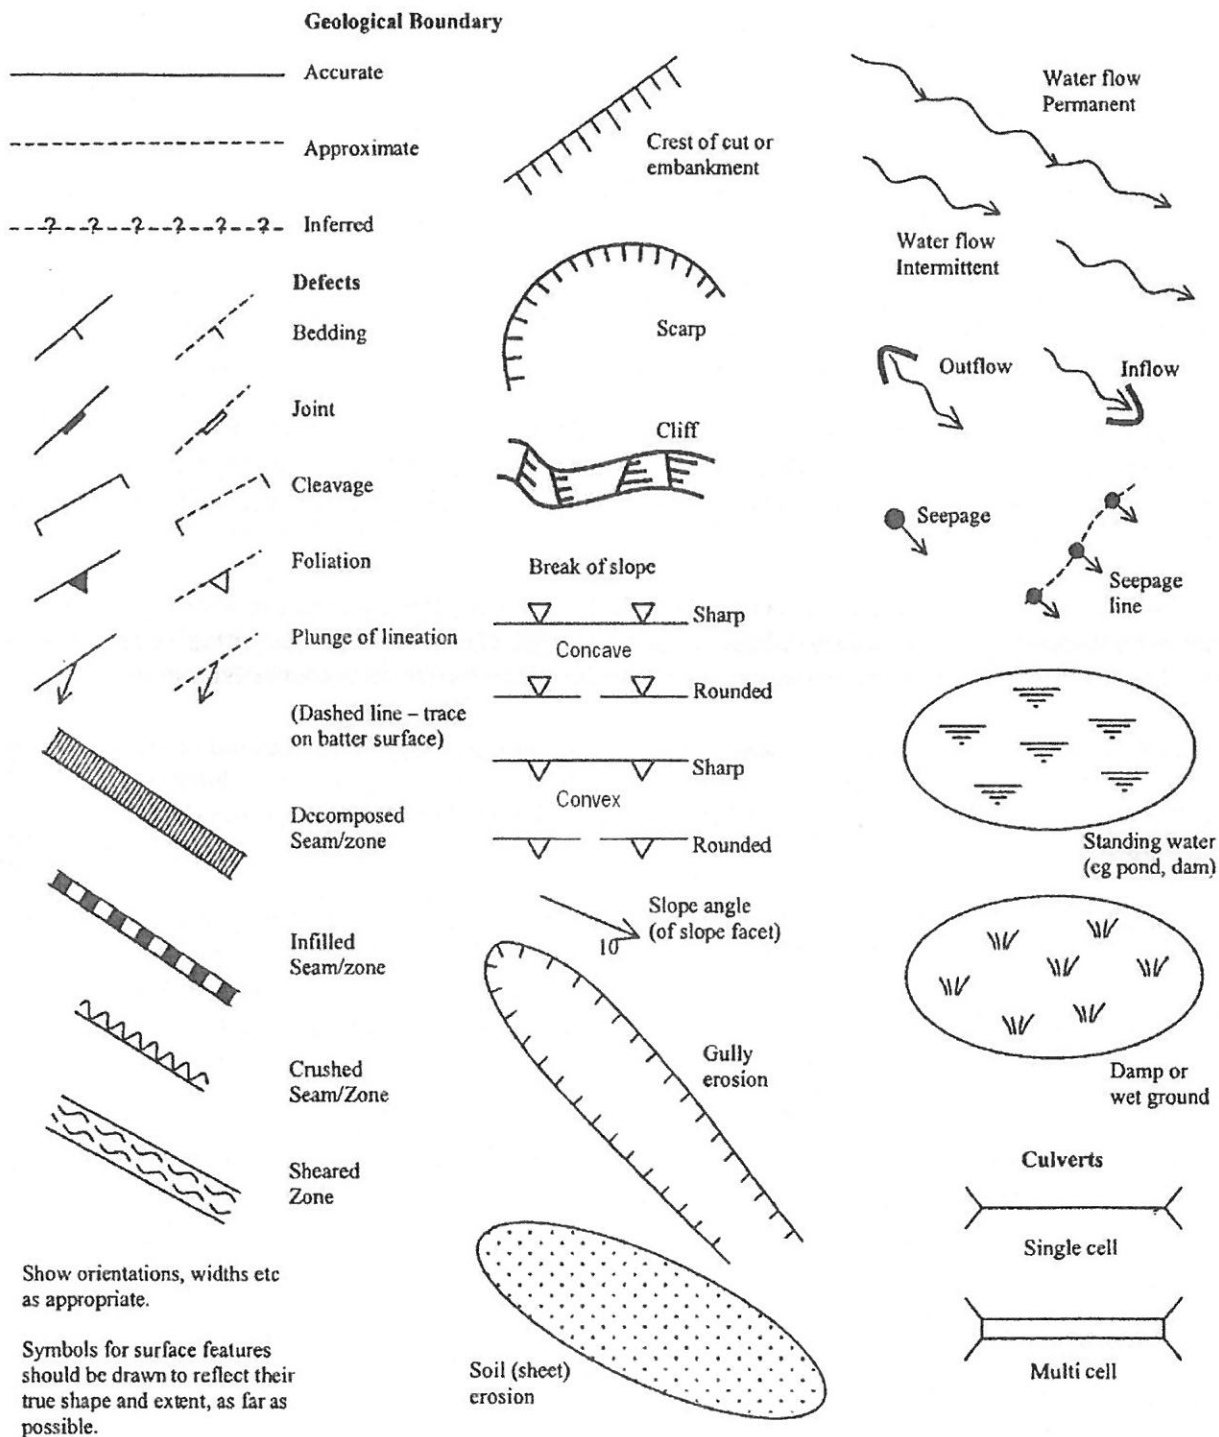
Examples of Mapping Symbols (after Guide to Slope Risk Analysis Version 3.1 November 2001, Roads and Traffic Authority of New South Wales).
