17 August 2016

Our ref: GEOTLCOV25199AA-BE

Proposed Additional Excavation for Basement Parking Level 2 Dee Why Town Centre site, 888 Pittwater Road, Dee Why NSW

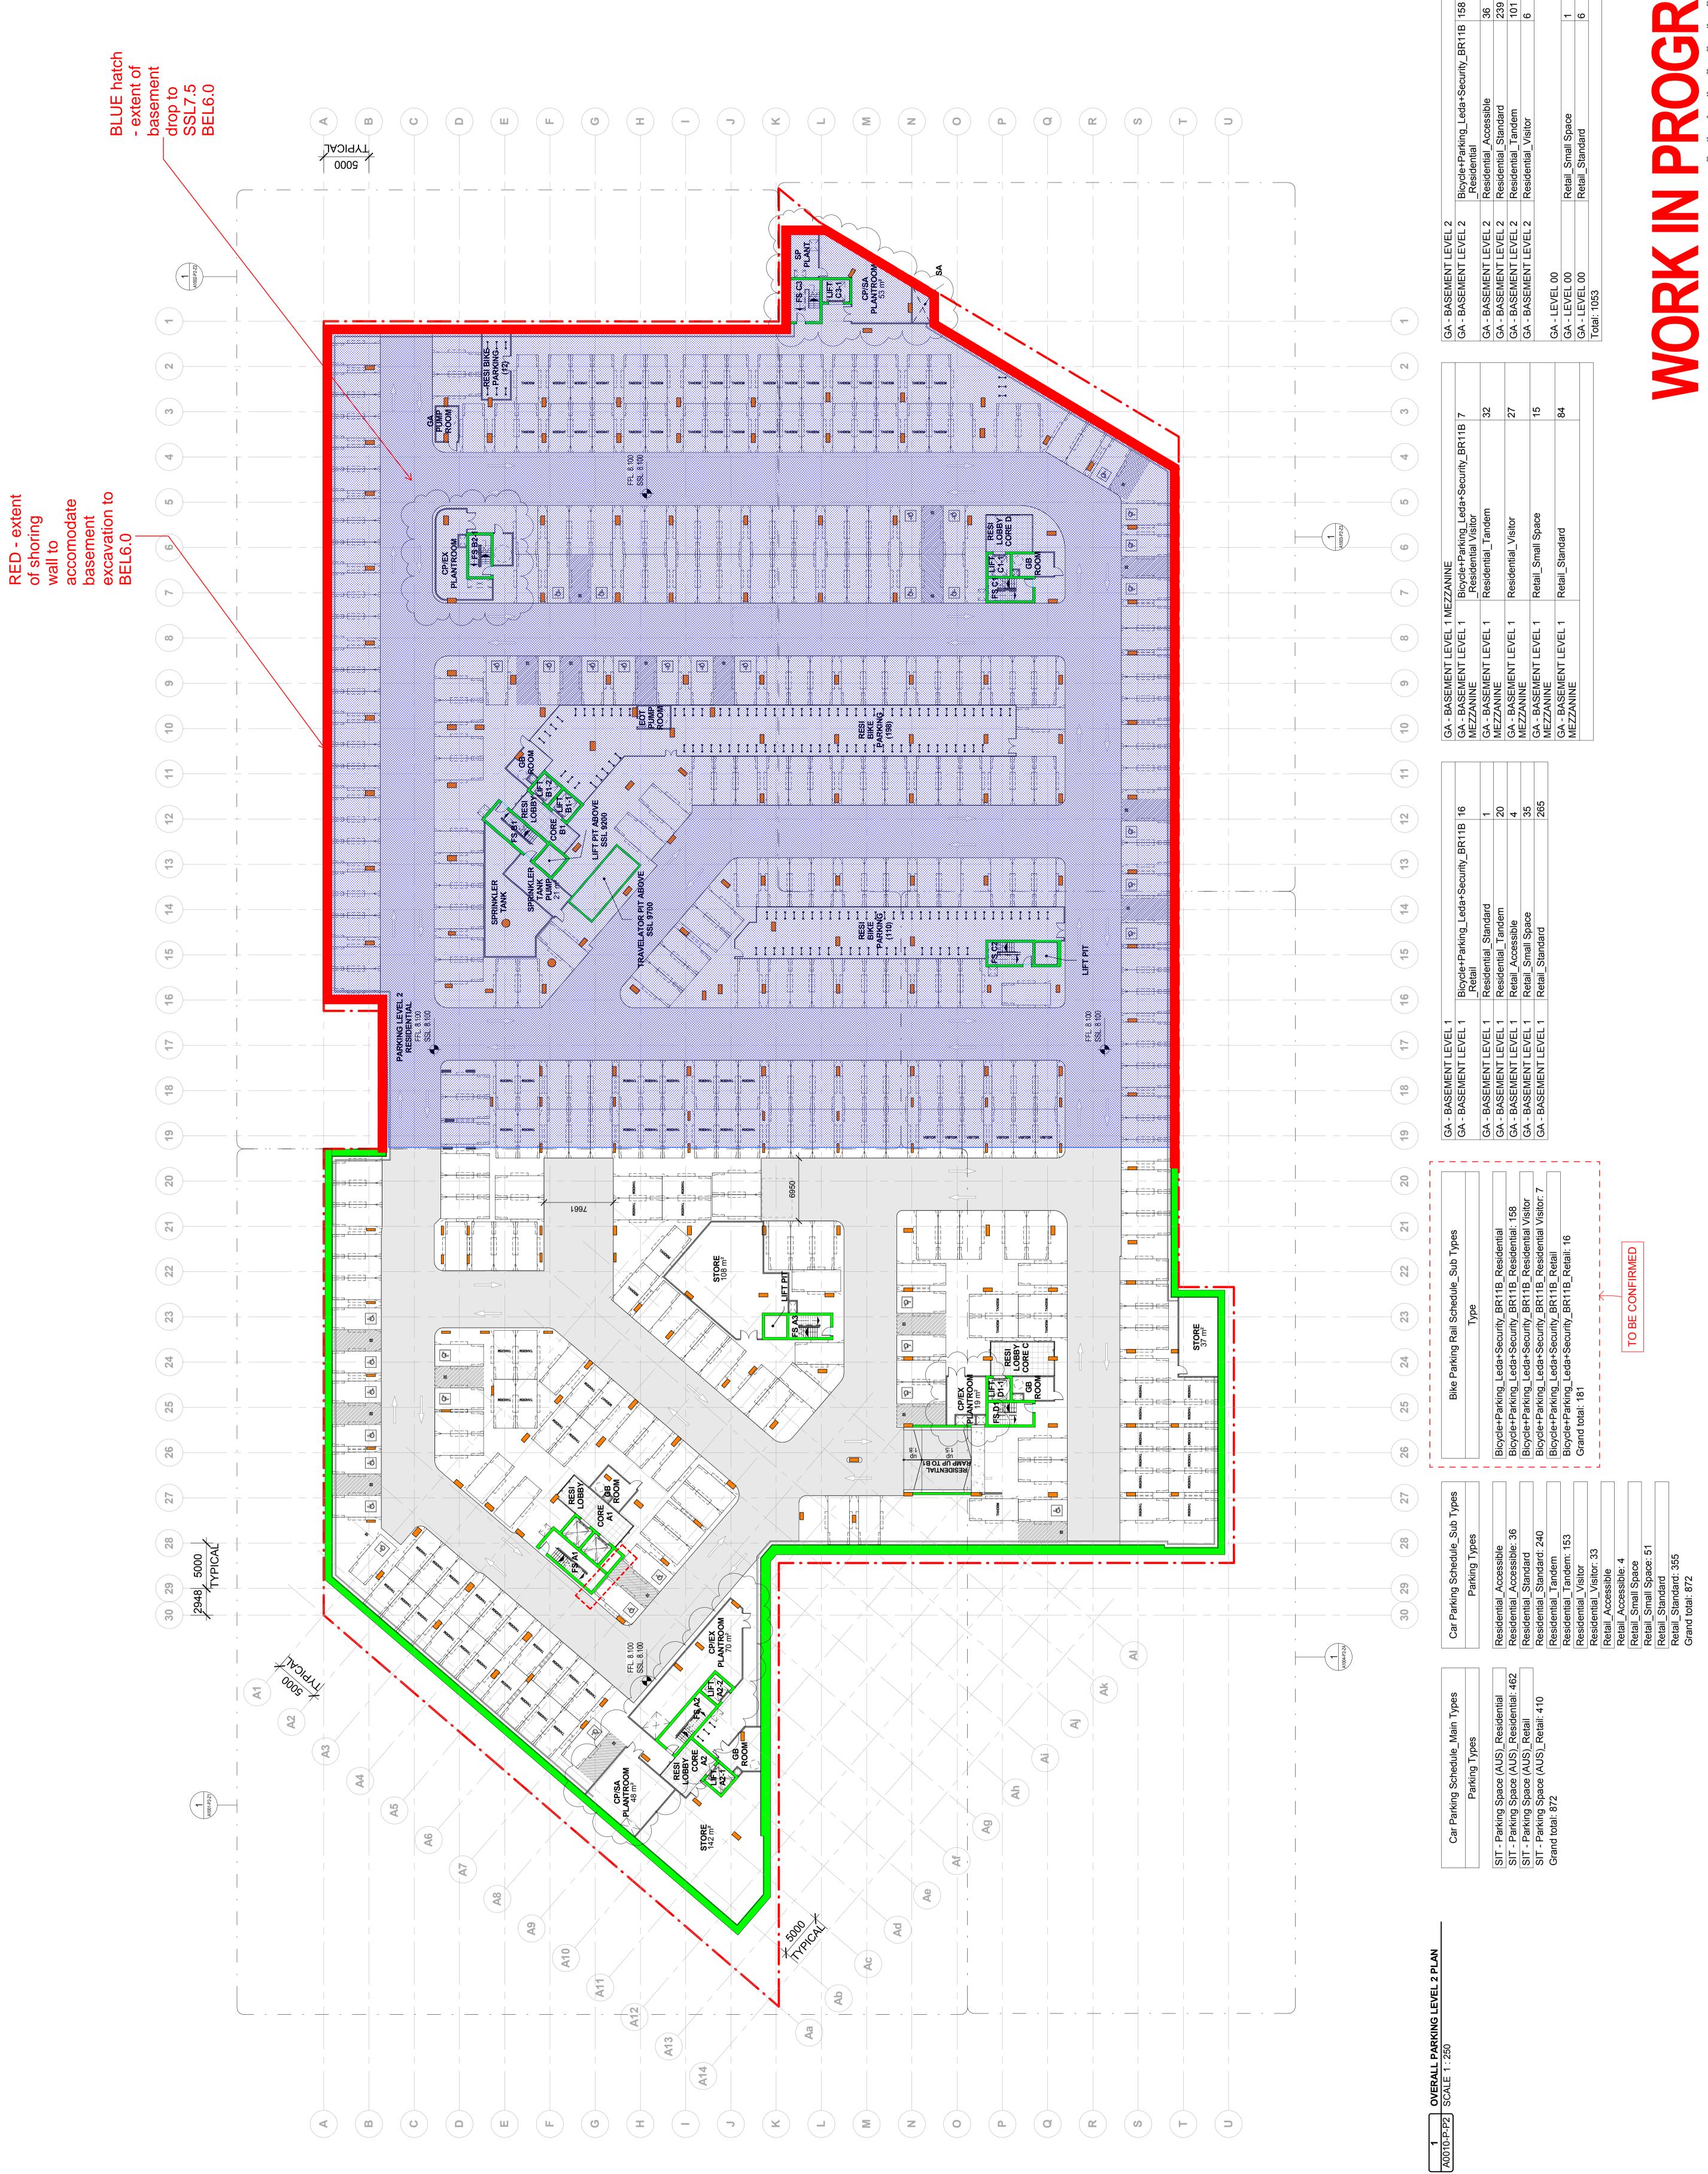
Meriton advised Coffey that an additional 0.6 metres of excavation is required in the eastern half of the basement footprint to accommodate design changes to the car park. Meriton requested Coffey's opinion, in writing, on potential effects of this change on management of excavated materials from the basement. The attached figure (Crone Architects, Drawing No. A0010-P-P2) shows the area affected by additional excavation.

Given the above information and Coffey's detailed understanding of natural soils within the intended excavation area, Coffey considers that excavation of an additional 0.6 metres of soil from the eastern

half of the basement will not generate spoil which is materially different from that excavated from the lower levels of the current basement.
