**GEOTECHNICAL RISK MANAGEMENT POLICY FOR PITTWATER
FORM NO. 1 – To be submitted with Development Application**

Report Title: Geotechnical Assessment	
Report Date: 18 February 2021	Report Ref No: 33855Yrpt
Author: Woodie Theunissen	
Author's Company/Organisation: JK Geotechnics Pty Ltd

REPORT TO
SUSAN ROTHWELL ARCHITECTS PTY LTD

ON
GEOTECHNICAL ASSESSMENT
**(In Accordance with Pittwater Council Risk
Management Policy)**

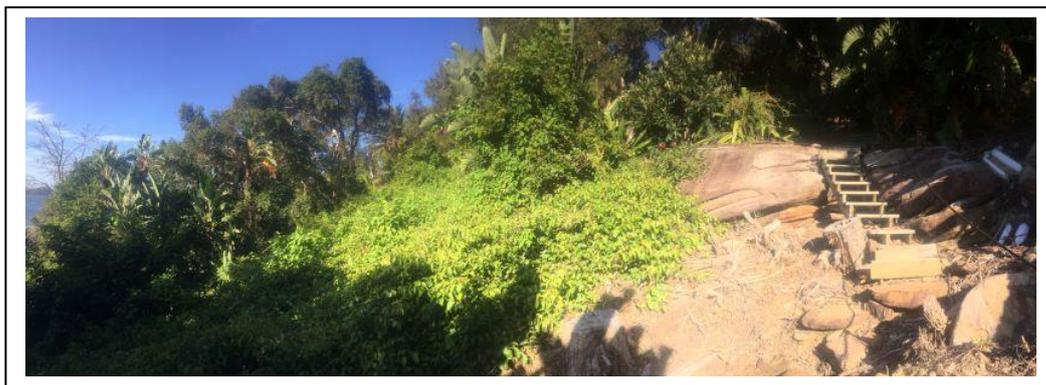
Where present sandstone outcrops are a maximum of about 2.7m in height and were assessed to be of at least medium to high strength. There appears to be two low height sandstone cliff lines that run diagonally across the site and are located approximately one-third of the way in from either ends of the site. While the upper cliff line could easily be observed and was undercut in places, the lower cliff line was heavily overgrown, inaccessible and could not be viewed, as can be seen in the photo below. Where undercut in the upper cliff line, the overhanging bedrock cantilevered by up to about 1.8m.

- 6.1.1 All proposed footings must be founded in sandstone bedrock. The footings should be designed for an allowable bearing pressure of 600kPa, subject to inspection by a geotechnical engineer prior to pouring. Care must be taken that footings are not founded on undercut sections of the existing cliff beneath the house. Removal of the overhanging rock or underpinning would be required where this occurs.

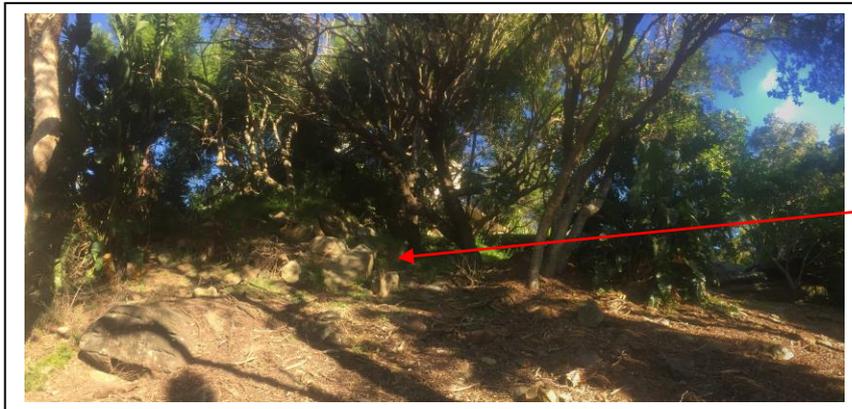
Rough
Sandstone
Boulder Wall

Approximately one third of the way down the eastern site boundary is what appears to be a rough sandstone boulder wall that appears to have been constructed to provide a level area to the rear of the house on the adjoining property to the east, 38 Sunset Road. This wall has a maximum height of about 2.5m and is raked back at about 45° to 50°. This wall extends into the site and does not appear to show signs of distress. This is shown in the photo below.
