**GEOTECHNICAL RISK MANAGEMENT POLICY FOR PITTWATER
FORM NO. 1 – To be submitted with Development Application**

Address of site 40 Sunrise Road, Palm Beach

**REPORT TO
SUSAN ROTHWELL ARCHITECTS PTY LTD**

**ON
GEOTECHNICAL ASSESSMENT
(In Accordance with Pittwater Council Risk
Management Policy)**

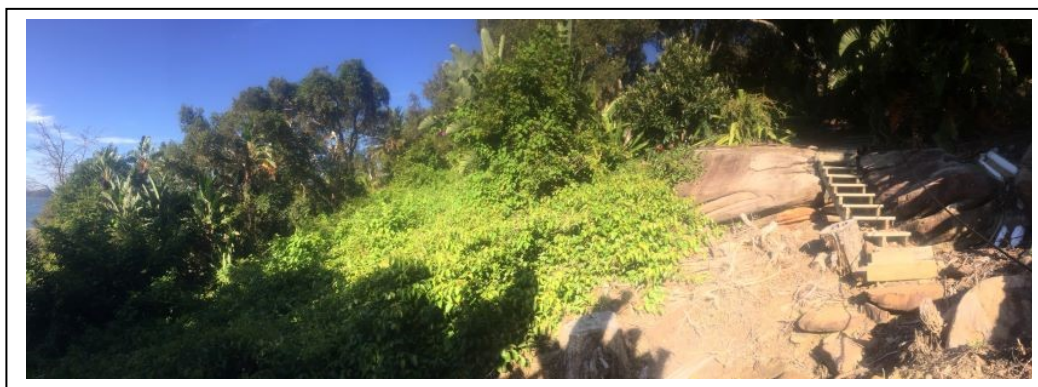
Where present sandstone outcrops are a maximum of about 2.7m in height and were assessed to be of at least medium to high strength. There appears to be two low height sandstone cliff lines that run diagonally across the site and are located approximately one-third of the way in from either ends of the site. While the upper cliff line could easily be observed and was undercut in places, the lower cliff line was heavily overgrown, inaccessible and could not be viewed, as can be seen in the photo below. Where undercut in the upper cliff line, the overhanging bedrock cantilevered by up to about 1.8m.

- 6.1.1 All proposed footings must be founded in sandstone bedrock. The footings should be designed for an allowable bearing pressure of 600kPa, subject to inspection by a geotechnical engineer prior to pouring. Care must be taken that footings are not founded on undercut sections of the existing cliff beneath the house. Removal of the overhanging rock or underpinning would be required where this occurs.

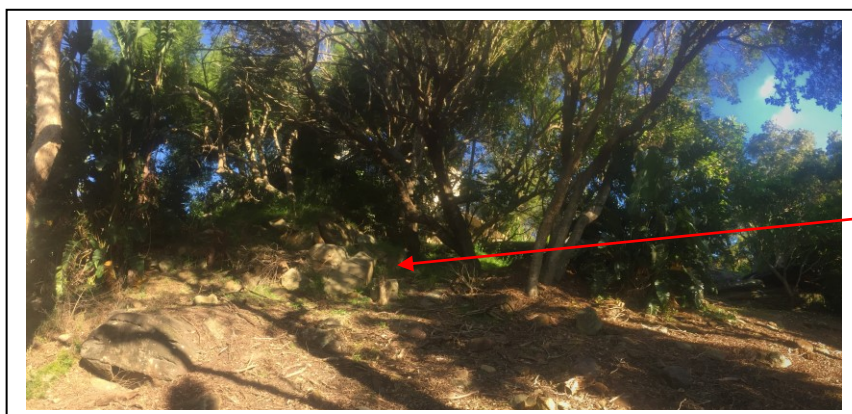
Rough
Sandstone
Boulder Wall

Approximately one third of the way down the eastern site boundary is what appears to be a rough sandstone boulder wall that appears to have been constructed to provide a level area to the rear of the house on the

adjoining property to the east, 38 Sunset Road. This wall has a maximum height of about 2.5m and is raked back at about 45° to 50°. This wall extends into the site and does not appear to show signs of distress. This is shown in the photo below.
