AS2870-2011 SITE CLASSIFICATION

**Lot 52, No 154 Plateau Road
Bilgola Plateau NSW**

Our REF: AWT 82468

AS2870 SITE CLASSIFICATION
Class P

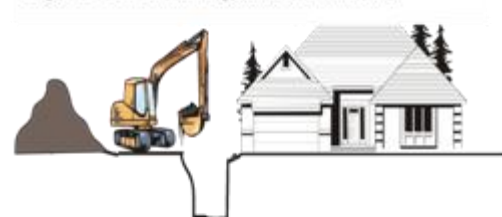
Fig. 11 De-stabilizing house foundations

- Special considerations if any excavations are to be dug near adjoining structures. (Fig. 11)
- Sloping the soil and paths away from the building by the minimum amount required by the building regulations to prevent water flowing towards the building foundations. (Fig. 10 & 18)

- Running machinery over shallow drain pipes may break them causing leaks and subsequent foundation movements.
- Any excavations close to building footings can cause them to sink by disturbing the foundation material or by drying the foundation clay. (Fig 11)
