# Preliminary Geotechnical Assessment

**Project:** New Swimming Pool  
13 Friendship Place, Beacon Hill NSW

**Ref:** AG 25284  
4 July 2025

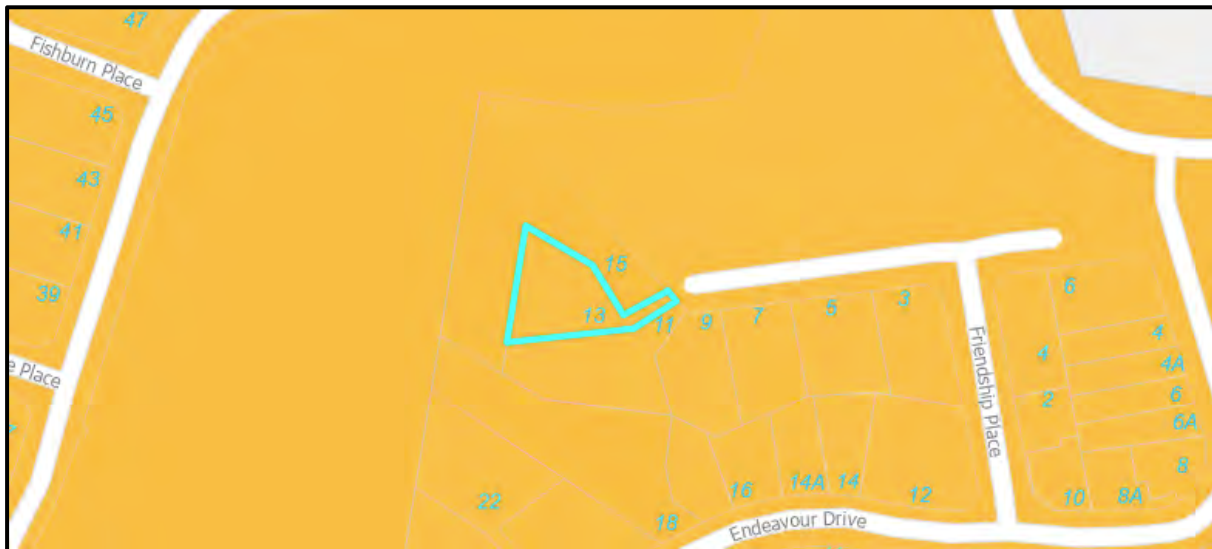
The site is mapped as **Area B** subject to specific landslip risk/geotechnical hazard mapping with reference to the Warringah (WLEP) Landslip Risk Map, Northern Beaches Council (**Image 1**).

**Figure 1.** Warringah Landslip Risk Map:  
13 Friendship Place, Beacon Hill NSW (© NBC Maps)

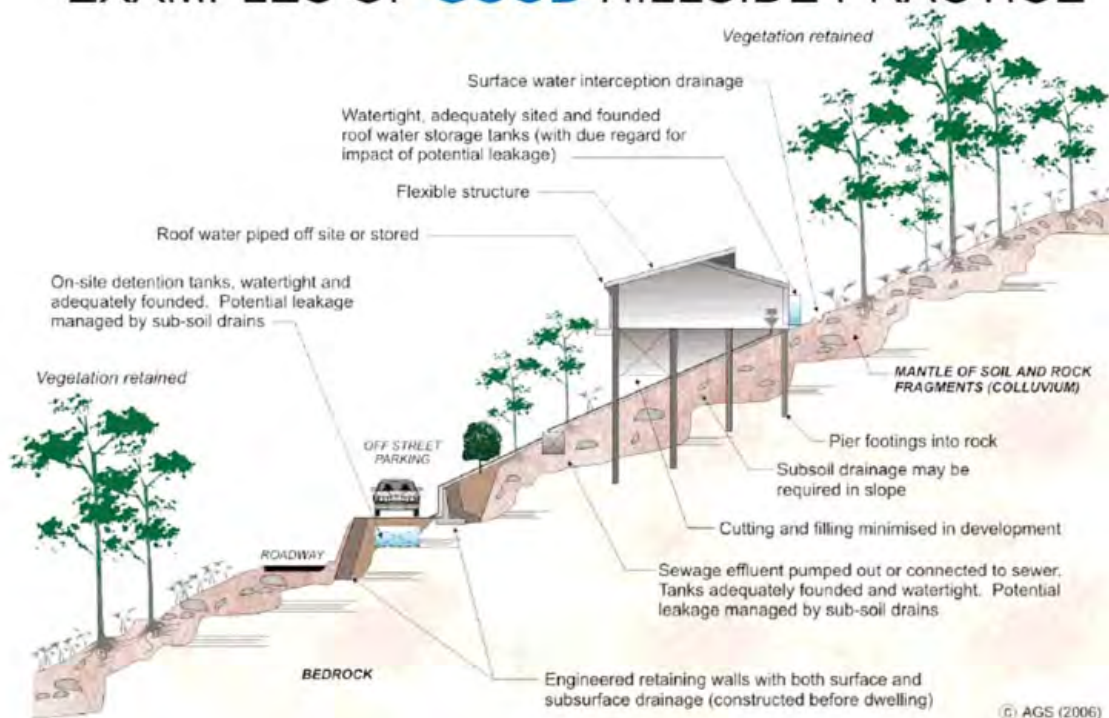
## EXAMPLES OF **GOOD** HILLSIDE PRACTICE

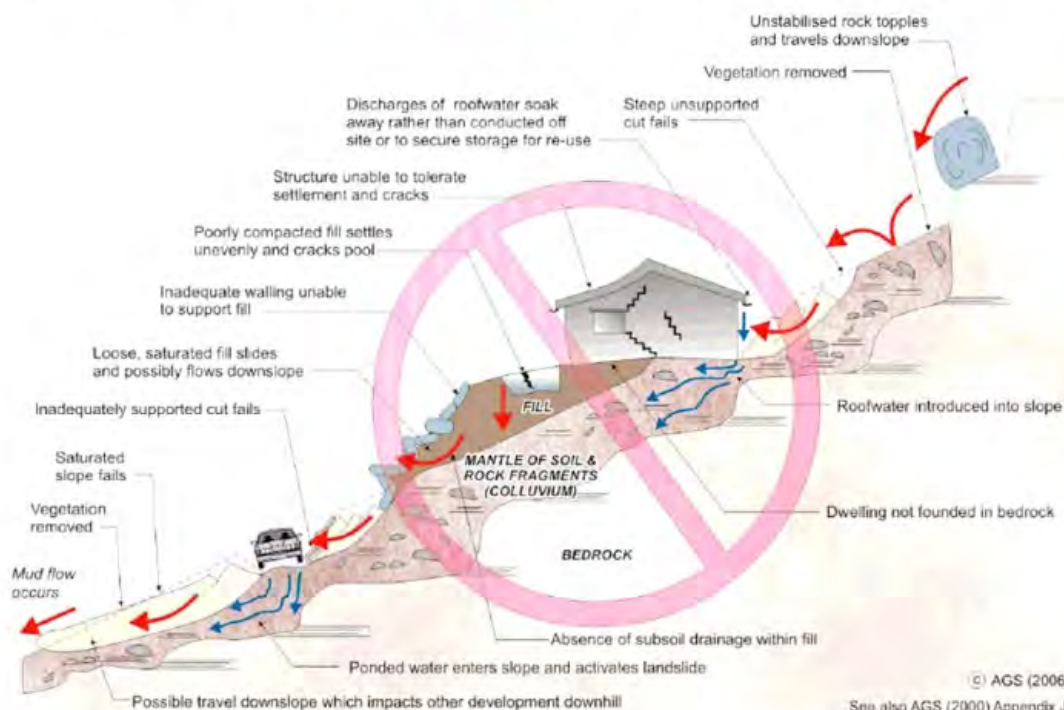
## EXAMPLES OF **POOR** HILLSIDE PRACTICE
