# Preliminary Geotechnical Assessment

**Project:** Alterations & Additions  
14 Pitt Road, North Curl Curl NSW

**Ref:** AG 25247  
10 June 2025

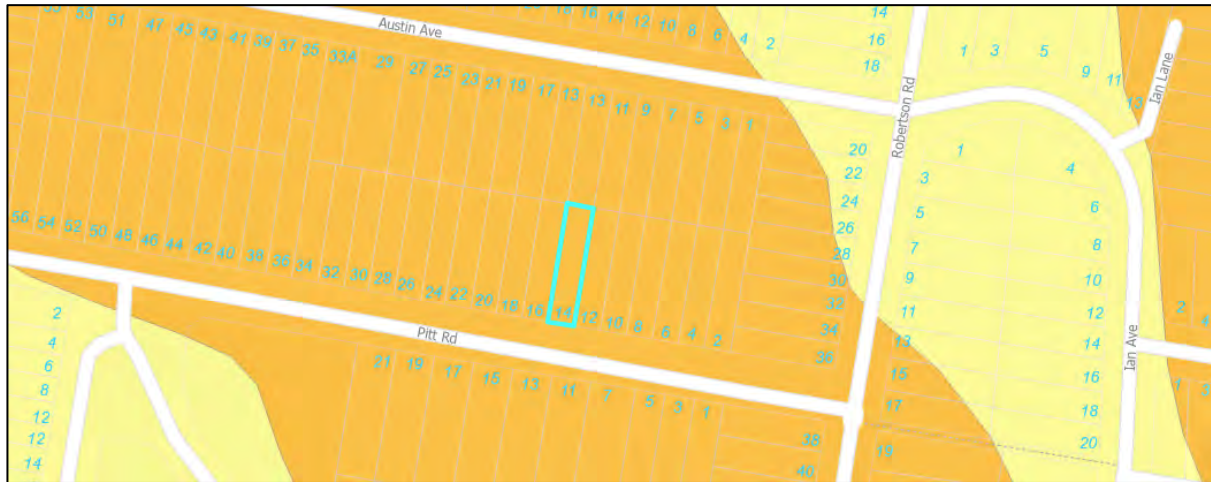
The site is mapped as **Area B** subject to specific landslip risk/geotechnical hazard mapping with reference to the Warringah (WLEP) Landslip Risk Map, Northern Beaches Council (**Image 1**).

**Figure 1.** Warringah Landslip Risk Map:  
14 Pitt Road, North Curl Curl NSW (© NBC Maps)
