**RESIDENTIAL DEVELOPMENT
37-43 HAY STREET COLLAROY NSW**

Reference: P2828_01

8 March 2023

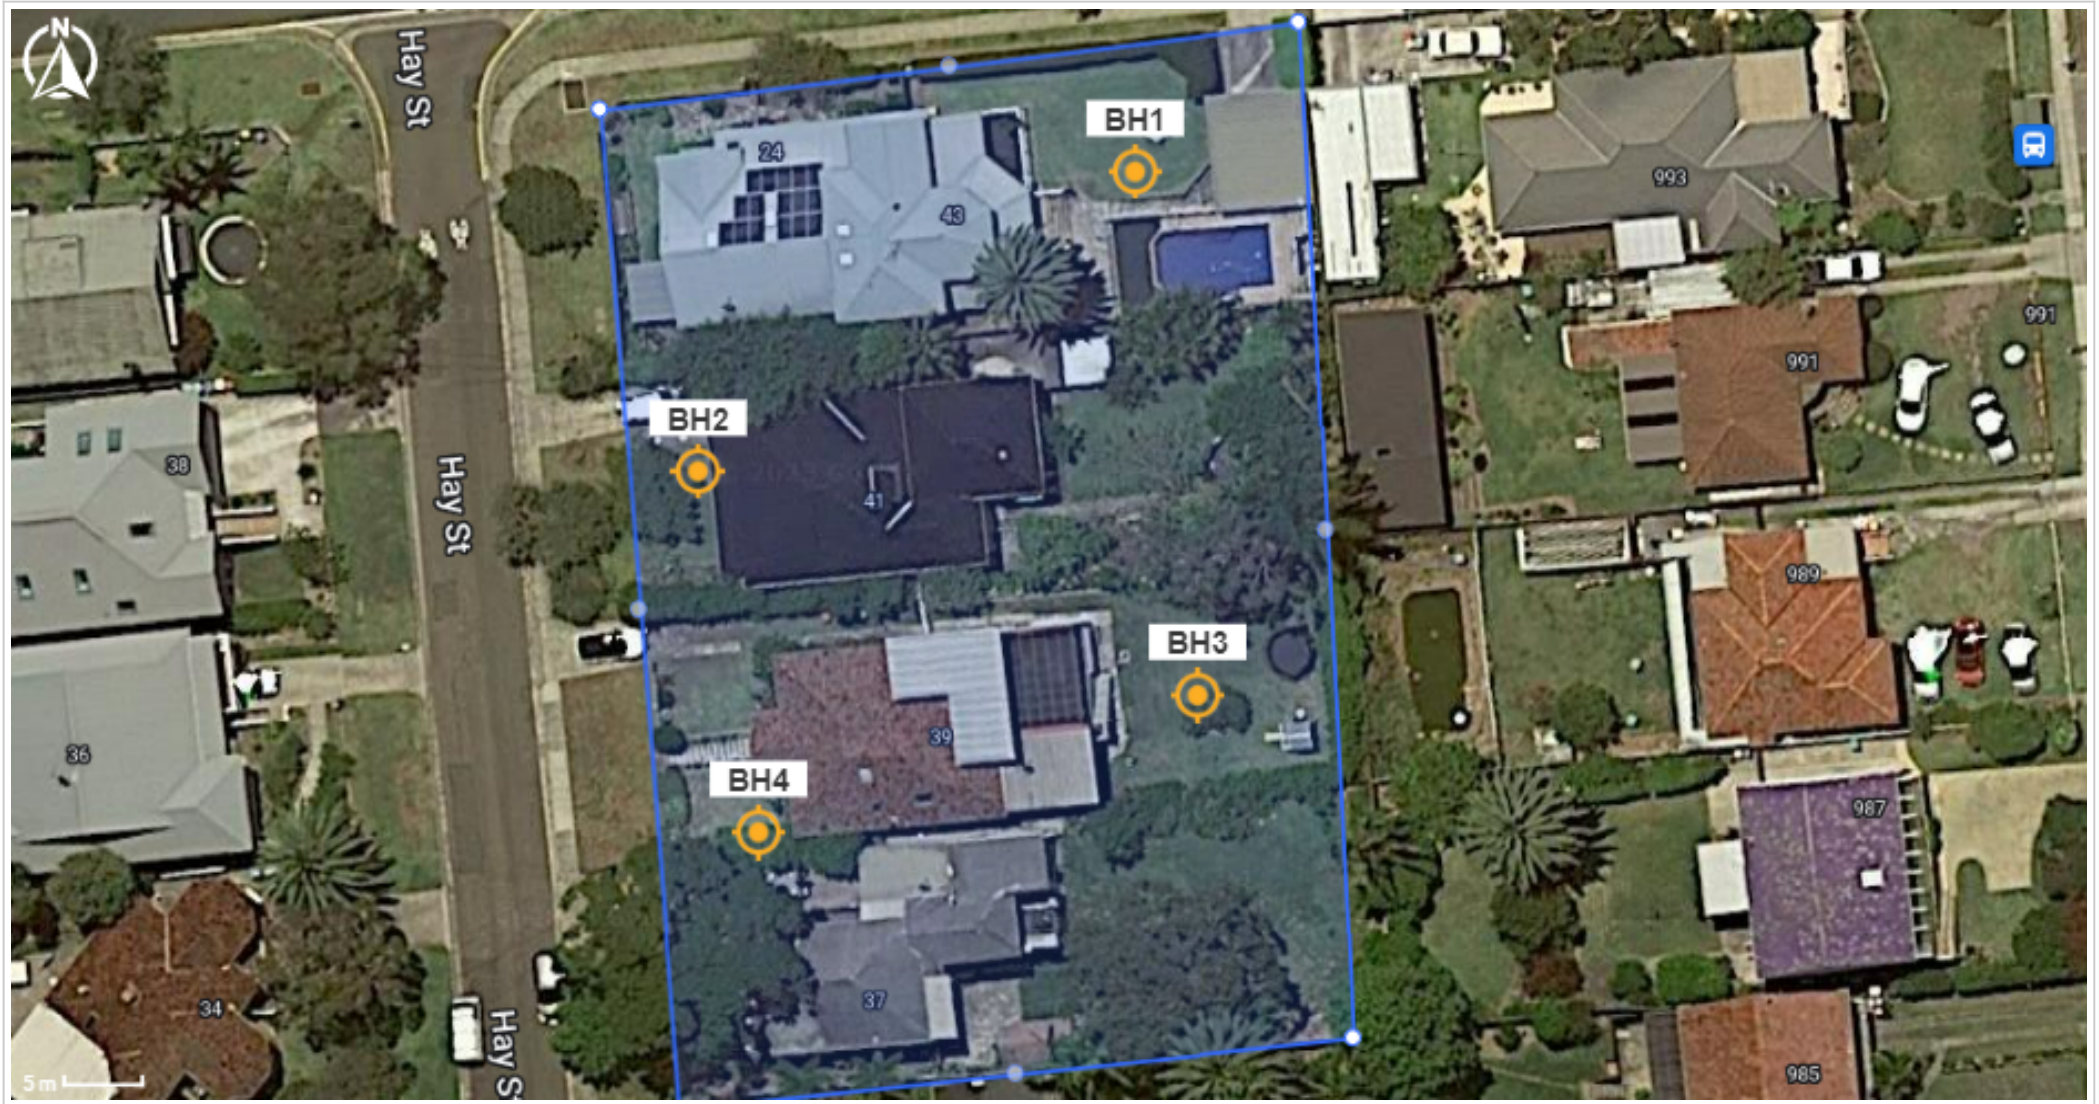
Map description	P2828 -Borehole Location Plan		
Site location	37-43 Hay Street, Collaroy NSW		
Client	Collaroy Living Pty Ltd		
Project name	Collaroy		
Project No	P2828	Scale	Not to scale

Investigation locations are shown on **Figure 1** and the borehole logs are presented in Appendix A.
