Job No: 11201/1
Our Ref: 11201/1-AE
26 February 2014

re: **Proposed Mixed Development**
1184-1186 Pittwater Road, cnr Clarke Street, Narrabeen
Geotechnical Investigation

Bonus & Associates Architects
Proposed Mixed Development
1184-1186 Pittwater Road,
Narabeen

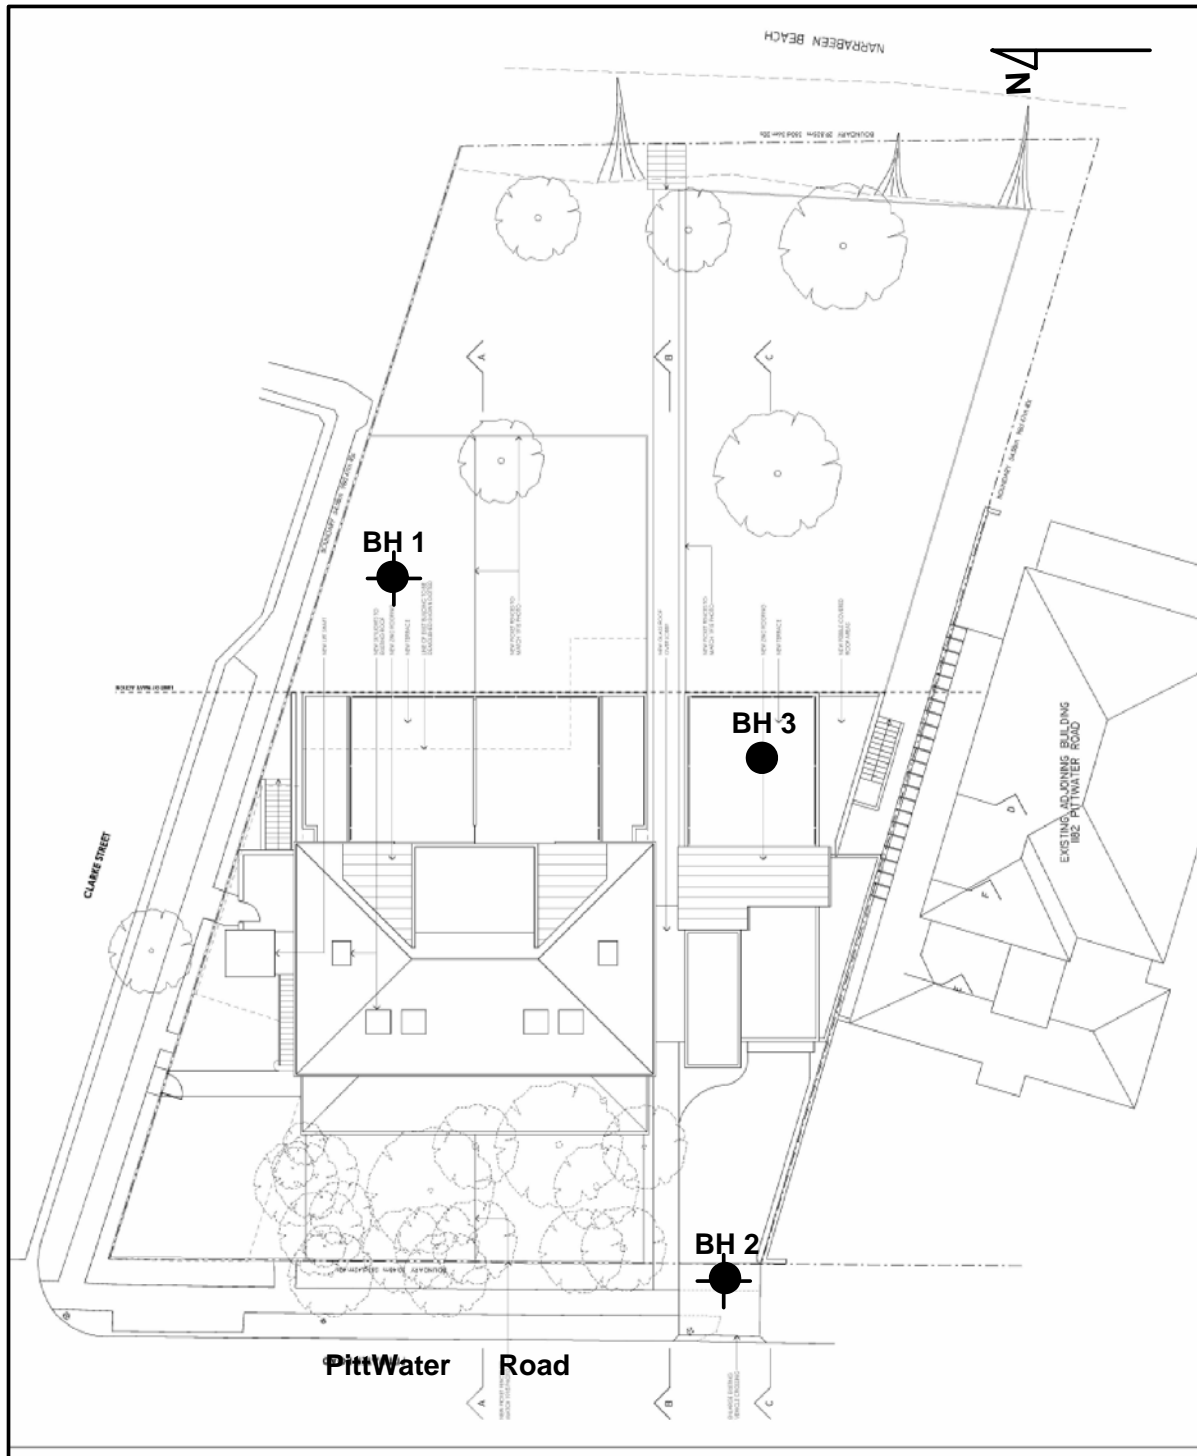
Borehole & Monitoring Well Location Plan

- Drilling at three locations (BH1, BH2 and BH3) using a utility mounted drilling rig fully equipped for geotechnical investigations. Boreholes were uniformly distributed in accessible portions of the site and drilled to depths of about 8.5m from existing ground surface. The approximate borehole locations are shown on the attached Drawing 11201/1-1. Borehole logs are also attached.

Drawing No: 11201/1-1
Job No: 11201/1
Drawn By: ZM
Scale: 1: 350
Date: 08/09/2006
Checked By: ZM

Attached	Borehole Location Plan – Drawing No 11201/1-1
	Engineering Borehole Logs
	Explanatory Notes
	Updated Basement Plan
	Laboratory Test Results
