AS2870-2011 SITE CLASSIFICATION

Lot 32 No 21 Soldiers Avenue Freshwater NSW

Our REF: AWT 75576

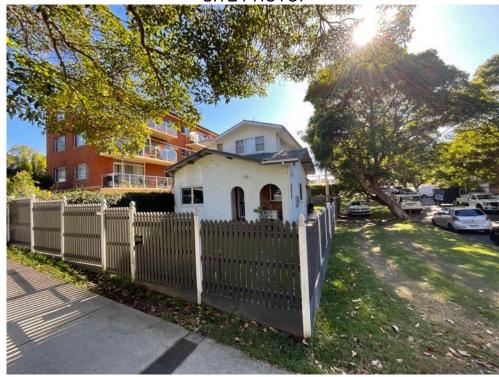
SITE PHOTO:

Site Features: Existing Dwelling with grass & adjoining trees
