Geotechnical Investigation Report

28 Lockwood Ave

Report G10132-1

Proposed Mixed-Use Development

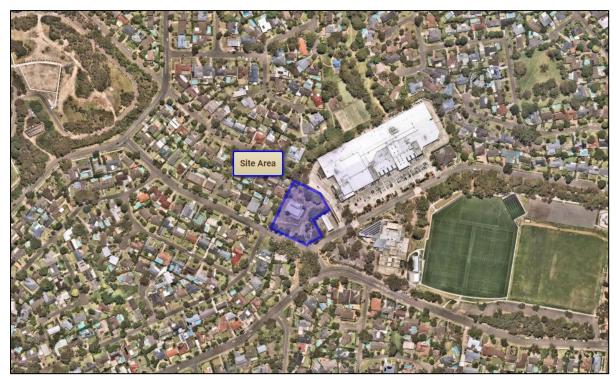
Image 2 - General Site Location

As indicated in Image 2, the site is bounded by:

- Residential dwellings (to west);
- Lockwood Av (to south);
- Service Station (to east); and
- Glenrose Place (to north).

It is understood that the proposed development comprises the demolition of the existing site structures and the construction of a two (2) multi-leveled structure with underground basement facilities, located within the internal confines of the site boundary (Image 2).

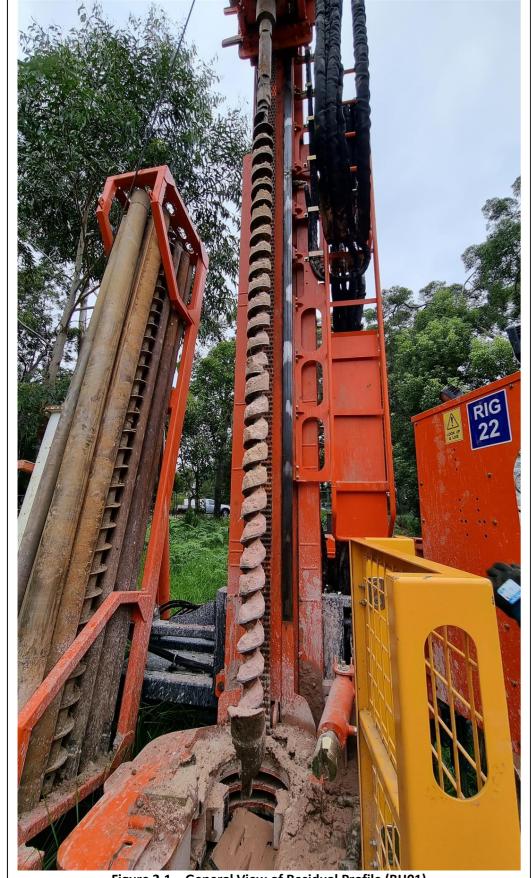
Figure 2.1 – General View of Residual Profile (BH01)

The residual soils comprise low plasticity, firm to stiff sandy clay, loose to very dense clayey sand and silty sand. The depth of the residual soil encountered, extends to an approximate depth of 2.2m to 2.5m across the site.

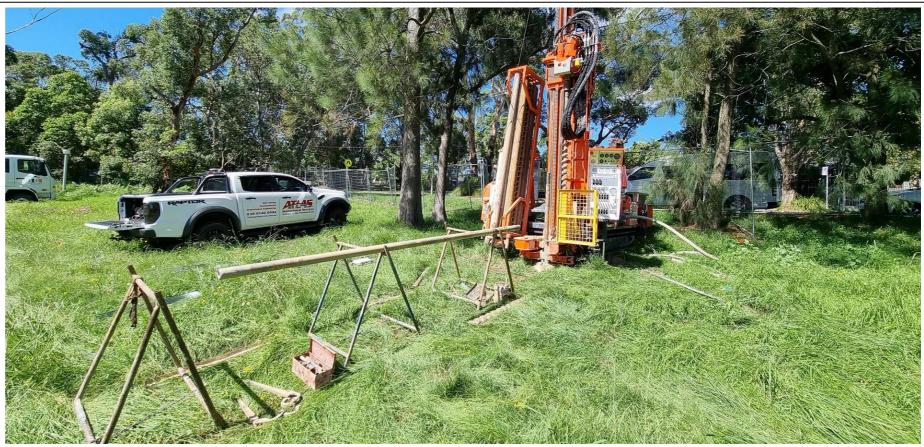
Figure 2.2 – General View of Drilling Operation (BH02)

The boreholes were drilled using a Hanjin D&B 8D drilling rig operated by BG Drilling. The boreholes were advanced by solid flight 100 mm diameter auger with a TC (Tungsten Carbide) drill bit. A combination of augering with a TC drill bit and core drilling with NMLC core barrel was used to advance each borehole and were terminated upon reaching the target depth.

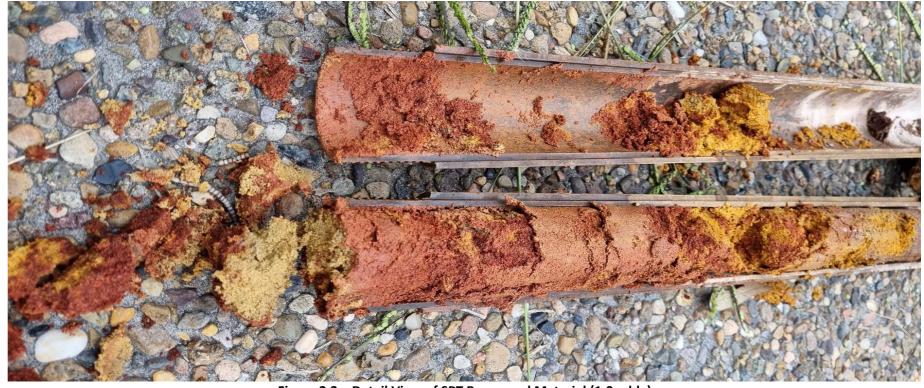
Figure 2.3 – Detail View of SPT Recovered Material (1.0m blg)

During the site investigation, the subsurface strata encountered was logged by an AGS's geotechnical engineer and SPTs were undertaken at selected intervals to assess shallow soil consistency. The borehole logs and the core box photos are enclosed in Appendix B and A respectively.

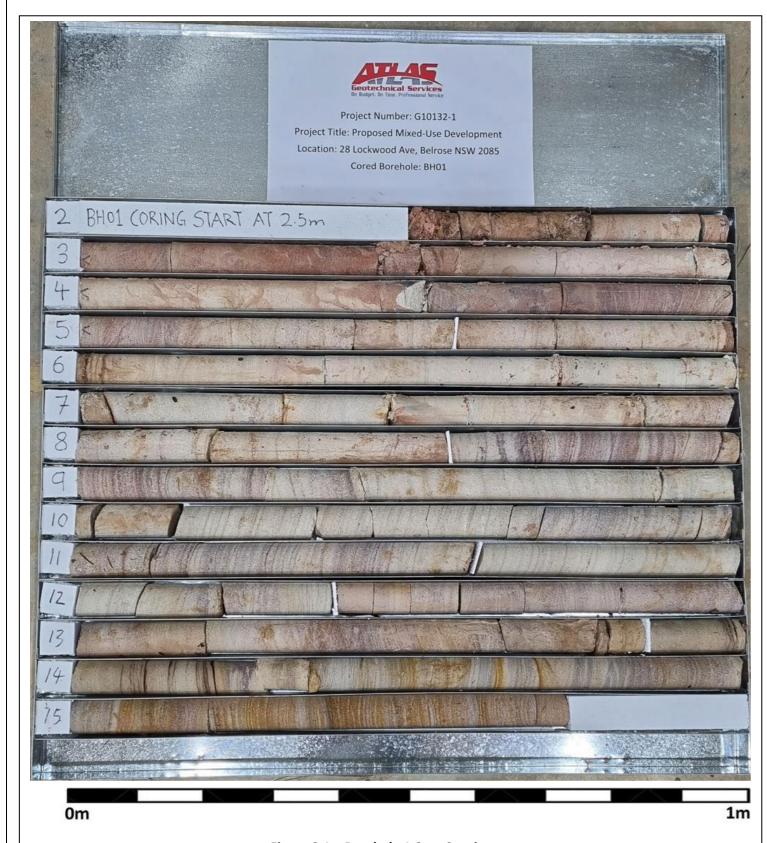
Figure 3.1 – Borehole 1 Core Specimens

The site is underlain by extremely to slightly weathered, extremely low to high strength sandstone bedrock extending to an approximate depth of 15.75m, across the site. Frequent clay seams were observed across all cored boreholes, varying between 4m, 8m, 11m and 14 below ground levels across selected boreholes.

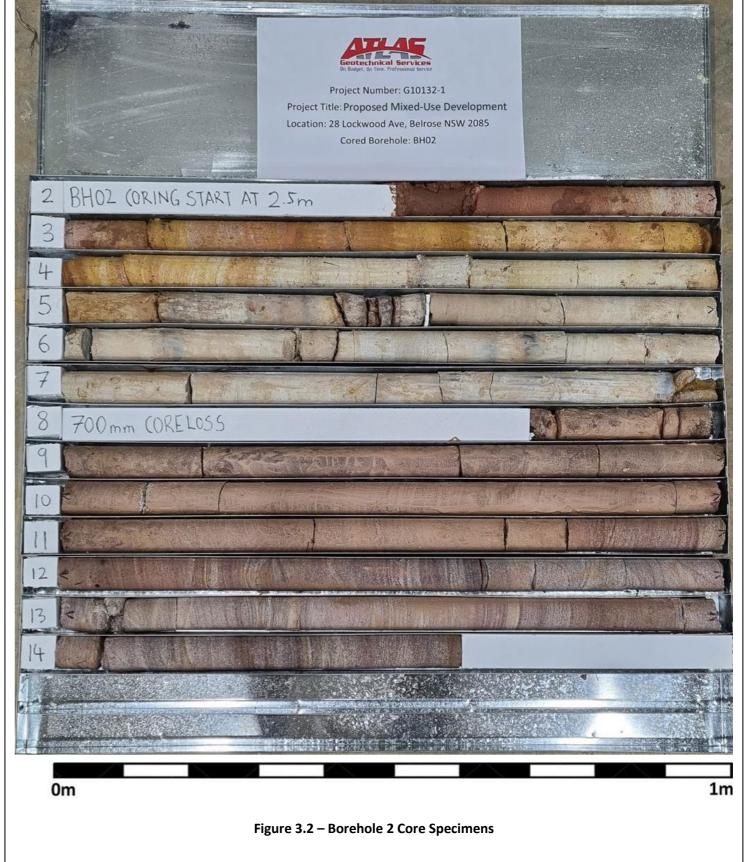
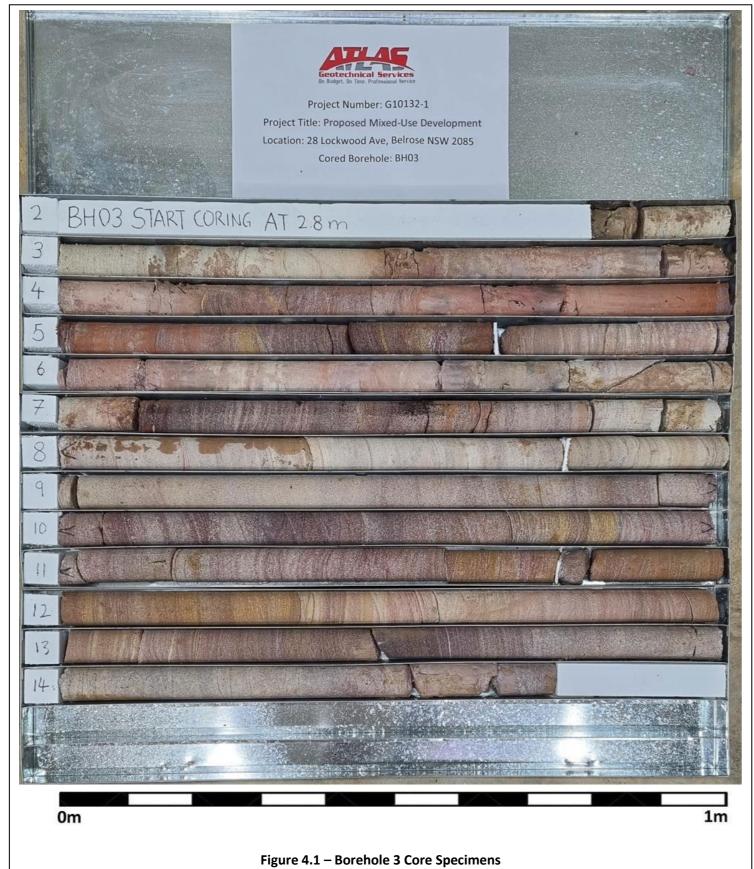
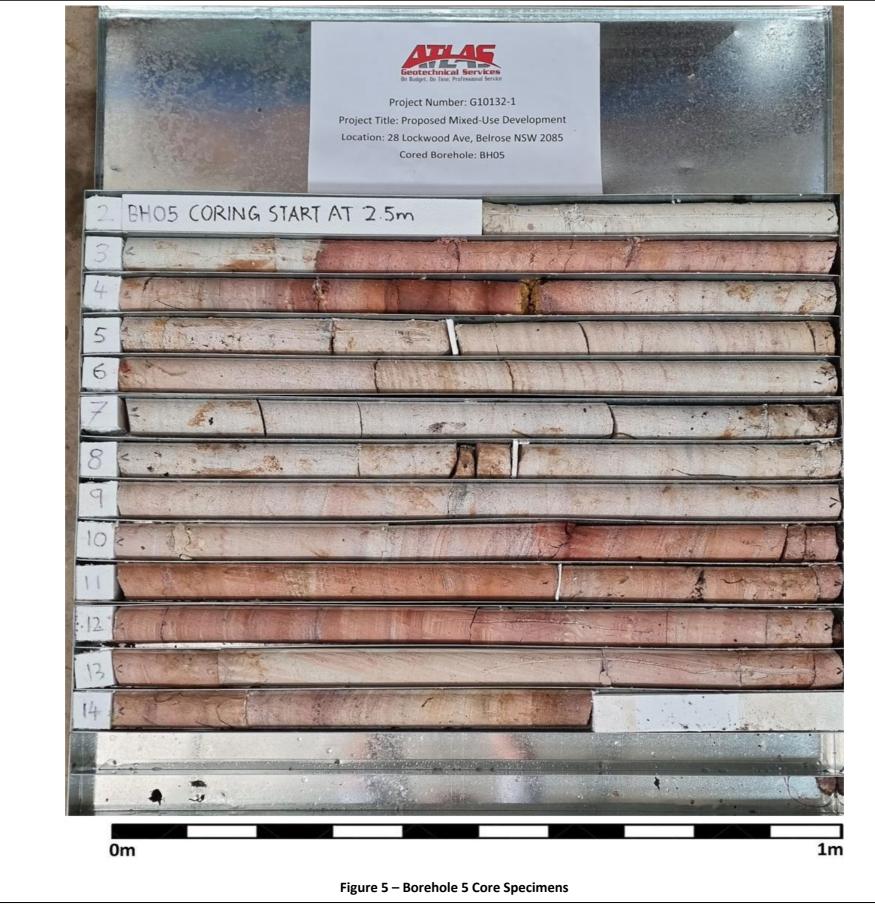
Core Specimens
