**Proposed Mixed Use Development  
349 Barrenjoey Road, Newport NSW**

Preliminary Geotechnical Assessment

Our ref: 6145-G1  
17 August 2020

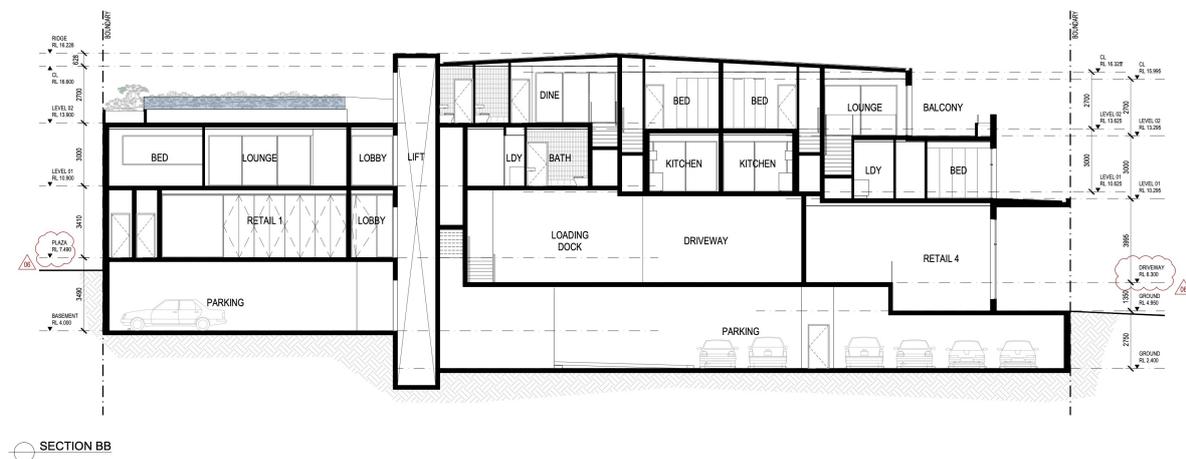
**Plate 1 - Section B-B**

Based on the supplied drawings, we understand that the project involves construction of a three-storey mixed-use development with a single-level basement car park, floor levels ranging from RL 2.4m AHD over eastern part to RL 4m AHD over western part. Excavation of up to 3m depth is anticipated, locally up to about 3.5m depth for the lift overrun pit, as indicated in Plate 1.

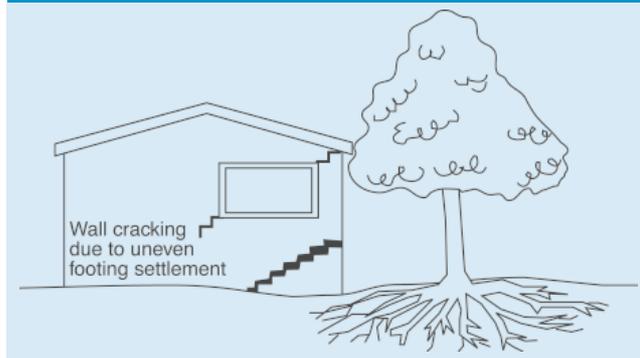
### Trees can cause shrinkage and damage

As the weather pattern changes and the soil begins to dry out, the external footings will be first affected, beginning with the locations where the sun's effect is strongest. This has the effect of lowering the external footings. The doming is accentuated and cracking reduces or disappears where it occurred because of dishing, but other cracks open up. The roof lines may become convex.
