Proposed Swimming Pool 13 Oceana St. East, Dee Why NSW

Geotechnical Investigation

Our ref: 6040-G1
25 May 2020

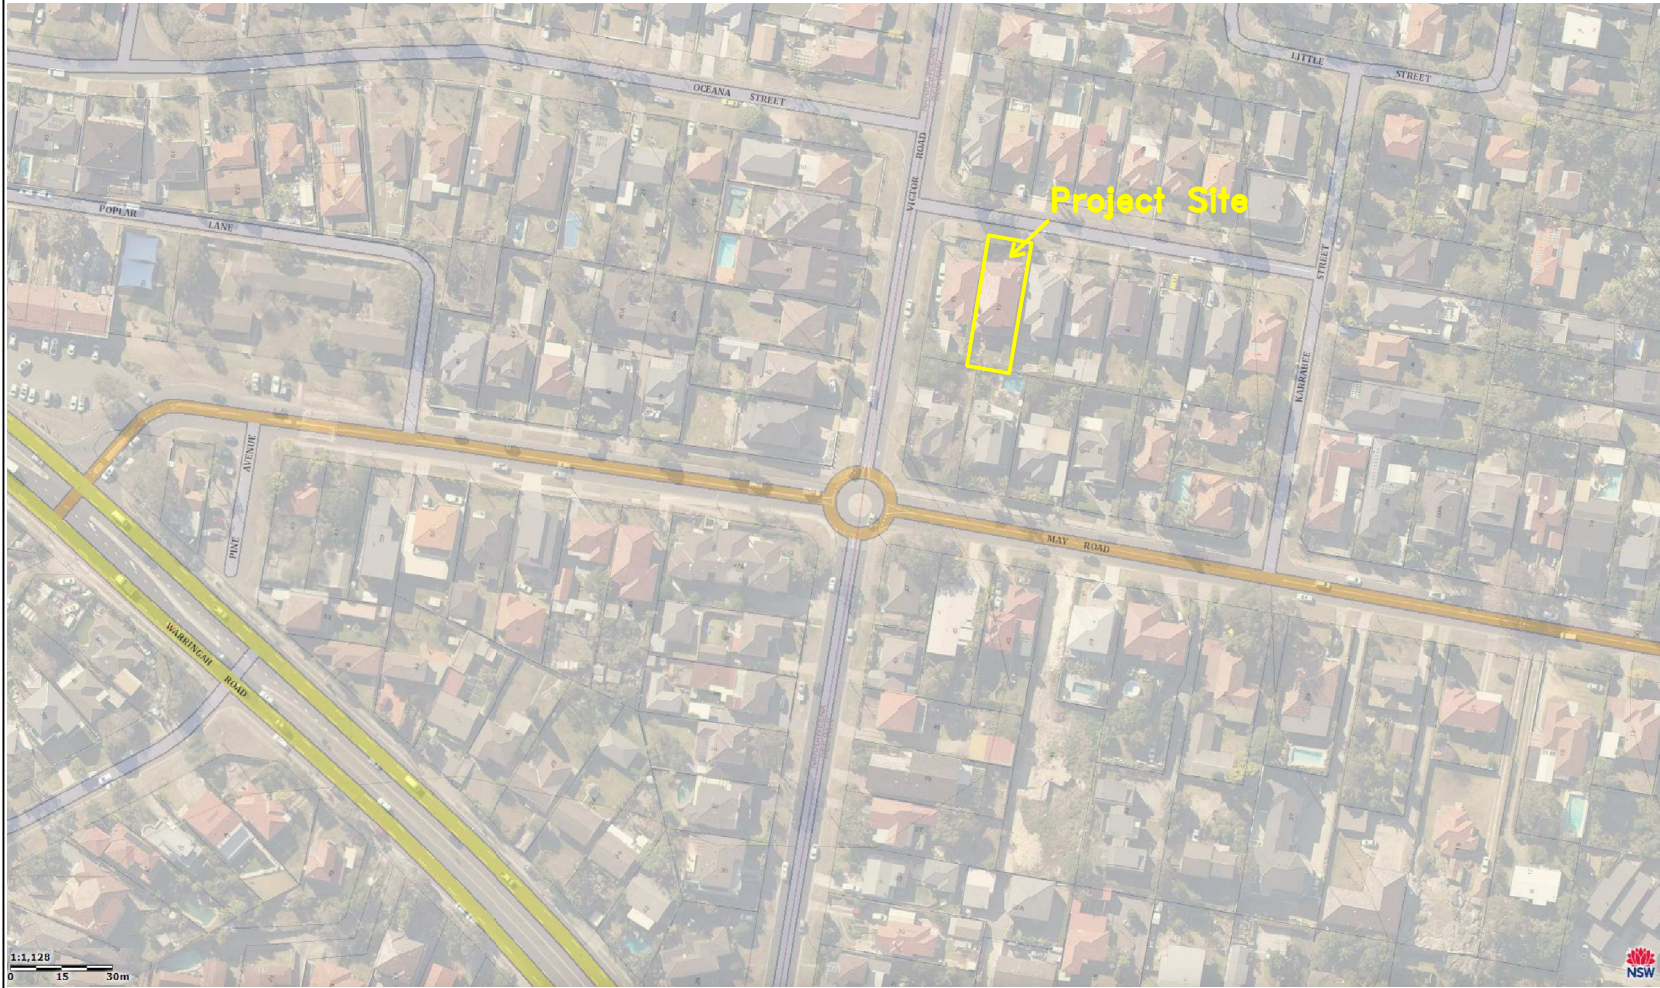
job no.:
6040
fig: 1
issue: A

THIS DRAWING IS USED TO
ILLUSTRATE TEST LOCATIONS
ONLY, AND MUST NOT BE
USED FOR ANY OTHER
PURPOSE. COPYRIGHT OF
SOURCE DRAWING REMAINS
WITH NSW SIX MAPS.

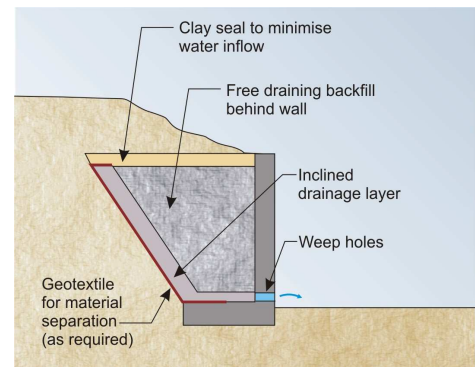
Figure 1- Typical formed concrete wall

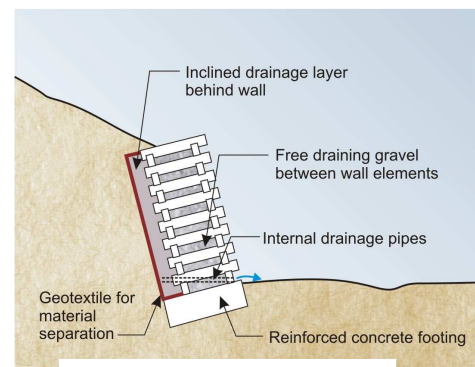
Figure 2 -Typical crib

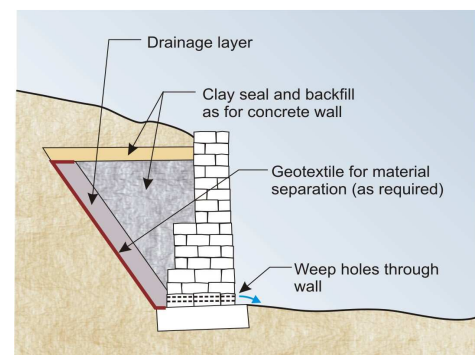
Masonry walls: natural stone, brick, or interlocking blocks (Figure 3) - more than about 1m high, should be wider at the bottom than at the top and include specific measures to permit drainage of the backfill. They should be checked as for formed concrete walls. Natural stone walls should be inspected for signs of deterioration of the individual blocks: strength loss, corners becoming rounded, cracks appearing, or debris from the blocks collecting at the foot of the wall.

Figure 3 -Typical masonry wall

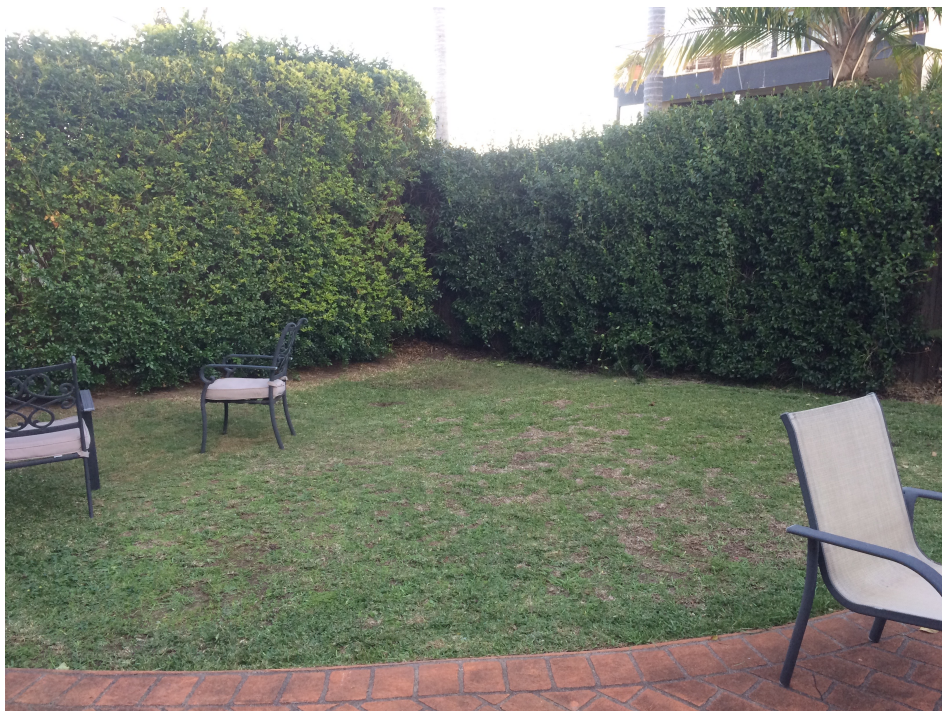
Photo 2
Proposed Swimming
Pool Area in the
Backyard Covered by
Grasses

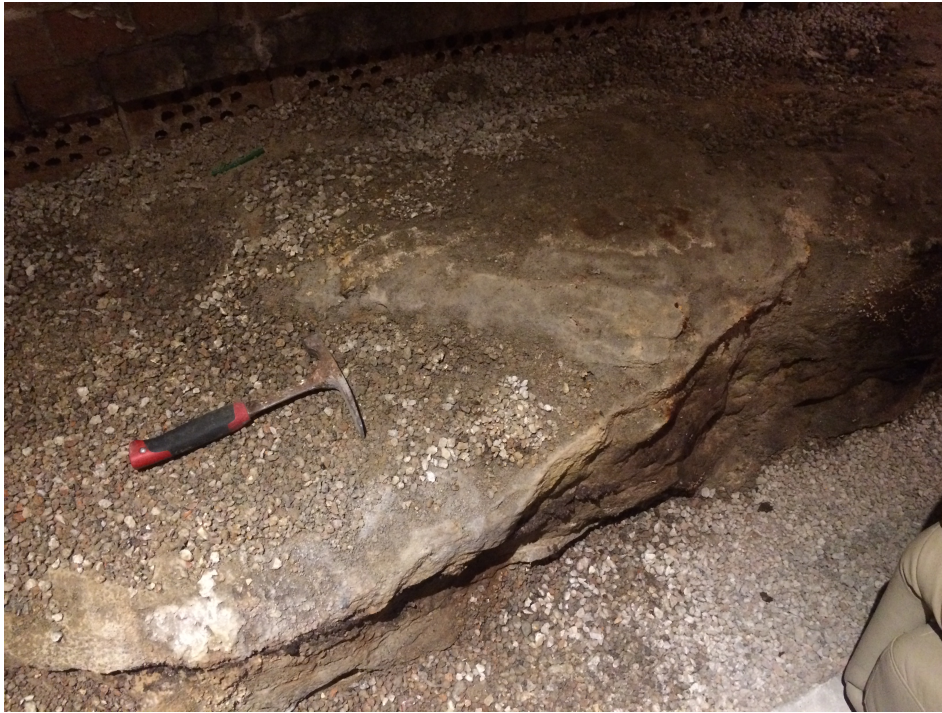
Photo 3

Outcrops of Sandstone
in the Basement Level
