MOD2021/0198

1 S4.55 EAST ELEVATION
1 : 100

1 Section 1 - SOUTH AND WEST RETAINING WALL
1 : 100

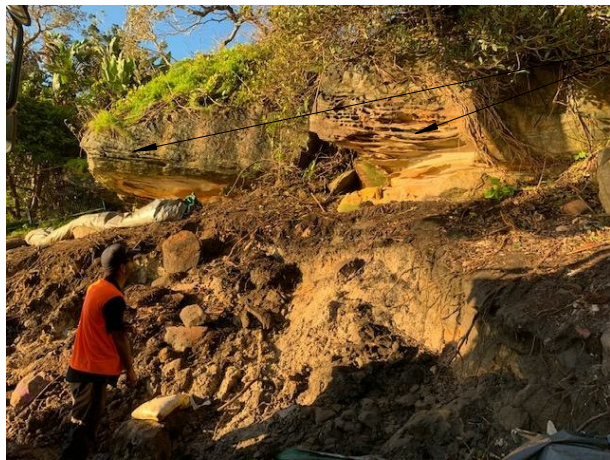
Note:
actual rock overhang
refer photos

raise top of west retaining wall
to support existing rock above
as geotech report

new fence to continue to
existing rock face between
properties on boundary line
- confirm on site

confirm extent of concrete piles
and capping beam to southern
boundary with engineers detail

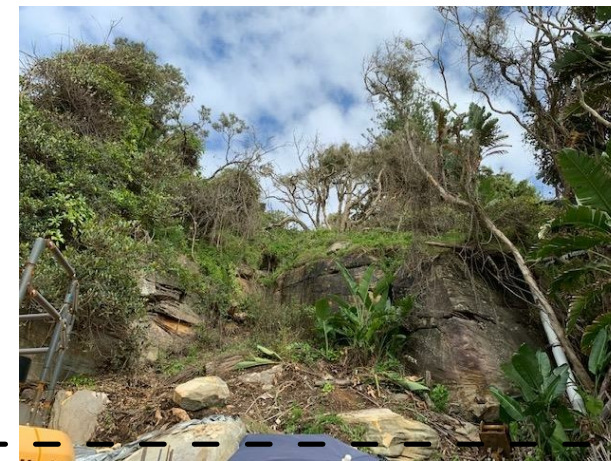
1 Section 2 - NORTH AND WEST RETAINING WALL
1 : 100

EXISTING ROCK FACE

approx RL 23.000
