1886 – 307 Sydney Road, Balgowlah
Archival Report
July 2022

1886 - 307 Sydney Road, Balgowlah
- ARCHIVAL REPORT

This archival Photographic Record of 307 Sydney Road, 12 Boyle Street, Balgowlah was prepared by Architectural Projects Pty Limited, Architects for Sun Property Balgowlah Pty Ltd in June 2022 to fulfil a Development Application & Conditions of Consent No. 19, and 20.

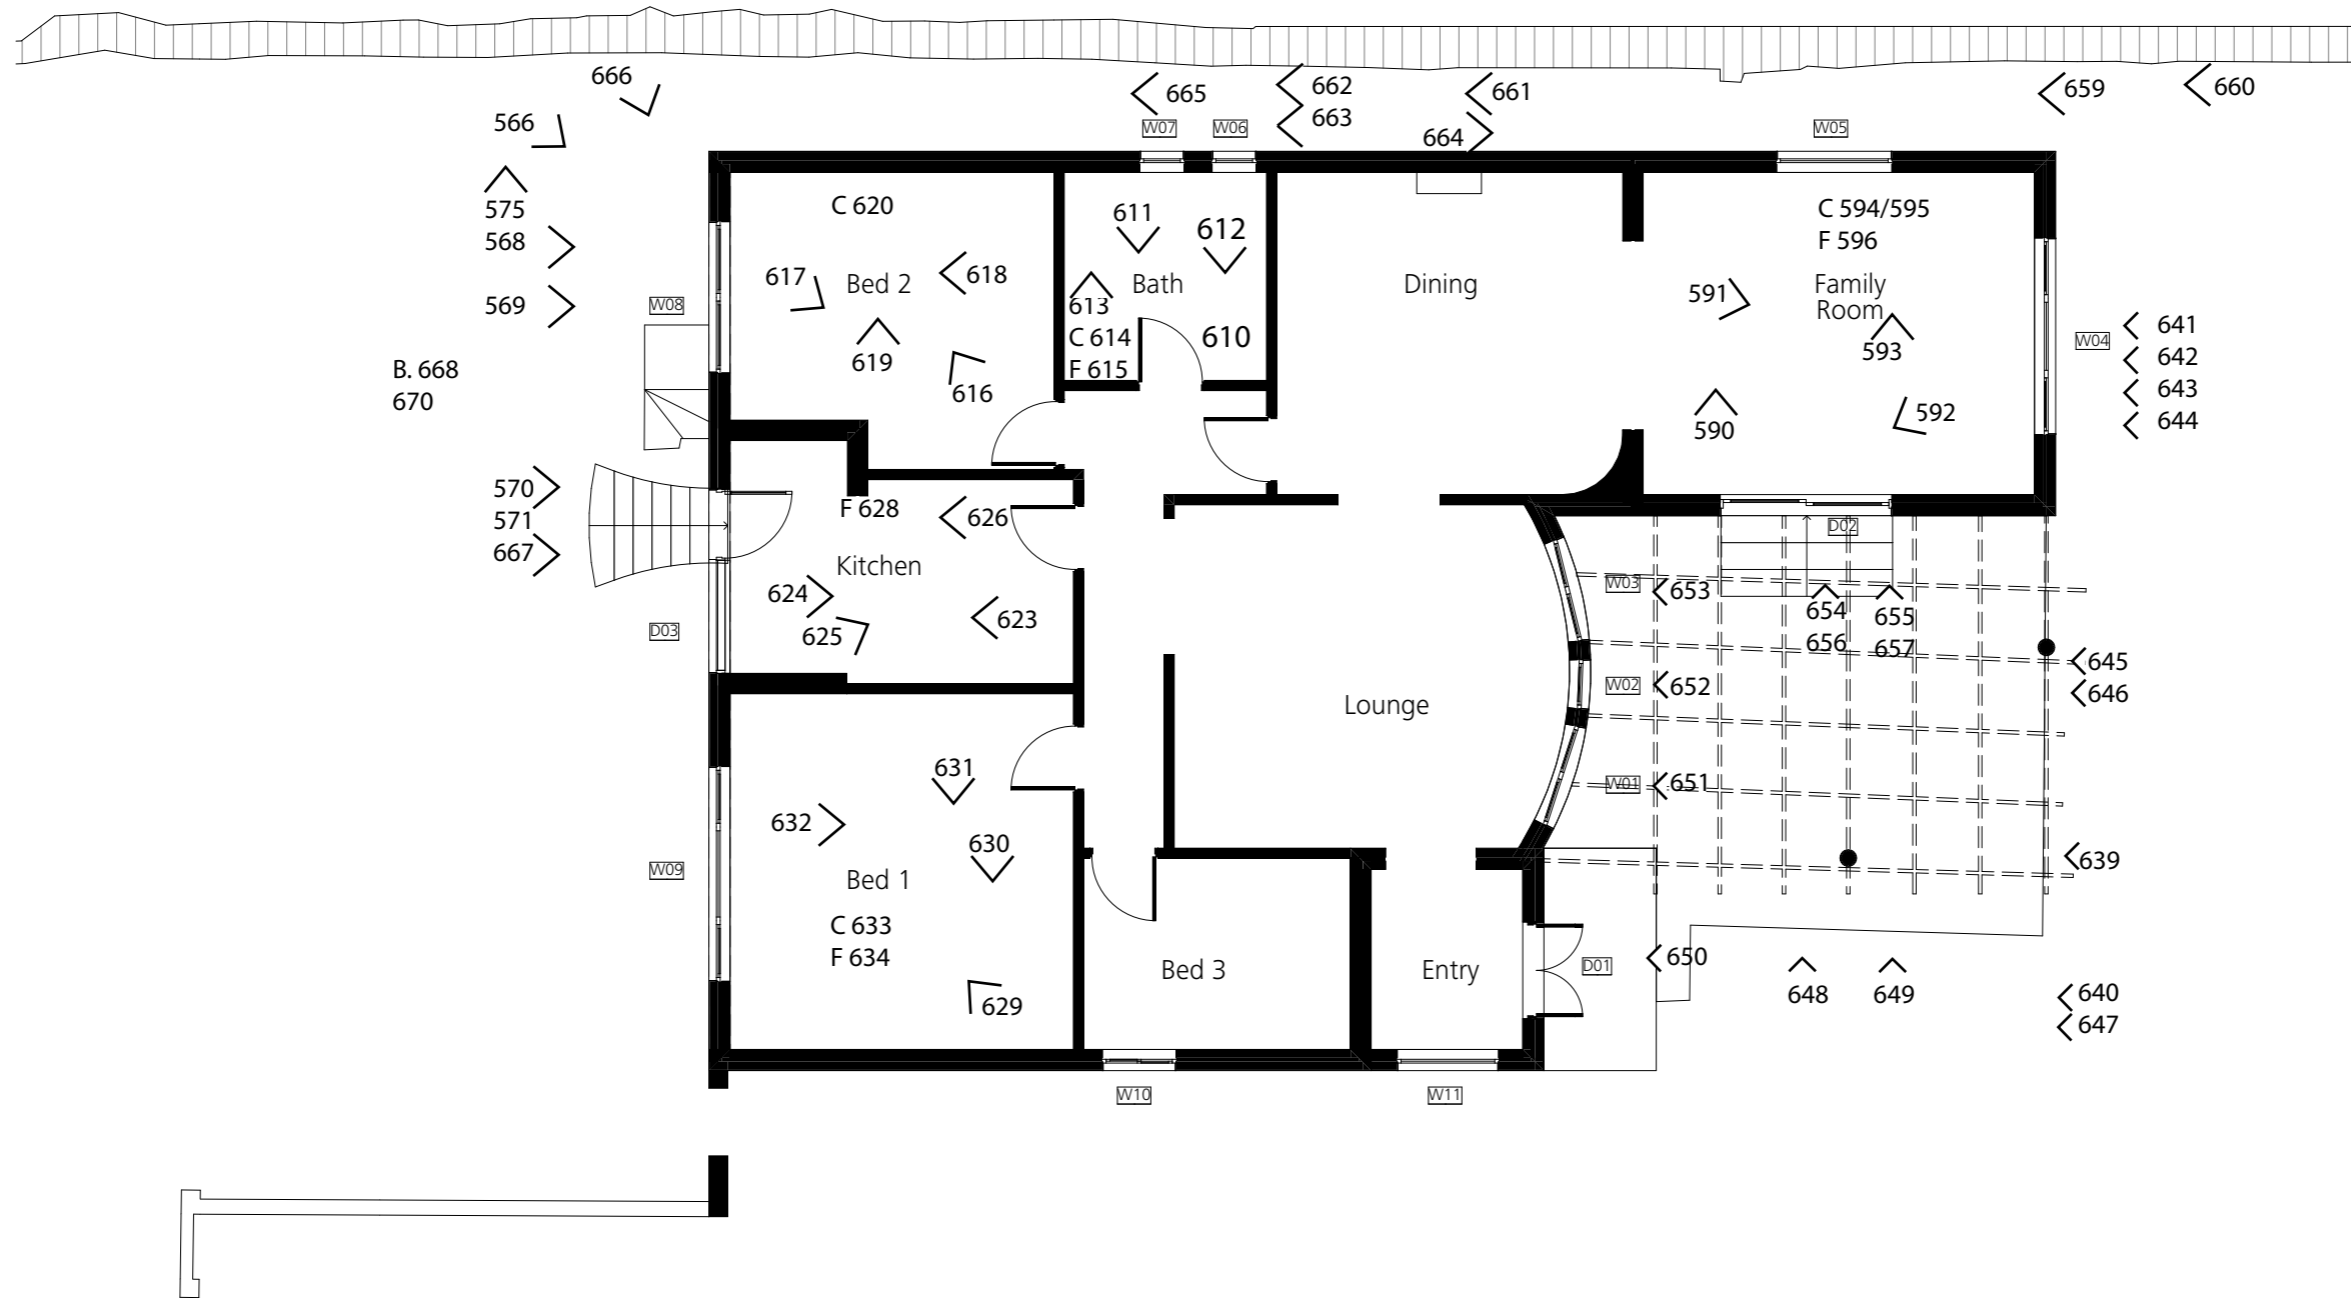
SK 1886.01

307 Sydney Road, Balgowlah
Context, Site, and Exterior Elevational Photographs and Ground Floor Plan
By Architectural Projects dated 30.5.22
