SERVICE PROTECTION REPORT

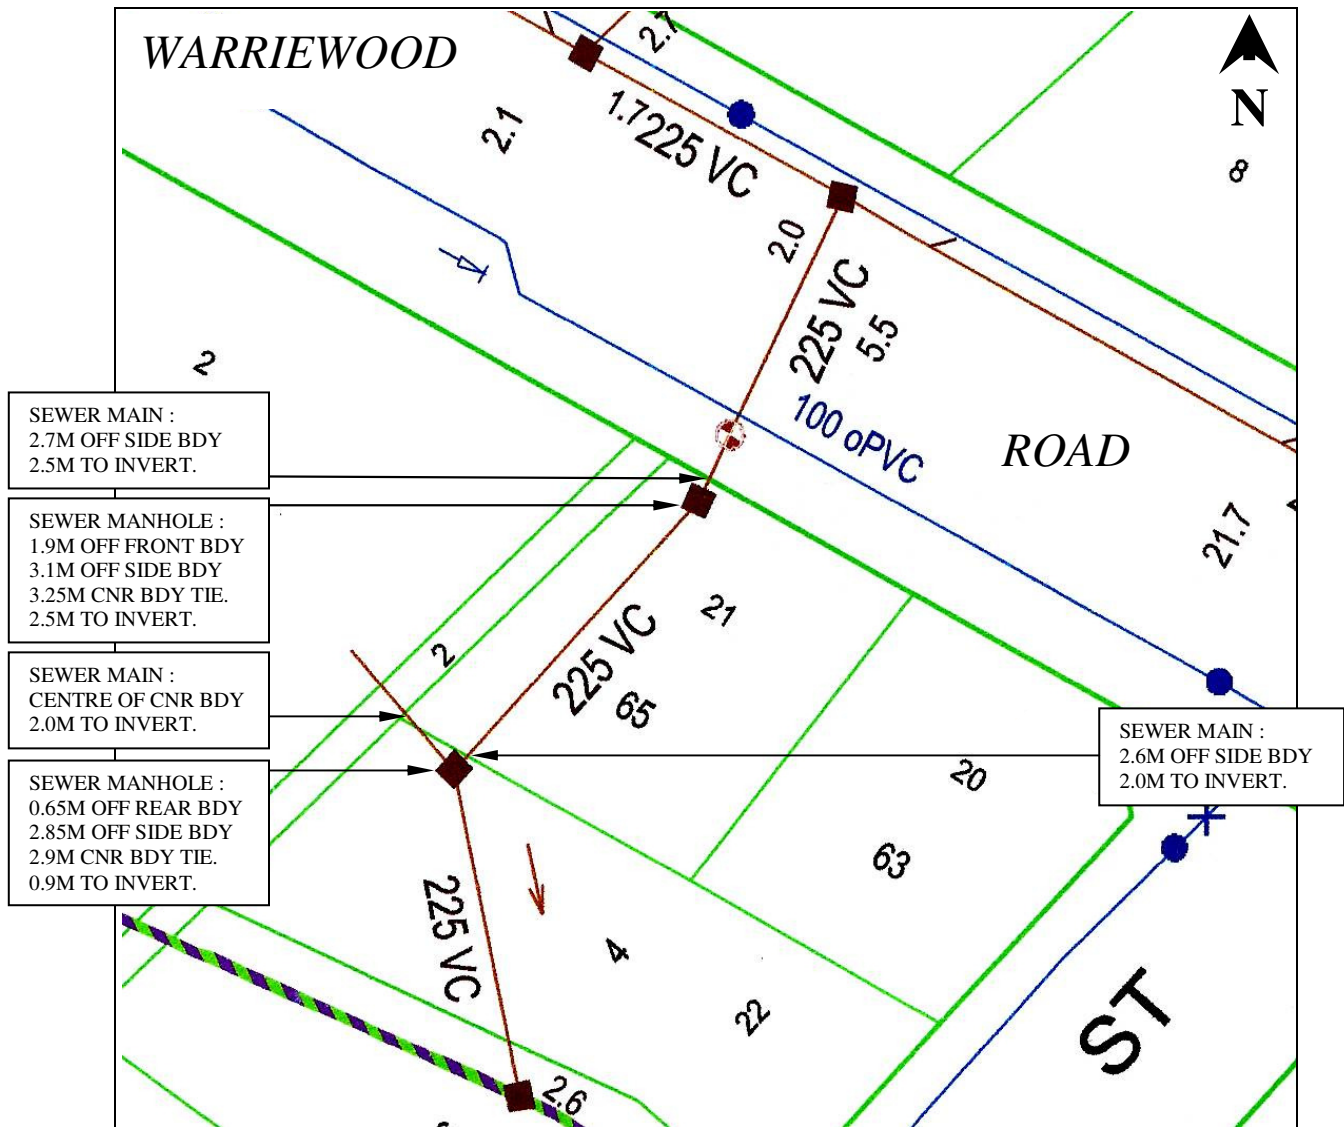
SYDNEY WATER ASSETS MUST BE POTHOLED BY HAND PRIOR TO EXCAVATION / PIERING / CONSTRUCTION WORK.

Asset Location Method: Electronic Equipment / Accessing Structures.

Pipe Size: 225mm

Pipe Type: VC.

Strata: Clay

Asset Indicators: Paint mark on Boundaries.

NB : ALL MEASUREMENTS TAKEN OFF BOUNDARY PEGS / RET. WALLS ONLY.
