Plan of Management

Petrest Crematorium

Unit 2, 4 Taronga Place, Mona Vale

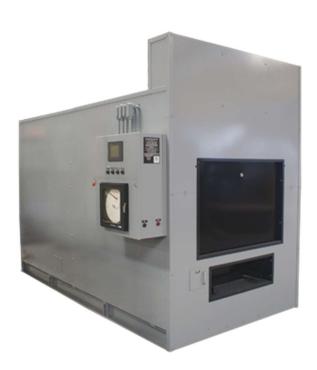
Appendix A – Example image of cremator to be installed. Model No. BPL 500-M3 Pet Cremator

Source: B&L Cremation Systems

The furnace to be installed is known as the BPL 500-M3 Pet Cremator. The furnace will be provided by HCS Industrial, Australian agents for B&L Cremation Systems, USA and ATI Incinerateurs, France.

The furnace comprises two (2) chambers, known as the primary and secondary chamber. The primary chamber is where the animals are placed for cremation. The purpose of the secondary chamber is to incinerate any combustible matter carrying over from the cremation process. The secondary chamber operates at 850°C, which is sufficient to eliminate any smoke and odour carry over from the primary chamber.

The furnace is fitted with an opacity monitor that is continually monitored during the operation of the furnace. In the unlikely event any smoke is detected in the exhaust system, the primary burners will turn off for a set period of time (2-3 minutes), and additional air is introduced to the furnace to assist with the process. If the emission has cleared after this time, the burners will be re-enabled, and cremating will continue.
