Preliminary Geotechnical Assessment

For Alterations and Additions at
65 Suffolk Avenue, Collaroy NSW

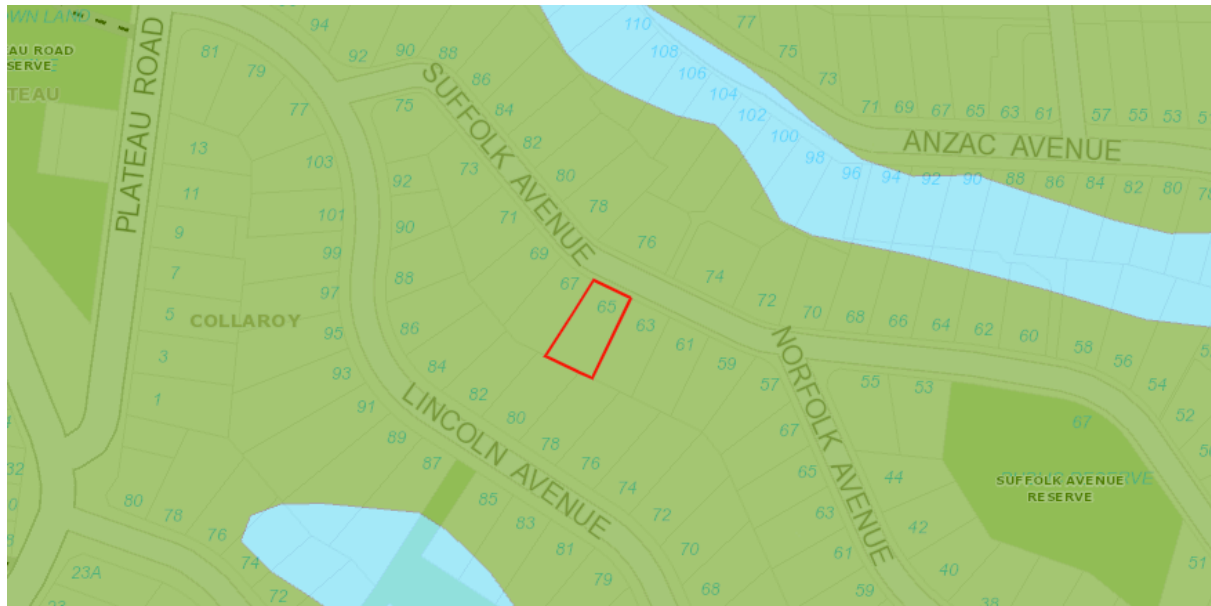
The site is mapped as **Area D** on the Landslip Risk Map WLEP 2011 (**Image 1**, below).

WARRINGAH LANDSLIP RISK MAP

- Area A - Slope less than 5 degrees
- Area B - Flanking Slopes from 5 to 25 degrees
- Area C - Slopes more than 25 degrees
- Area D - Collaroy Plateau Area Flanking Slopes 5 to 15 degrees
- Area E - Collaroy Plateau Area Slopes more than 15 degrees
