## **Preliminary Geotechnical Assessment**

**Project:** New Dwelling  
14 Ernest Street, Balgowlah Heights NSW

**REF: AG 21437**  
13 December 2021

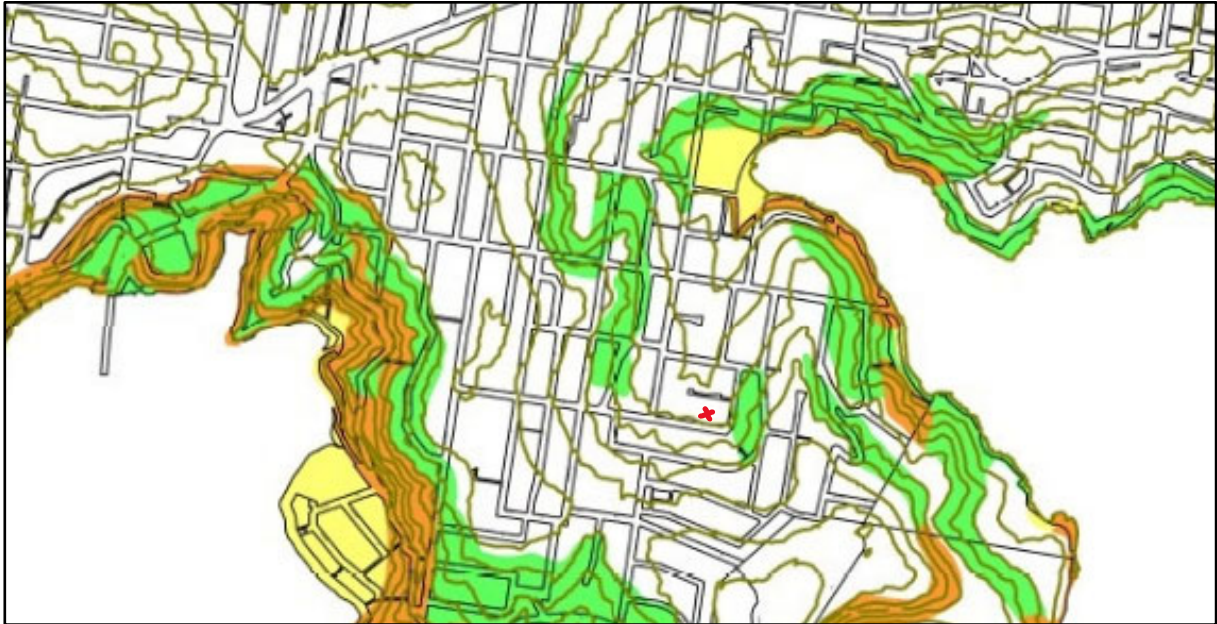
**Image 2.** MDCP Landslip Hazard Map: 14 Ernest Street, Balgowlah Heights NSW - red cross (© NBC Maps)

The site is classified as **Area G4** with reference to Schedule 1, Map C, Potential Landslip Hazard Areas, Appendix 1B of the Manly Development Control Plan (**Image 1**).
