Alterations & Additions 1A The Serpentine, Bilgola Beach NSW

Following our site inspection of the existing structure on 28 April 2022, we have concerns regarding the effect of the level of the natural ground and trees directly adjacent to the southwest edge of the house.

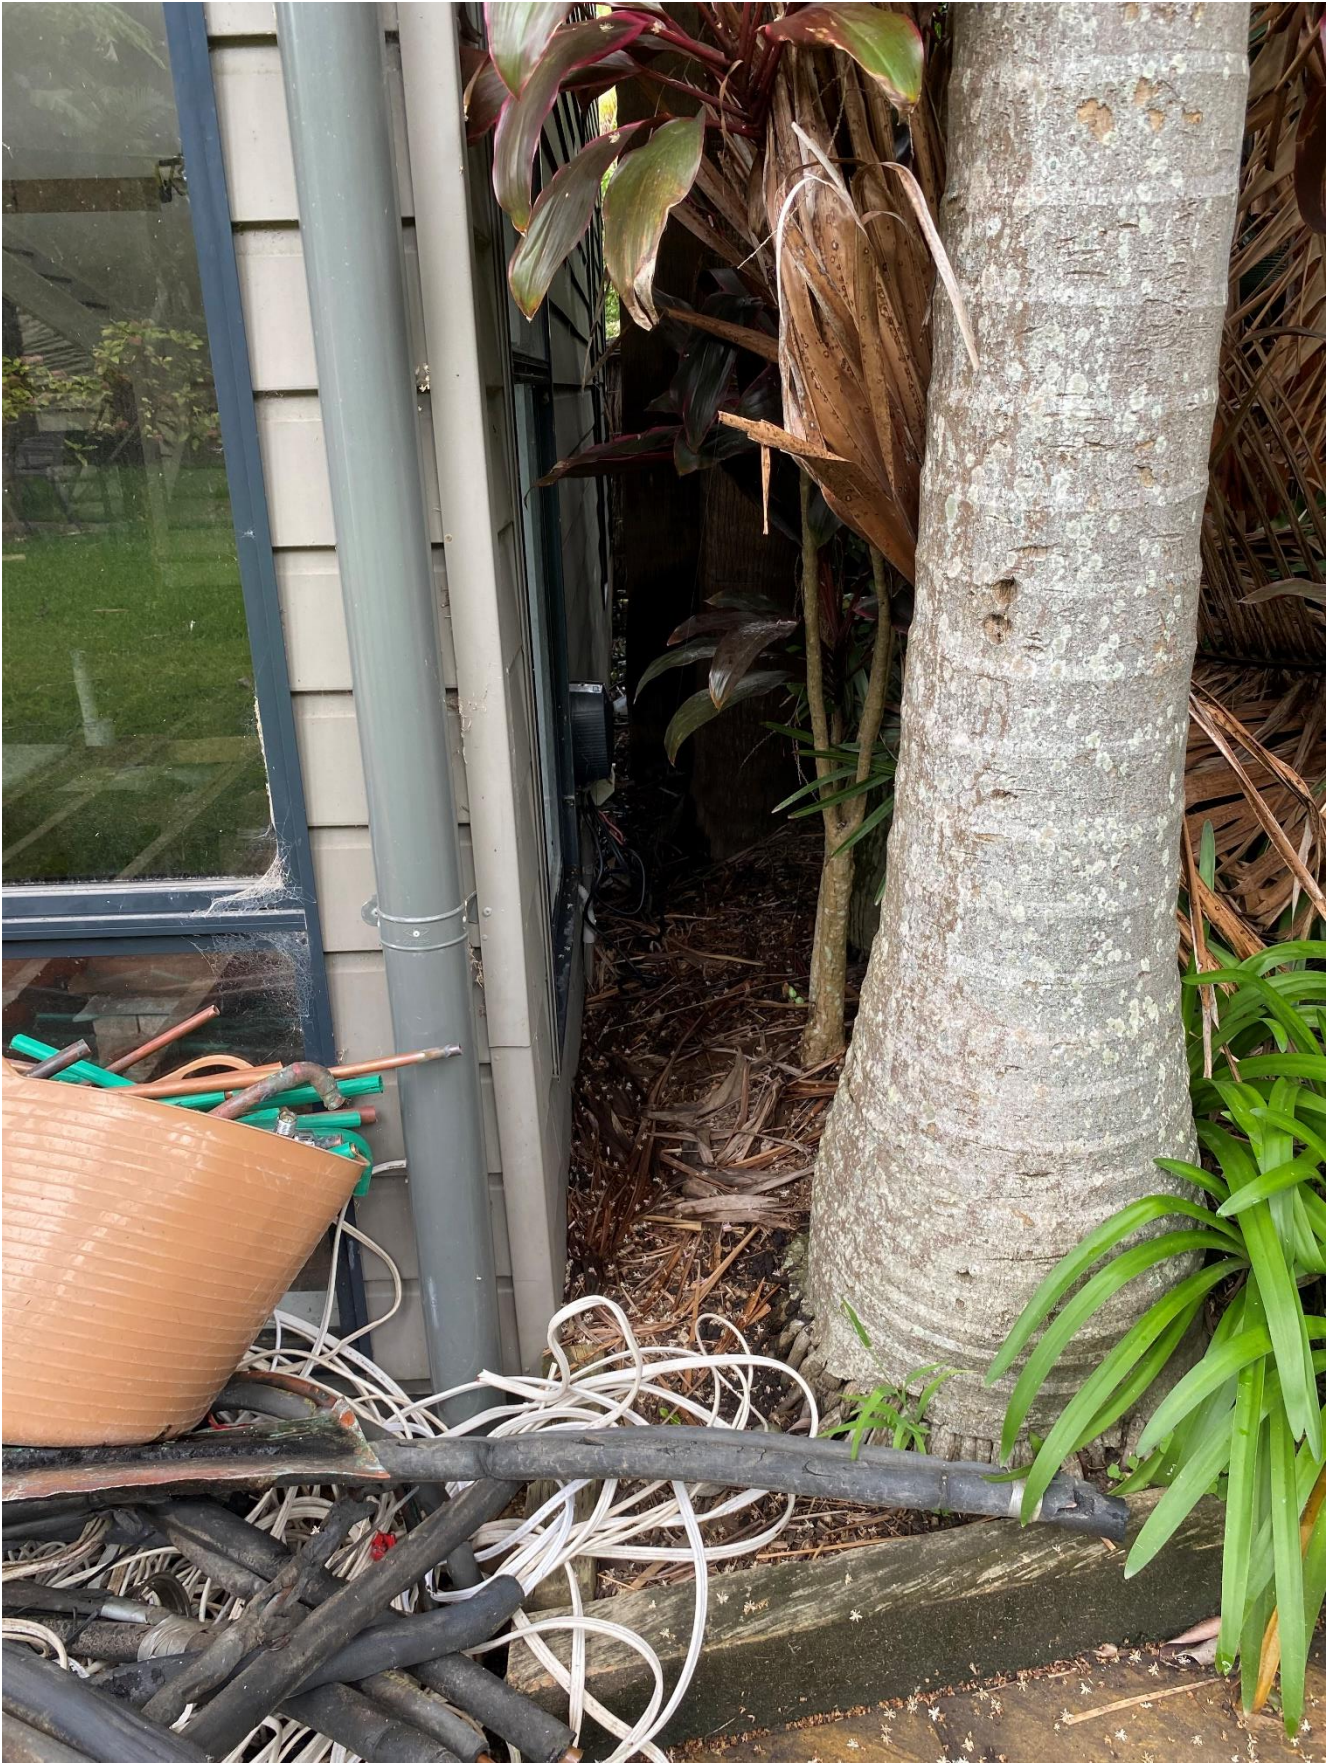
Due to the garden bed being above the cladding level and hence timber framing, the existing wall frame has rotted, and tree roots have penetrated the floor space below the timber framed floor. Due to a lack of cross ventilation in the area, the natural ground below the floor is damp, offering an ideal environment to attract termites. Please refer to the attached pictures.

External view of South west Wall

We propose to replace the entire side wall of the house to the top of the existing strip footing and then install a concrete or solid block wall to raise the level of the timber framing above the surrounding ground level and include penetration in such a wall to promote cross ventilation of the subfloor.

Therefore, to address our concerns and to achieve a structurally adequate solution in accordance with the Building Code of Australia and Australian standards, we request that the level of the external garden bed be lowered along the southwest side of the house. To achieve such a solution, we recommend that the trees directly adjacent to the house will need to be removed.

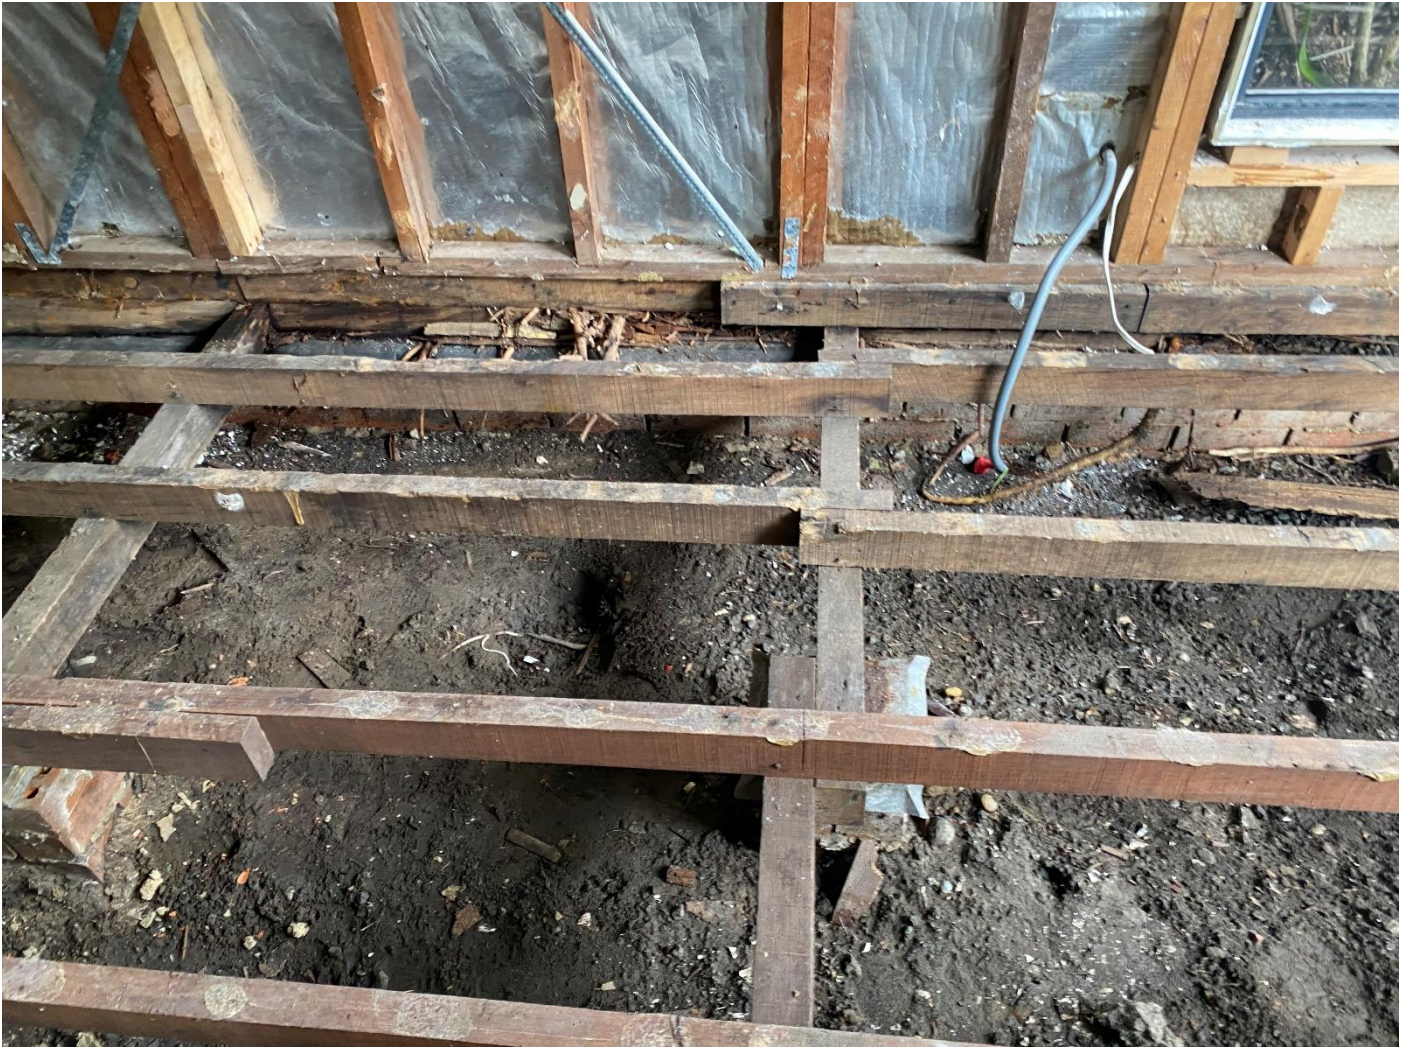
Internal Timber Framing of South West Wall and Floor
