**DRAFT FINAL REPORT:**

**Northern Beaches Council Stormwater Management Study**

February 2022

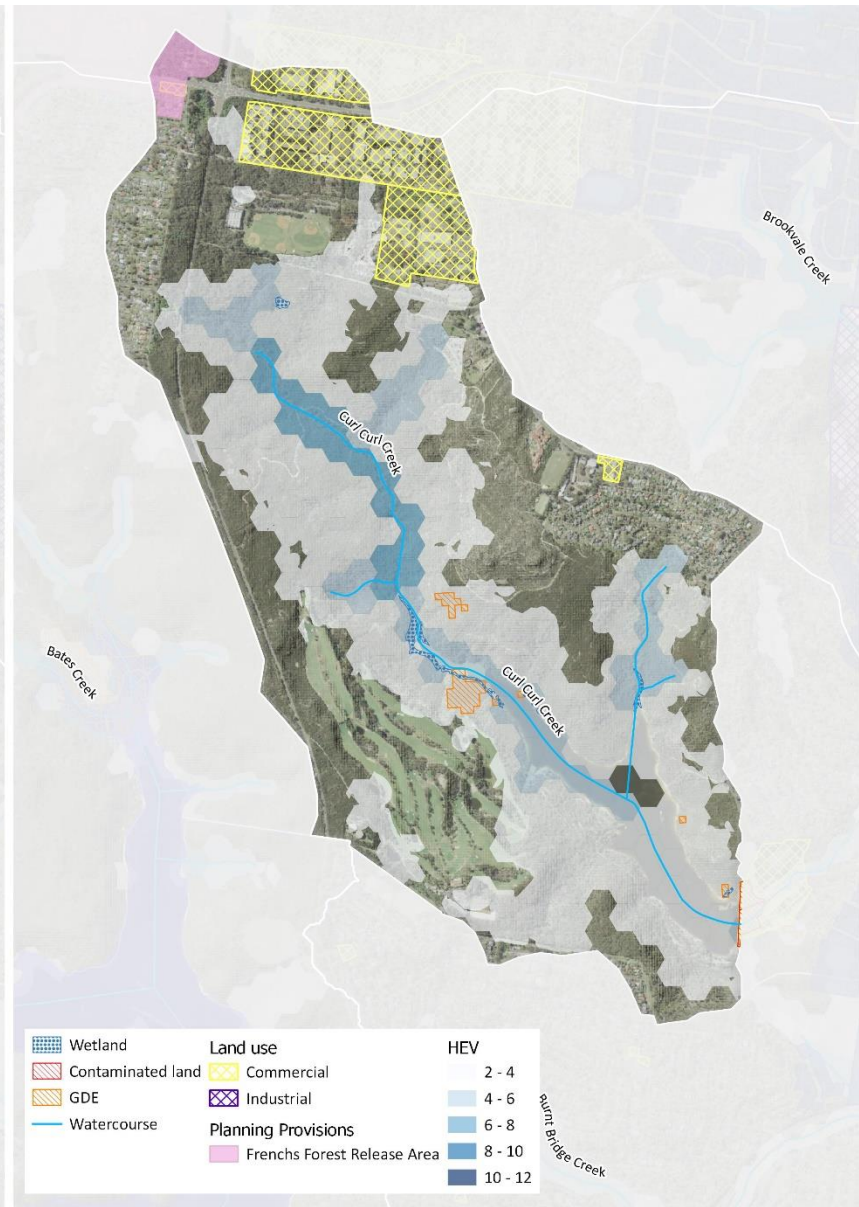
#### 4.4 Curl Curl Creek

Curl Curl Creek	Current fraction imperviousness: 12 % (Potential increase <2%)			References
<b>Objectives and timeframe for community environmental values and uses</b>	<p><b>Freshwater creek:</b> <i>Maintain or Improve</i> condition for aquatic ecosystems, visual amenity and secondary contact recreation. <i>Maintain or improve</i> existing condition for flows including 1) Protect pools in dry times; 2) Protect natural low flow; 3) Mimic natural drying in temporary waterways; and 4) Manage groundwater for ecosystems.</p> <p><b>Dam:</b> <i>Maintain or Improve</i> existing condition for all environmental values and uses</p>			Local Strategic Planning Statement (LSPS)
<b>Existing values</b>	<ul style="list-style-type: none"> <li>• High ecological value</li> <li>• High recreational and scenic value</li> <li>• HEV score higher along main creek line upstream of dam</li> </ul>			Monitoring Evaluating and Reporting (MER) Project 2015/2016

<b>Existing catchment pressures and stressors</b>	<p><b>Curl Curl Creek</b></p> <ul style="list-style-type: none"> <li>• Poor water quality</li> <li>• Potentially polluted groundwater or fertiliser use resulting in high nitrogen levels</li> <li>• Elevated turbidity level points to soil disturbance in the catchment</li> <li>• Some weeds present</li> </ul> <p><b>Manly Dam</b></p> <ul style="list-style-type: none"> <li>• Wet weather increases nutrient flows to the dam which promote phytoplankton growth (e.g. in 2008).</li> <li>• Release of water from the dam which occurs occasionally and after major rainfall events flushes Cyanobacteria (and phytoplankton) improving water quality</li> </ul>			Warringah Creek Management Study 2004  Manly Dam Water Quality Draft Report _1July_2010
Conditions	Key indicators	Existing condition	Trajectory	Draft waterway objectives
<b>1. Hydrology</b>	Imperviousness	Expected to be slightly modified	Stable with small increase in imperviousness expected in the next 20 years	<b>Maintain condition</b>

<b>2. Water quality</b>	Turbidity, nutrients, macroinvertebrates, microbial	<p>TP and TN above trigger value for aquatic ecosystems.</p> <p>NOx at or just above trigger value for aquatic ecosystems.</p> <p>Macroinvertebrates diversity is similar to that expected to be present</p>	Stable with small increase in imperviousness expected in the next 20 years	<p><b>Improve condition</b></p> <p>*noting multiple sources of pollution Address potential erosion issue in the catchment</p>

Elevated turbidity levels.		
<b>3. Riparian vegetation</b>	Riparian vegetation extent and quality, weed infestation	Riparian zone connected to good quality bushland, very few weeds and high conservation value (NSW OEH, 2016)	Stable	<b>Maintain condition</b>
<b>4. Physical form</b>	Geomorphic condition, bed and bank erosion, sedimentation, sand slugs	-Upper reach (500m) highly modified urban stream -Mid to lower reaches (to Manly Dam) primarily confined by bedrock with boulders and cobbles in channel and pools, riffles and waterfalls. Good geomorphic condition	Stable	<b>Maintain condition</b>

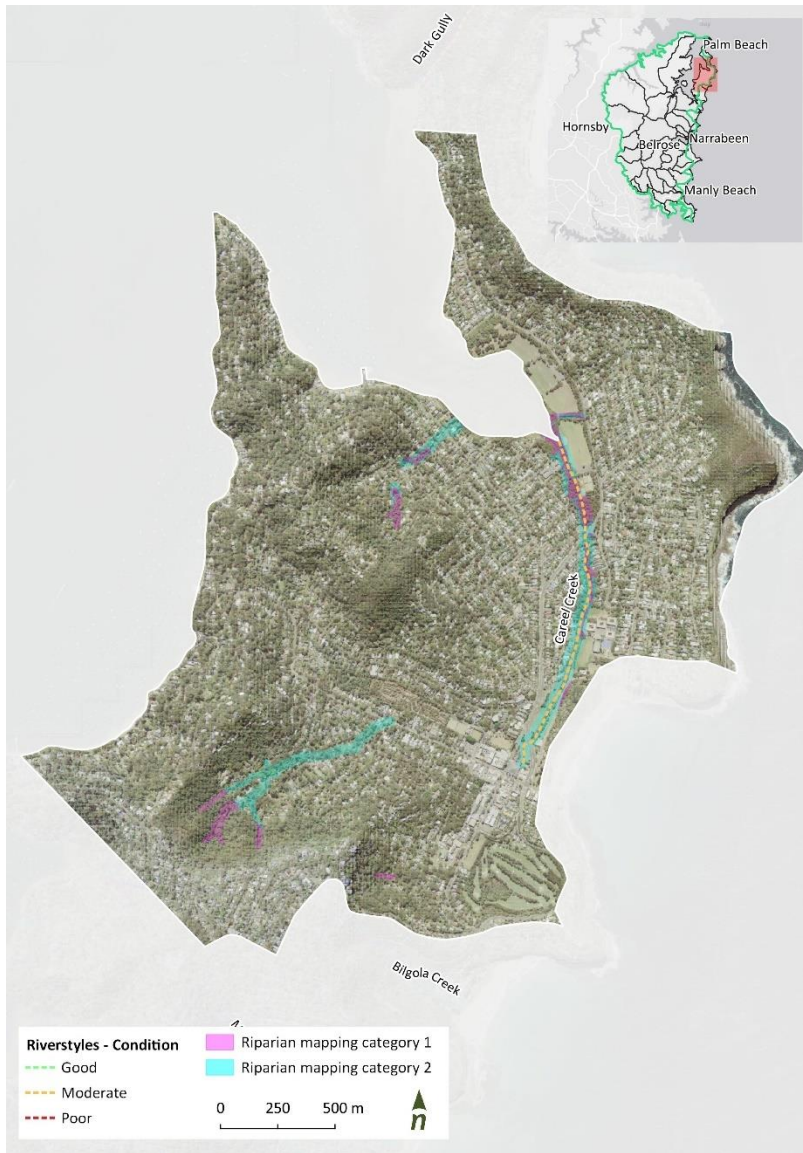
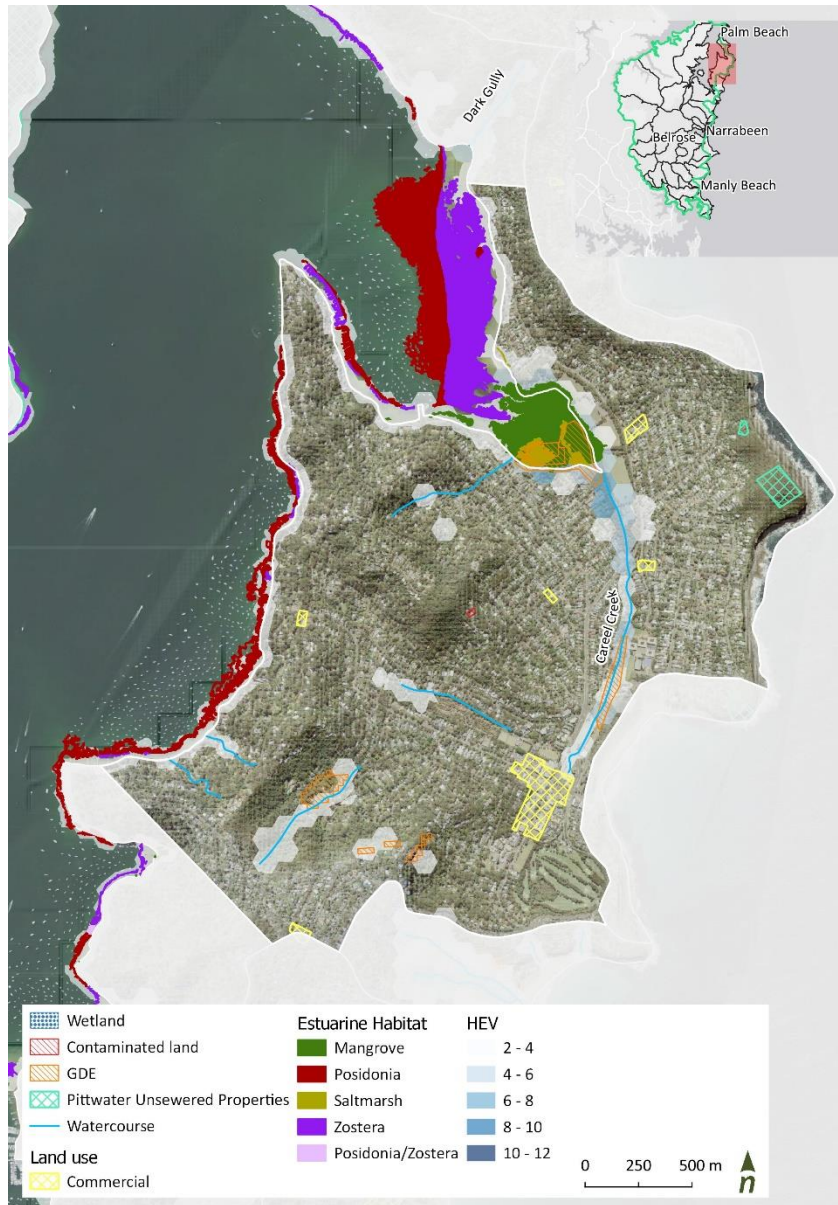
## 4.7 Careel Creek

<b>Careel Creek</b>	<b>Current fraction imperviousness: 25 % (Potential increase &lt; 4%)</b>	
<b>Objectives and timeframe for community environmental values and uses</b>	<p><b>Freshwater creeks:</b> <i>Maintain or Improve</i> existing condition for visual amenity; <i>Improve</i> condition for aquatic ecosystems and secondary contact recreation (5-10 year timeframe); <i>Maintain or improve</i> existing condition for flows including 1) Protect pools in dry times; 2) Protect natural low flow; 3) Mimic natural drying in temporary waterways; and 4) Manage groundwater for ecosystems.</p> <p><b>Estuary (Careel Bay):</b> <i>Maintain or Improve</i> existing condition for all environmental values and uses</p>	Local Strategic Planning Statement (LSPS)
<b>Existing values</b>	<p><b>Careel Creek</b></p> <ul style="list-style-type: none"> <li>• Substantially modified – large concrete channel</li> <li>• Low riparian vegetation along channel. Weeds present.</li> <li>• Endangered Ecological communities closer to Careel Bay</li> </ul> <p><b>Careel Bay</b></p> <ul style="list-style-type: none"> <li>• Wetland habitats (mangrove forest, saltmarsh, mudflats, seagrass beds)</li> <li>• Saltmarsh has decreased significantly since 1946</li> <li>• Mangroves have spread over the saltmarsh</li> </ul>	<p><b>References:</b></p> <p>BMT-WBM Careel Creek Issues Paper Final - December 2010</p> <p>FINAL REPORT Urban Sedimentation and Pollution Audit in the Pittwater Estuary - Environmental Investigation Report - AWC Consulting Sept 2012</p>

<b>Existing catchment pressures and stressors</b>	<p><b>Careel Creek</b></p> <ul style="list-style-type: none"> <li>• High volume of runoff and poor water quality</li> <li>• Gross pollutant/litter loads. Decaying organic matter source of odour</li> <li>• High tidal flow – flow can leave channel easily</li> <li>• High nutrient levels (decomposition of litter, stormwater input, sewer overflow)</li> <li>• Flooding (open channel has capacity up to 20% AEP)</li> <li>• Nutrient loads promoting weeds along creek line. Creek in turn contributing weeds to saltmarsh</li> <li>• High levels of urbanisation</li> <li>• Septic seepage</li> </ul> <p><b>Careel Bay</b></p> <ul style="list-style-type: none"> <li>• Poorly flushed bay. Stormwater inputs takes time to dissipate</li> <li>• Sewer overflows and stormwater inputs enhancing presence of mangroves</li> <li>• Sedimentation over saltmarsh enhances establishment of mangroves</li> <li>• Sediments are contaminated from boating, light industry and domestic activities</li> <li>• Faecal coliforms sometimes high especially in dry weather (septic seepage?)</li> <li>• Bike tracks affecting salt marsh area</li> </ul>

Conditions	Key indicators	Existing condition	Trajectory	Draft waterway objectives
<b>1. Hydrology</b>	Imperviousness	Expected to be moderately to highly modified	Stable given small increase in imperviousness	<b>Improve condition</b> e.g. reduce runoff volume and flow rates to reduce flooding
<b>2. Water quality</b>	Turbidity, nutrients, macroinvertebrates, microbial	<p>TP and TN expected to be above trigger value for aquatic ecosystems.</p> <p>Macroinvertebrates diversity likely to be less than expected to be present</p> <p>Microbial level expected to be above trigger values for secondary recreation.</p>	Stable	<b>Improve condition</b>
<b>3. Riparian vegetation</b>	Riparian vegetation extent and quality	Very poor riparian condition upstream of Barrenjoey Road. Forested into estuarine wetlands in lower reaches - condition unknown	Stable	<b>Improve condition</b>
<b>4. Physical form</b>	Geomorphic condition, bed and bank erosion, sedimentation, sand slugs	Highly modified urban stream in upper and mid reaches (constructed concrete drain). Moderate geomorphic condition	Stable	<b>Improve condition where possible</b>
