GEOTECHNICAL ADVICE
REMEDIATION OF FAILED RETAINING WALL
55 ROBERTSON ROAD, SCOTLAND ISLAND, NSW

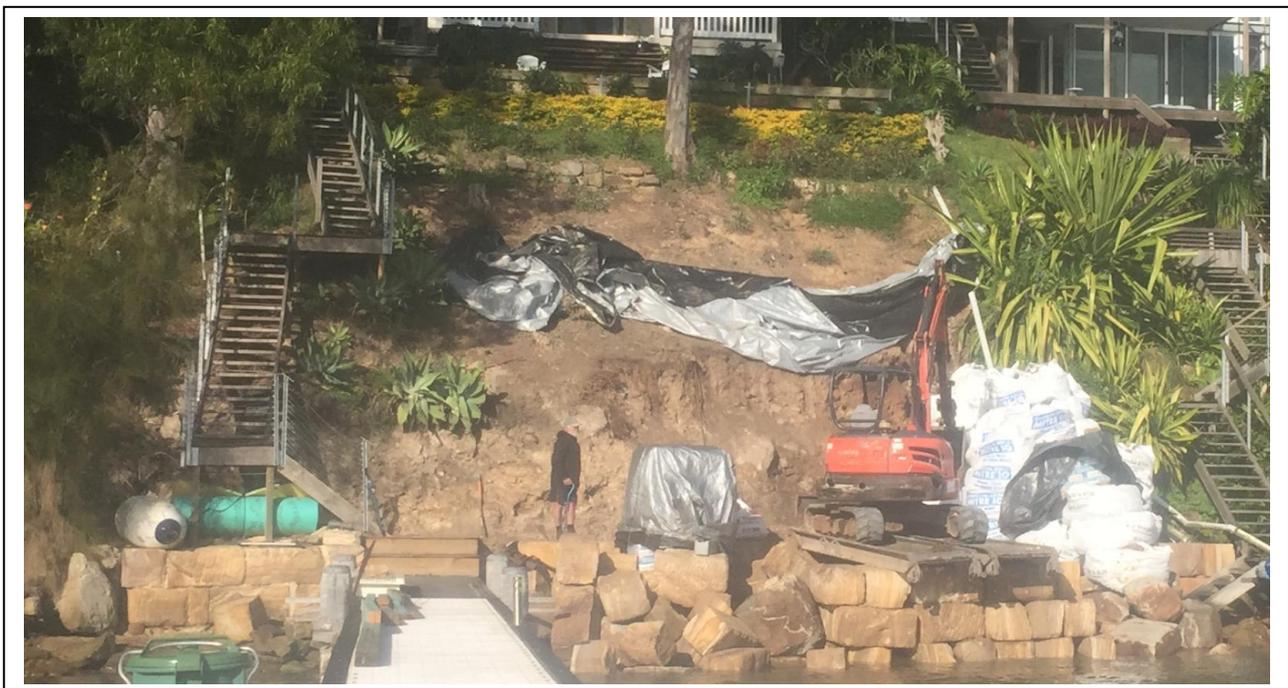
On 28 June 2021 the undersigned, Mr Woodie Theunissen, visited the above site to inspect the slope failure that has occurred at the front of the property along the waterfront. From the north of the house the ground drops down steeply to water at an angle of about 30°. The sandstone block wall located along the front of the property had been dismantled and excavation was underway to remove that portion of the slope that had already failed, the extent of which was about 5m from the seawall and was defined by tension cracks.

At the back of the removed sandstone block wall a cut face with a height of about 2.5m had been created. The materials exposed in this cut comprised approximately 1.6m of clay fill overlying natural clay and extremely weathered siltstone bedrock. Siltstone bedrock of at least very low strength was exposed at the

base of the cut, which is at roughly the top of the seawall. Immediately behind the wall fill was exposed. The seawall had a height of about 1.5m with sandstone bedrock generally visible at the toe of the sea wall.

It is understood that a new Dintel retaining wall will be constructed to support the cut. This wall will be founded on the underlying sandstone bedrock. For the design of this wall we recommend the that the following design parameters be adopted:

- A triangular earth pressure distribution,
- A coefficient of active earth pressure, K_a , of 0.8,
- A bulk unit weight of 20kN/m^3 ,
- All surcharge loads and appropriate hydrostatic pressures must be added to the above pressures,
- Unless the existing seawall has sufficient capacity to resist the applied lateral loads all lateral loads must be transferred to the underlying sandstone bedrock by socketing piers into the bedrock. A lateral resistance of 200kPa may be adopted for that part of the pile that extends greater than 0.5m into the underlying sandstone bedrock.
- Where piles are founded on the underlying sandstone bedrock of at least very low strength they may be designed for an allowable bearing pressure of 600kPa. All piles should have a nominal socket of 0.3m.

At the time of our site visit the existing excavation had extended to roughly the alignment of the proposed wall. Near vertical cuts had been formed through the fill and natural soil. It should be noted that vertical cuts through soils are potentially unstable and may collapse at any time without warning. Consequently, we recommend that temporary batters be formed through the soil at no steeper than 1 Vertical(V):1 Horizontal(H) or the cut be temporarily propped. Even where propping is proposed, we recommend that the soils which have already slipped (i.e. those soils on the downhill side of the tension cracks) be removed and the soils behind battered. The contractor must take care during construction that the slope is appropriately supported such that the works can be safely constructed.
