Heritage 21 has been asked to summarise the key historical factors relating to the subject building at 21 Whistler Street, Manly.

1. Heritage Statement

2. Historical Context (extracted from the Statement of Heritage Impact report dated Sep 2018)

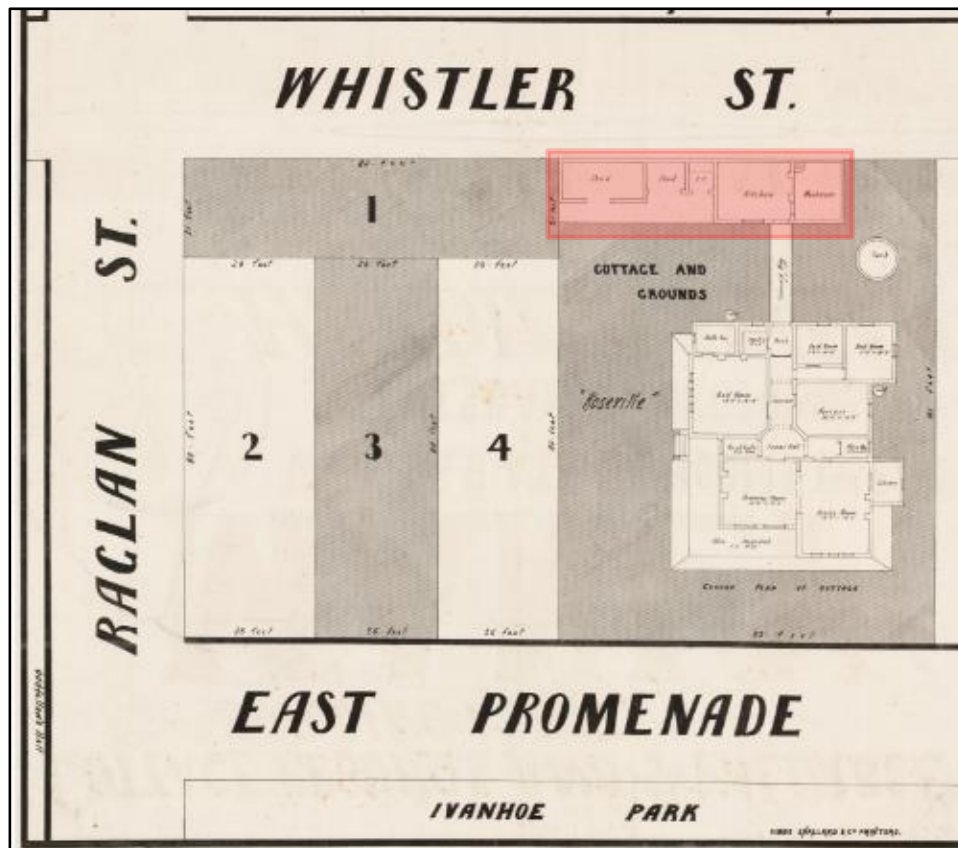
Figure 6. Subdivision of larger allotment. Original 1877 rear domestic wing highlighted by red box (Source: State Library of NSW. 698 - SP/M5/742 - Cottage, Grounds and 4 valuable Building Sites Manly)

Historical research has not been able to uncover the extent of demolition of the domestic service wing, however a detailed inspection of the existing building by Heritage 21 has found no significant physical evidence of the 1877 structure. Further, as depicted in Figures 6 to 9 below, the original subdivision plan and later image of “Roseville” cottage demonstrate differences in proportion, scale and fenestration detailing of the original service wing. Therefore, it is our conclusion that the existing building was erected at some point between 1917 and 1939.

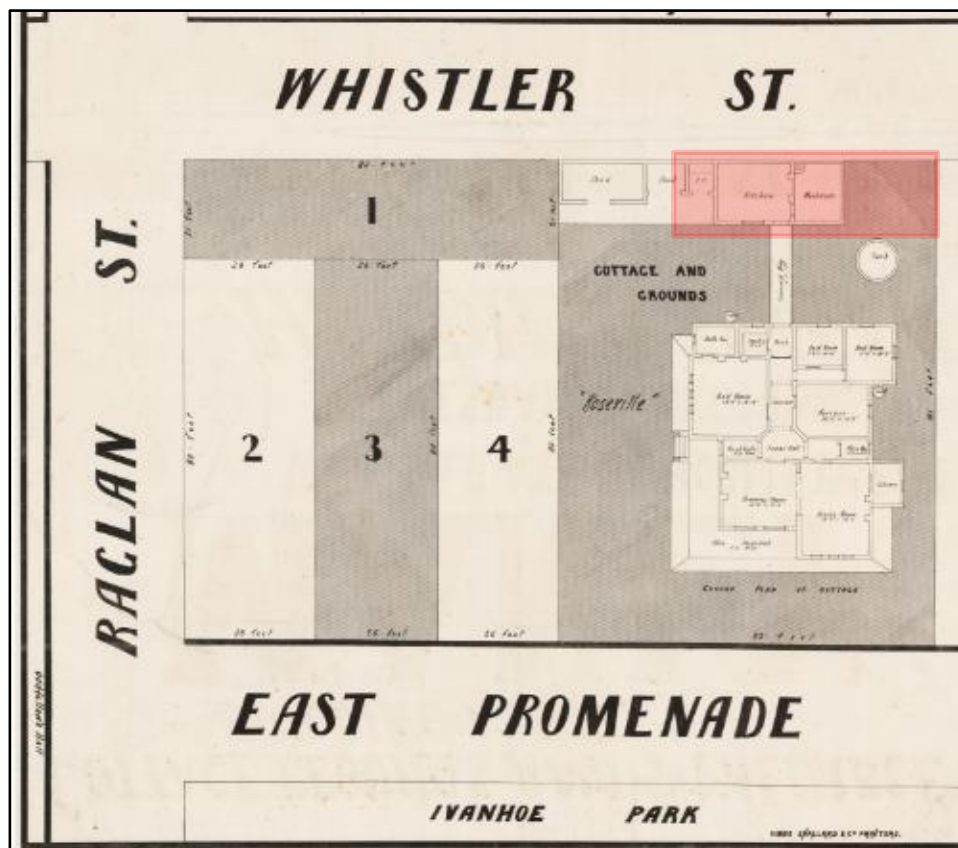
Figure 7. Subdivision of larger allotment. Approximate siting of the 1884-1917 rear domestic wing highlighted by red box (Source: State Library of NSW. 698 - SP/M5/742 - Cottage, Grounds and 4 valuable Building Sites Manly)

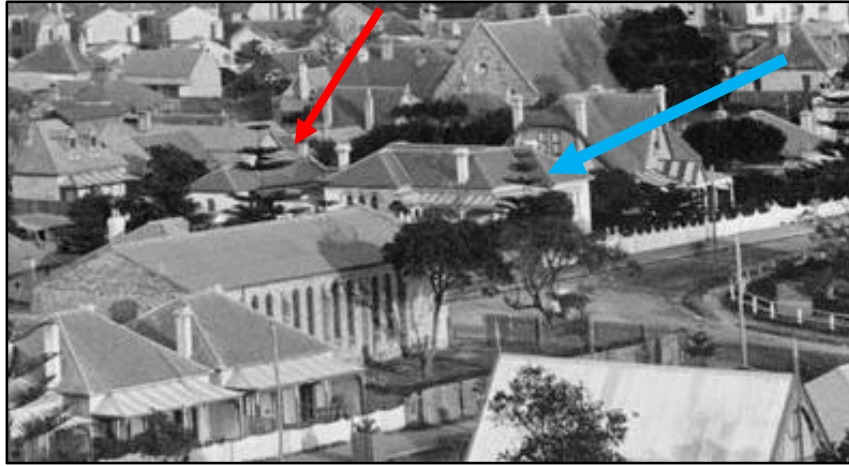
Figure 8. Image of “Roseville” cottage and rear domestic dwelling, corresponding with the configuration of the rear domestic wing in Figure 6 above. Blue arrow marks original cottage, red arrow marks location of domestic wing. Note the configuration of the built form of the service wing differs in proportions, scale and details including fenestration, to that of Figure 6 above. (Source: MAAS. Glass plate negative, full plate, ‘Manly, looking east’, Kerry and Co, Sydney, Australia, c. 1884-1917. <https://collection.maas.museum/object/28691>)

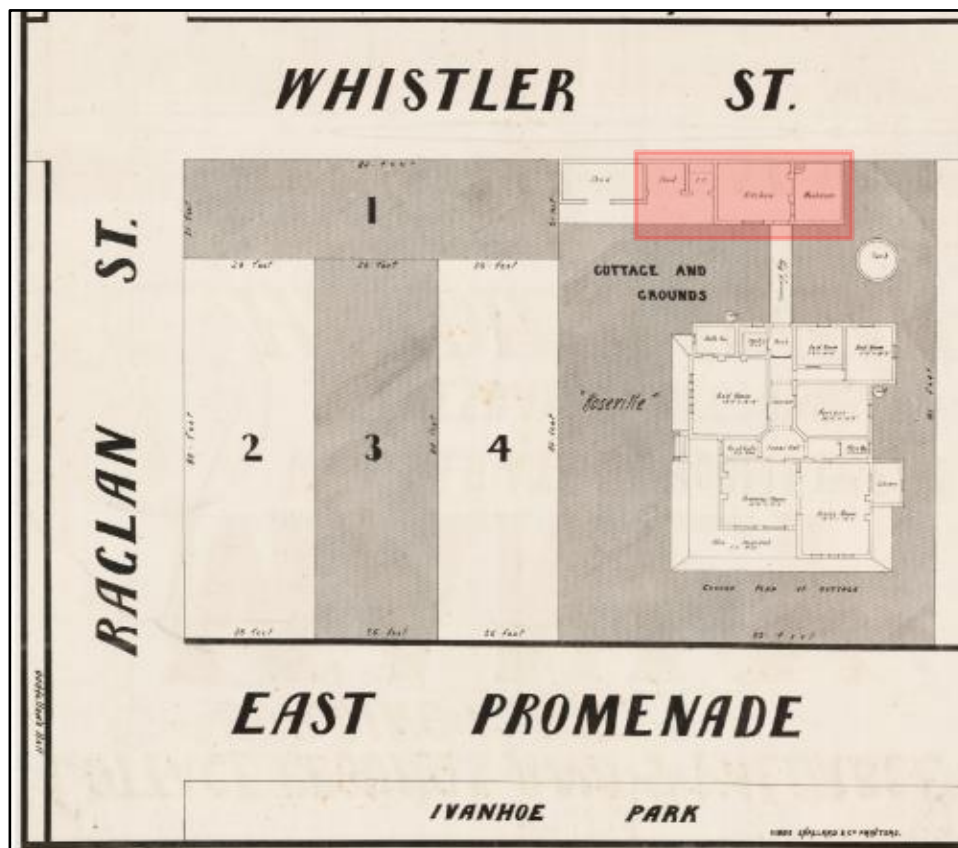
Figure 9. Subdivision of larger allotment. Approximate existing location of subject building highlighted by red box (Source: State Library of NSW. 698 - SP/M5/742 - Cottage, Grounds and 4 valuable Building Sites Manly)

It is the opinion of Heritage 21 that the siting of the existing subject building responds to the footprint of the domestic service wing, which was located to the rear of the original “Roseville” structure.
