Martin Peacock Tree Care  
Arboricultural & Horticultural Consultancy

Arboricultural Statement – Proposed Boatshed, 60 Hudson Parade, Clareville, NSW

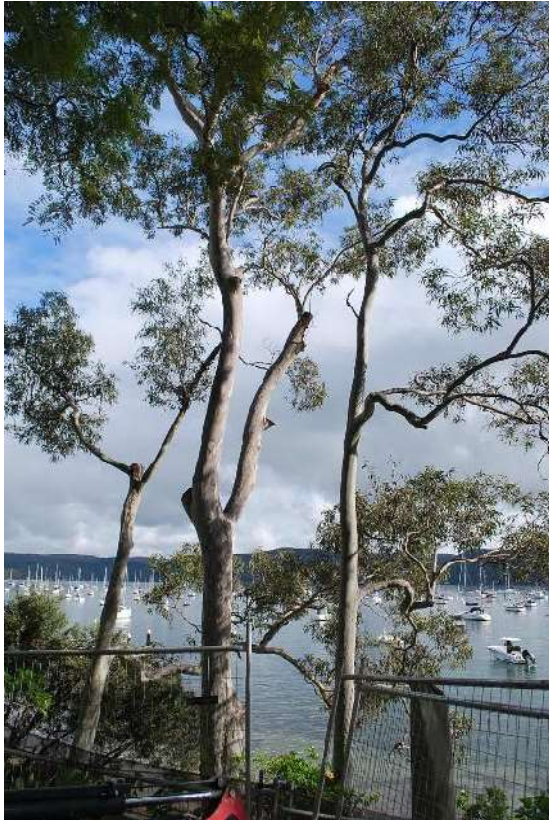
1: Showing Trees T15-T17 (right to left)

When undertaking approved development works the establishment of TPZ areas for Trees T15, T16 and T17 will be required. Due to the sloping nature of the site a combination of trunk and ground protection will be required. Tree specific TPZ requirements should be determined as part of a pre-construction site meeting between the Project Arborist and the Project Manager. Development works within the TPZ areas should use tree sensitive methods as detailed within *Section 9.0 Recommendations* of the AIA Report.

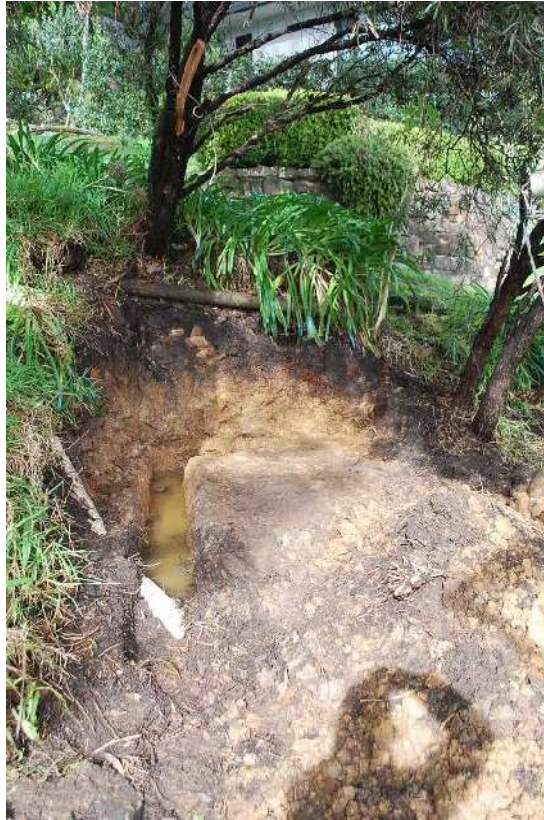
The investigatory excavation works demonstrate that construction of the Boatshed should not impact Trees T15, T16 and T17, as no woody roots are present in the rear section of the Boatshed footprint and the front section of the Boatshed will be constructed above existing grade on piers (located to avoid significant roots).

2: Showing Boatshed footprint excavated to required depth (bottom of proposed slab).

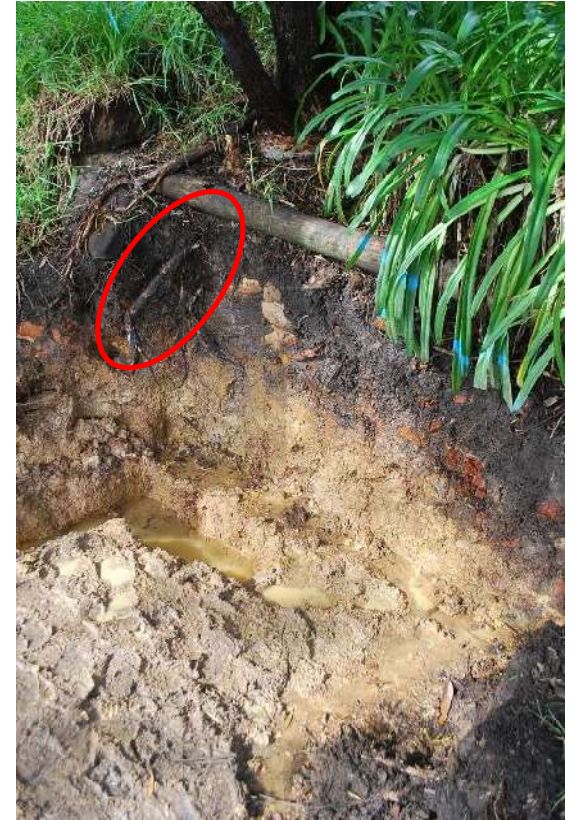
Based on the above; to determine the impact of Boatshed construction upon the trees' the entire footprint of the Boatshed was excavated by hand to the required depth (bottom of slab). Only one (1) woody tree root which originated from an adjacent *Callistemon viminalis* (Weeping Bottlebrush) was identified within the Boatshed footprint (refer Appendix B – Photographs).

3: Showing *Callistemon* root identified by excavation works
