Bush Fire Assessment Report

8 Barrabooka Street, Clontarf, NSW

FPAA Accreditation No: BPAD31642 Report No: 8Bar-01 Date: 20/07/2022

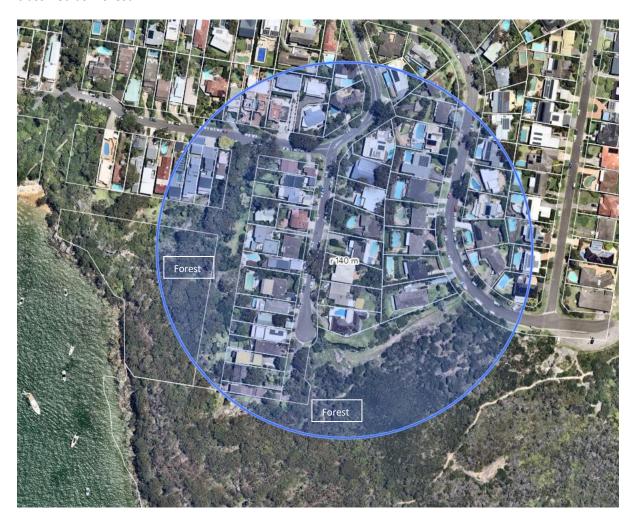
Figure 4: Aerial photo showing vegetation within 140m of the site.

For the purpose of a Bush Fire Risk Assessment, vegetation within 140m of the site is assessed and classified. In this instance there is Category 1 vegetation that lies to the south and west of the site which is of significance. The predominant vegetation formation within this area consists of Sydney Coastal Dry Sclerophyll Forest (Refer to Figure 5) which for the purpose for this assessment will be classified as 'Forest'.

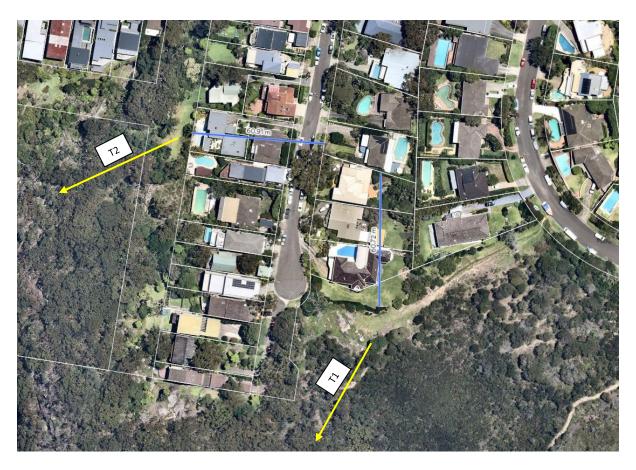
Figure 7: Aerial photo showing distance to surrounding vegetation.

Transect	Distance to classified vegetation	Vegetation Classification	Assessment of effective slope	FDI	Bushfire Attack Level
T1	61.96m (60.72m off site, 1.240m onsite)	Forest	Downslope >5-10 degrees	100	BAL-19
T2	61.96m (60.72m off site, 1.240m onsite)	Forest	Downslope >10-15 degrees	100	BAL-19

<u>Summary:</u> Based upon the relevant provisions of PBP and AS3959-2018, the maximum anticipated radiant heat attack for the dwelling is <19kW/m2 and the subsequent minimum construction standard is BAL-19 AS 3959- 2018.
